## Technical Bulletin No. 007

### LP® SmartSide® Trim and Siding Explanation of High and Low Point Overlay Fissures

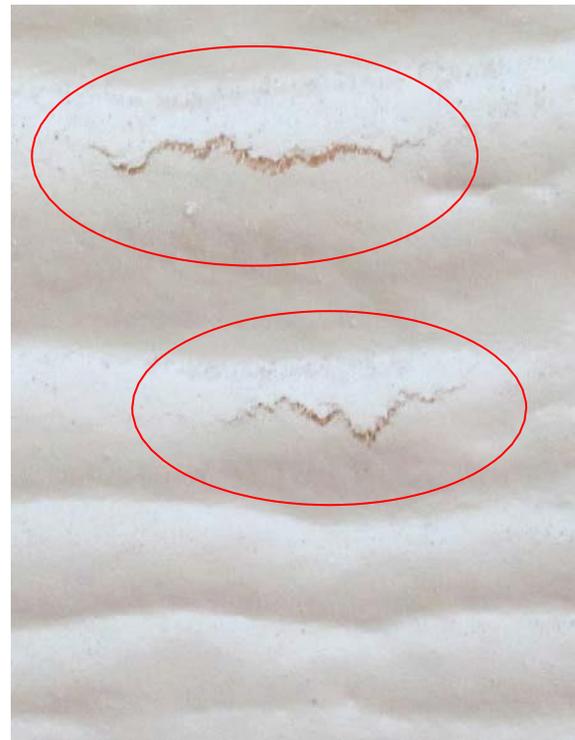
**Figure 1**

Small surface fissures may be evident in the overlay face and are inherent to the SmartSide production process. Figure 1 provides an example of a surface fissure. The primed overlay is stretched up to eighteen inches when the texture is pressed into the surface. Small surface fissures will occur at the peaks and valleys of the texture where the texture is highly defined. These very small cracks do not reduce the performance or durability of our siding.

Once the product is finished, these fissures become less evident and are difficult to locate unless someone is intentionally seeking them out. Viewing them from any distance is nearly impossible. The fissures tend to be an amber color and contrast somewhat with the factory primer. When finishing SmartSide trim and siding, white and lighter color paints will require enough film thickness to avoid any paint transparency.
