Evaluation of Impact Damage Resistance of Two Types of Commercial Housing Siding

National Aeronautics and Space Administration
Glenn Research Center
Ballistic Impact Laboratory

Dec. 21, 2012

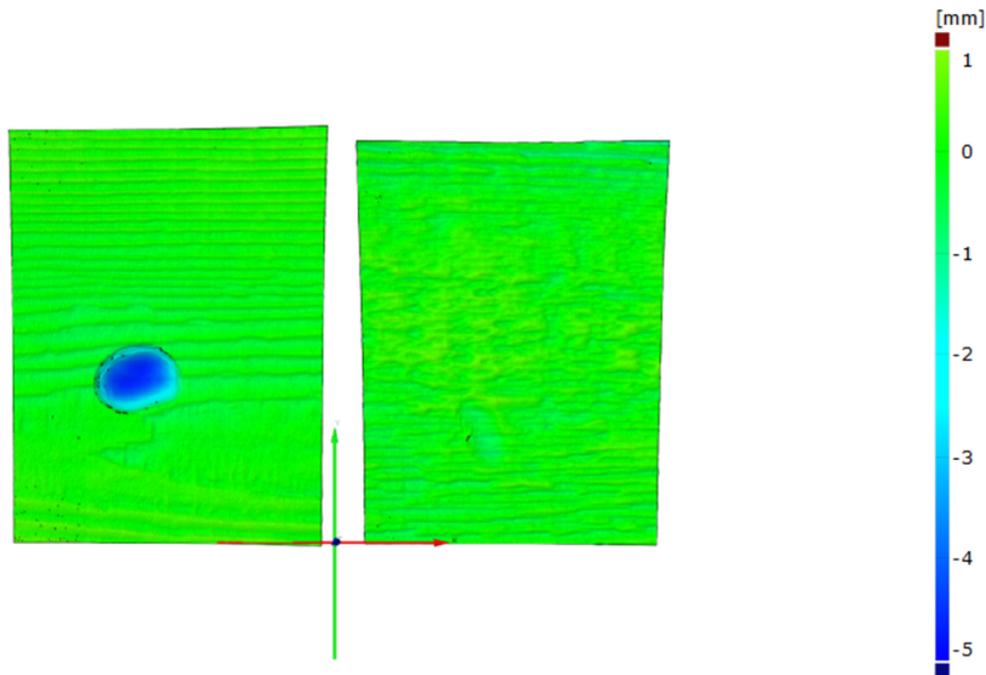
Figure 6. Surface topology from FC (left) and LP (right) panels from tests LVG712 and LVG714

The FC sample sustained a relatively deep dent on the front of the panel with a depth of 4 to 5 mm. The LP panel sustained a small dent with a depth of approximately 1 mm.

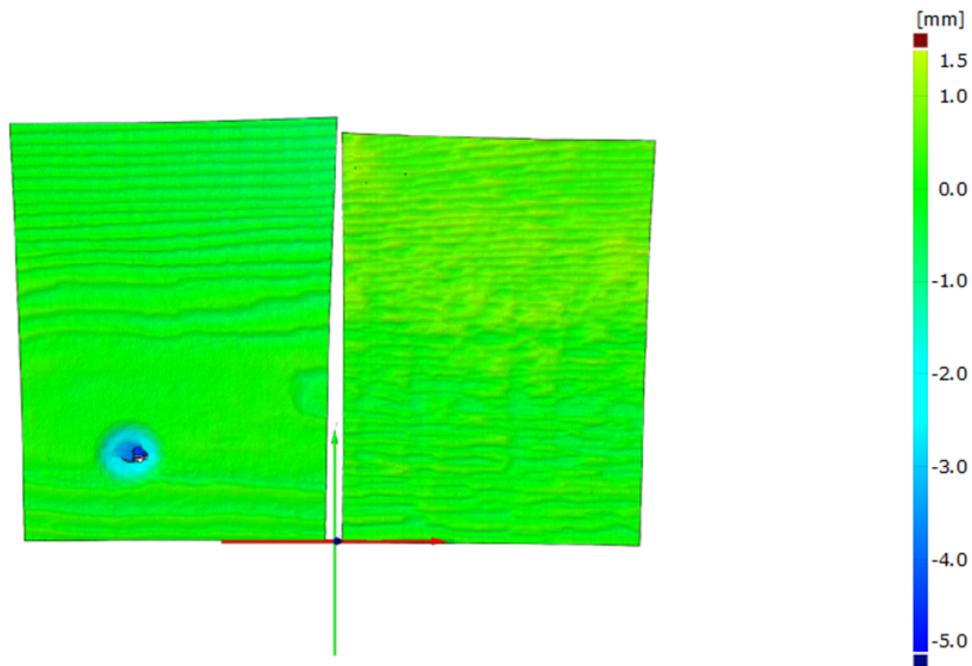
Figure 7. Surface topology from FC (left) and LP (right) panels from tests LVG719 and LVG718

For the golf ball projectile the surface scans from tests LVG719 and LVG718 were compared. The impact velocities were 49.4 mph for the EC siding sample and 63.8 mph for the LP siding sample. Figure 7 shows the surface topology after impact. There was essentially no damage in the LP siding sample, but the FC siding sample sustained a hole and significant spalling on the back side despite a lower impact velocity.

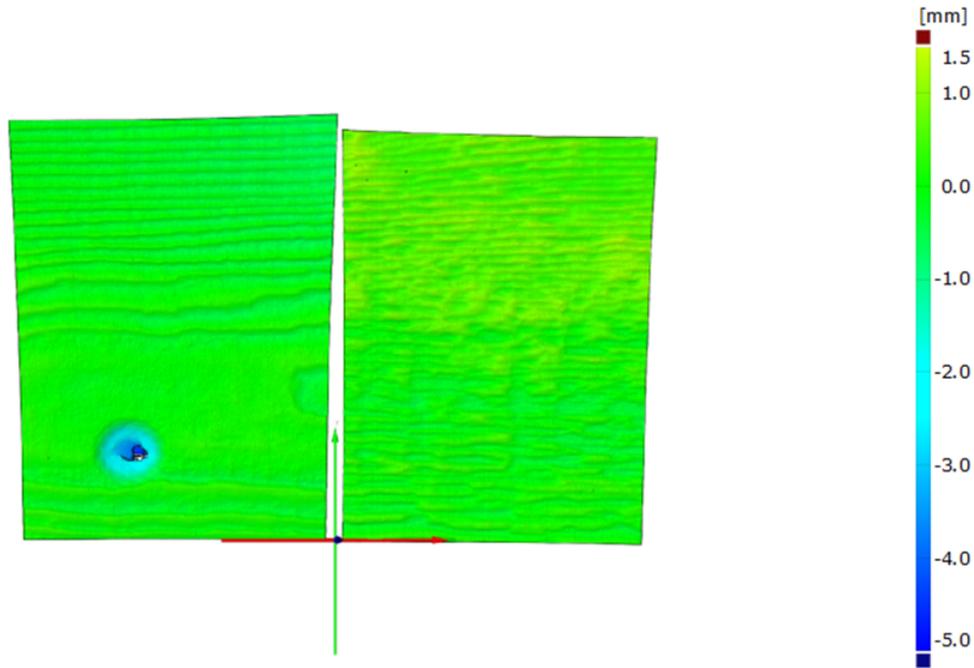
Figure 8. Surface topology from FC (left) and LP (right) panels from tests LVG720 and LVG723

For the marble projectiles surface scans from tests LVG720 and LVG723 were compared. The impact velocities were 120.8 mph for the FC siding sample and 114.5 mph for the LP siding sample. Figure 8 shows the surface topology after impact. There was significant front and backside damage to the FC sample. The LP sample had slight front side damage with some cracking of the paint. No significant structural damage was evident in the LP sample.

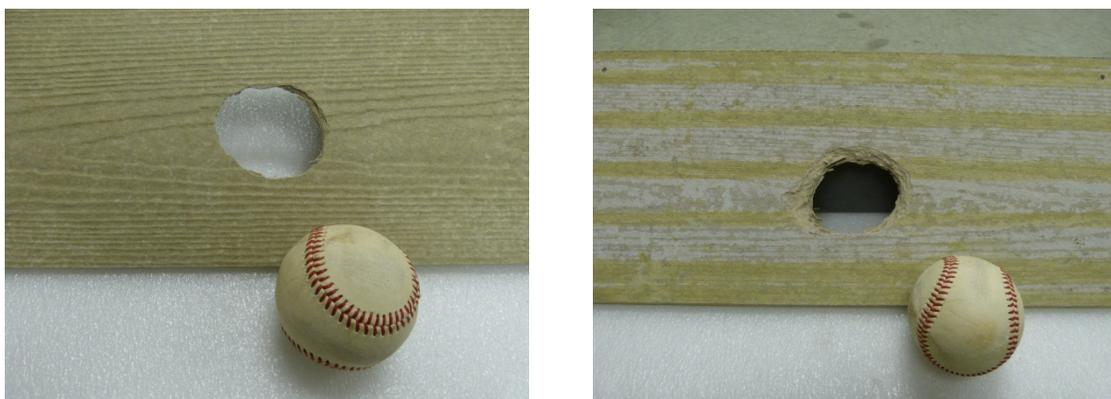
Figure 9. Posttest front (left) and rear (right) photos of FC panel impacted by a baseball in test LVG733

For the baseball projectile, surface scans were not conducted due to the extensive damage to the FC siding samples. Tests LVG733 and LVG731 were compared visually. The impact velocities were 72.8 mph for the FC siding sample and 77.7 mph for the LP siding sample. Photographs of the impacted panels are shown in figures 9 and 10. The FC siding sample sustained a large hole and backside spalling. There was no visual evidence of damage in the LP siding sample.
