# Failure Investigation of Boiler Tubes Failed Due to Thermal Fatigue and Corrosion Fatigue

Aditya Gokhale, Deepak Kumar Gope, Prahlad Halder, Anil Kumar Das,  
Anand D Varma\*

Advanced Materials Research Lab, NTPC Energy Technology Research Alliance, NTPC Ltd.,  
Greater Noida, Uttar Pradesh, India.  
anandvarma@ntpc.co.in

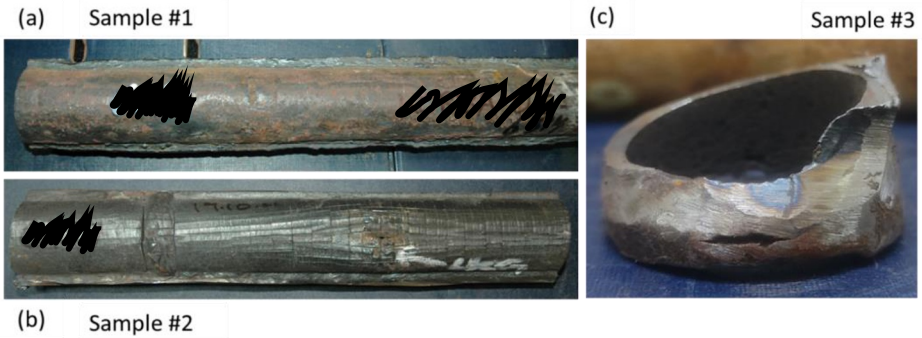
**Fig. 1.** Photograph of the as received failed tubes. (a) – (b) Water Wall tube (c) The stub of economiser tube connecting the header. Note: This belongs to the stub hence cutting was difficult.

Photographs of the as received failed tubes is shown in Figure 1. The chemical composition of the three samples is presented in Table 1. Sample #1 and #2 are water wall tubes conforming to SA 210-GrA and SA 213 – T22. Sample #3 is an economiser tube conforming to SA210 – GrA. The tubes showed numerous damage features. Figure 2 shows the magnified view of the different features observed on the three samples through naked eyes. Sample #1 showed no failure however it showed a dent, shown in Figure 2 (a) ① and numerous circumferential lines or serrations, shown in Figure 2 (a) ②, on the external surface. Sample #2 showed a puncture type failure, shown in Figure 2 (b) ②. Sample #2 also showed longitudinal and circumferential cracks on the external surface. Sample #3 was the region near the stub weld and there was a problem accessing and cutting the sample for analysis; as a result, a ring was sent for analysis. Severe grinding marks can be seen in Figure 1 (c).

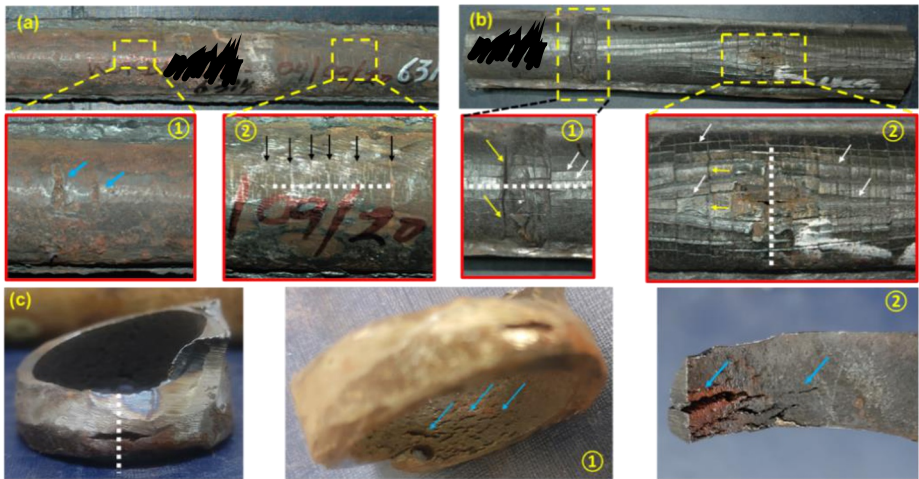
**Fig. 2.** Photographs of the as received failed tube showing different macro features (a) Sample#1: Water wall showing circumferentially aligned micro cracks, indicated by black arrows (b) Sample#2: Water Wall tube showing circumferentially longitudinally aligned cracks, indicated by yellow arrows and white arrows respectively. (c) Sample #3: The stub of economiser tube connecting the header. Internal surface showing numerous fissures, indicated by blue arrows. The white dotted line shows the sectioning plane for metallographic examination.

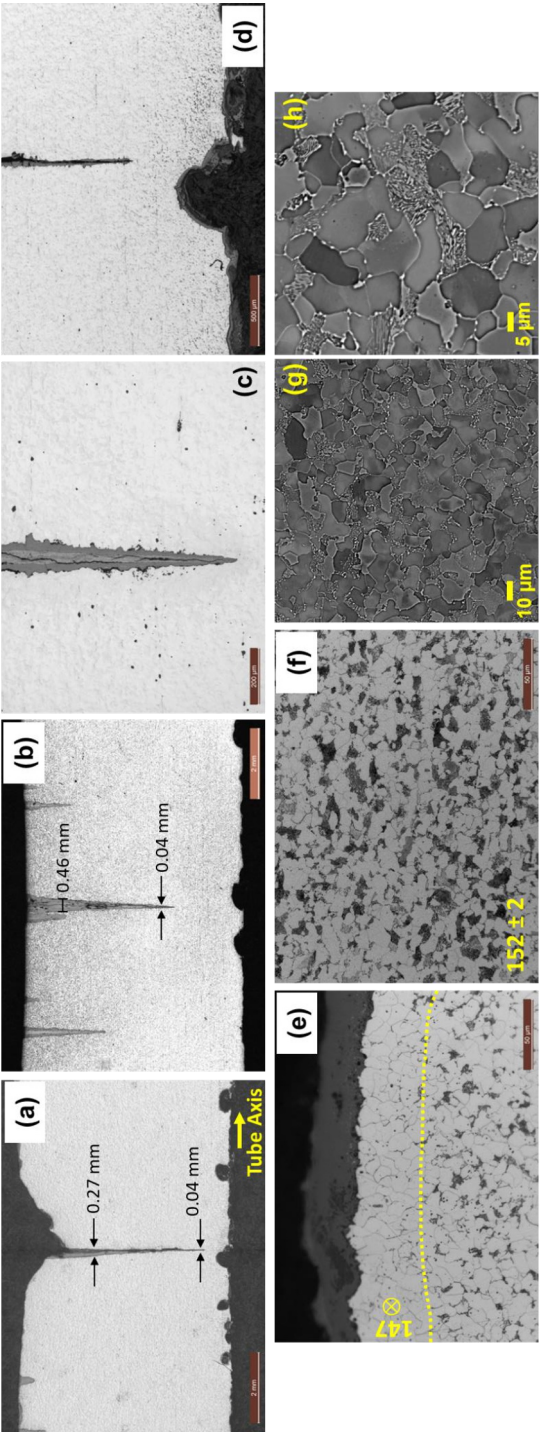
Metallographic examination revealed the damage mechanisms. Microstructural examination of Sample #1 showed sharp notches originating from the external surface, as shown in Figure 3. The notches had a very sharp tip with thickness  $\sim 0.04$  mm. The external surface also showed de-carburization, with hardness  $\sim 147$  HV0.5. Sample #2

**Fig. 3.** Sample #1. (a) Longitudinal cross section showing the wedge type feature. (b) The wedge feature has almost consumed the entire thickness of the tube. (c) De-carburization can be observed on the external surface, demarcated by yellow dotted line. (d) Longitudinal cross section of the tube showing multiple wedge features. (e) The circumferentially aligned wedges are oxide filled with sharp tips. (f) Optical image showing the Ferrite-Pearlite microstructure. The numbers indicate the Vickers hardness at that particular location.

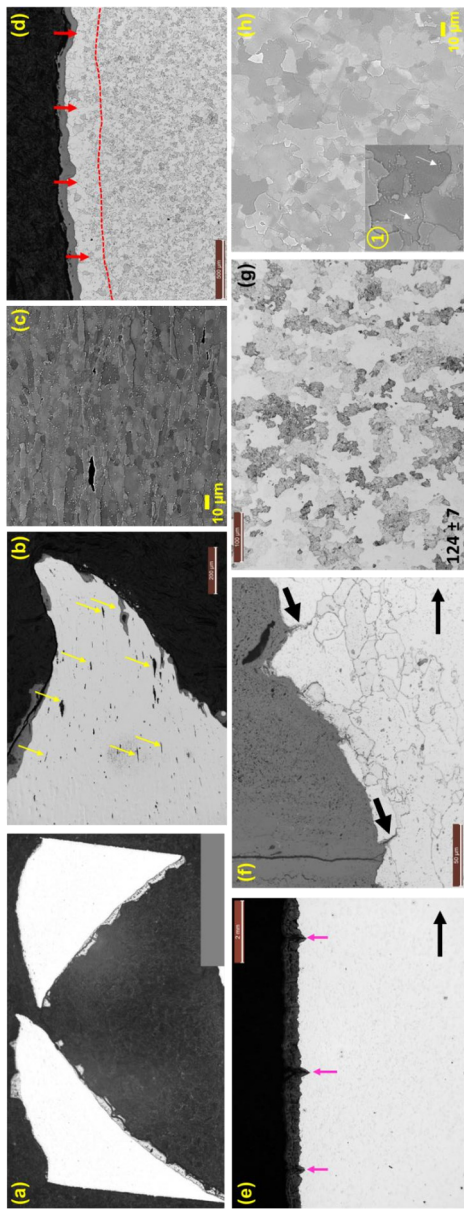
showed both longitudinal and circumferential cracks, as seen in Figure 1 (b). Microstructural examination of Sample #2, near the puncture failed region, showed extensive thinning, as seen in Figure 4 (a). The failed edge showed numerous elongated voids (Figure 4 (b) & (c)). External surface showed marginal decarburized layer and small notches originating from the external surface. Closer examination of these notches revealed that oxidation progressed on the grain boundaries (shown in Figure 4 (f)). The microstructure showed extensive degradation with a considerable loss in the hardness wherein the hardness was  $124 \pm 7$  HV0.5. The circumferential cracks were observed originating from the external surface and travelling along the heat affected zone (HAZ) of the weld, as seen in Figure 5. Voids were also observed in the weld bead region (shown in Figure 5 (2)). Hardness profile around the weld, base metal and HAZ showed a considerable drop in hardness. The hardness for this material is around 170 – 180 HV 0.5 [10]. However, in the present case the hardness has dropped to approximately 130 HV 0.5.

Fig. 4. Sample #2. (a) Circular cross section showing the failed edge. (b) Magnified image of the failed edge. The wedge feature has almost consumed the entire thickness of the tube. (c) De-carburization can be observed on the external surface, demarcated by yellow dotted line. (d) Longitudinal cross section of the tube showing multiple wedge features. (e) The circumferentially aligned wedges are oxide filled with sharp tips. (f) Optical image showing the Ferrite-Pearlite microstructure.

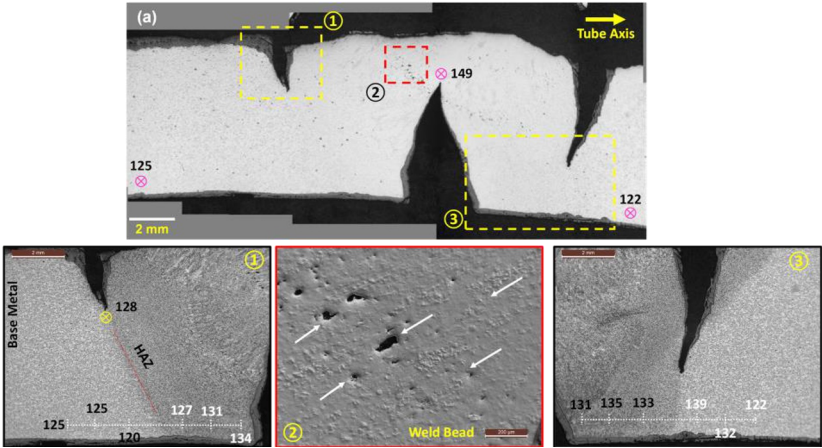
**Fig. 5.** Sample #2. (a) Microstructure of the welded region showing the cracks. Note that these cracks are wider than the ones observed in sample #1. ① and ③ shows the cracks initiating from the external surface along the HAZ. ② Shows the weld bead region with numerous creep voids in the weld bead region. The numbers indicate the hardness.

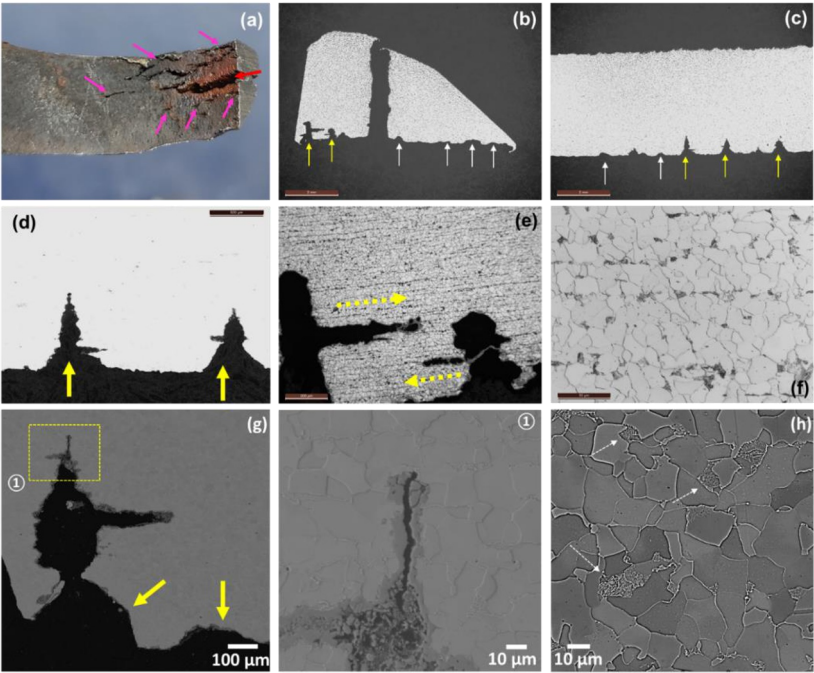
The economiser stub tube was received in a poor condition. The internal surface, shown in Figure 6, showed numerous fissures, indicated by magenta arrows. Some of the fissures have combined to form a large crack, indicated by red arrow. As opposed to the fatigue failure, the cracks in this sample originated from the internal surface, as shown in Figure 6 (b) – (d). Corrosion pits were evident and the corrosion also proceeded laterally (seen in Figure 6 (e)). It can be observed that the notches are originating from the internal surface and do not bear a sharp tip but rather a blunt bulbous head. This is a sign of prevailing corrosion activity. The hardness was in the range 147 – 150 HV0.5.

**Fig. 6.** Sample #3. (a) Photograph of the internal surface of the weld stub region showing numerous fissures, indicated by magenta arrows, and the large crack, indicated by red arrow. (b) – (d) Microstructure of the failed region showing the corrosion pits, indicated by white arrows, and the corrosion fatigue cracks, indicated by yellow arrows. (e) Microstructure near the corrosion fatigue crack showing the lateral corrosion attack. (d) Microstructure showing healthy Ferrite-Pearlite.

Corrosion fatigue is fatigue in corrosive environment. The fatigue cracks originate from the internal surface as pitting due to corrosion makes these site vulnerable for crack initiation. Ahmad et.al., investigated failure in SA 210-A1 grade tube. It was observed that the internal surface showed evidence of corrosion on the internal side of the tube. Transgranular cracks were found to originate from the internal surface of the tube with the origins tracing back to the base of the corrosion pit. Ahmad et.al., [16] concluded that one of the tubes failed due to corrosion fatigue and also interplay of thermal fatigue and creep-fatigue interaction. Corrosion fatigue is usually catastrophic and calls for an immediate shutdown due to failure. Generally, corrosion fatigue initiates from the internal side in water wall tubes and appears as multiple fissures on the internal side, which are visible through naked eyes; these fissures combine to form a larger crack [17][18]. In the present case the internal surface of the failed tube showed extensive fissures and cracking, shown in Figure 6 (a). Metallographic examination revealed that the internal surface showed corrosion pits, shown in Figure 6 (b) and (c). Notches originating from the internal surface were also observed, as shown in Figure 6 (d) and (e). The optical image, shown in Figure 6 (f), shows a Ferrite-Pearlite microstructure. The cracks are originating from the internal surface of the tube. Unlike the thermal fatigue cracks, as shown in Figure 3, these cracks have a wider base and circular or bulbous head unlike sharp tips of their thermal fatigue cracks counterparts. Furthermore, the evidence of corrosion is clear wherein it not only progresses inwards but also sideways (as seen in Figure 6 (e)).
