# Failure Analysis of Spillway Gate of a Hydro Project - A Metallurgical Perspective

Deepak Kumar Gope, Anand D Varma, Anil Kumar Das, Prahlad Halder\*

Advanced Materials Research Lab, NTPC Energy Technology Research Alliance, NTPC Ltd.,  
Greater Noida, Uttar Pradesh, India.

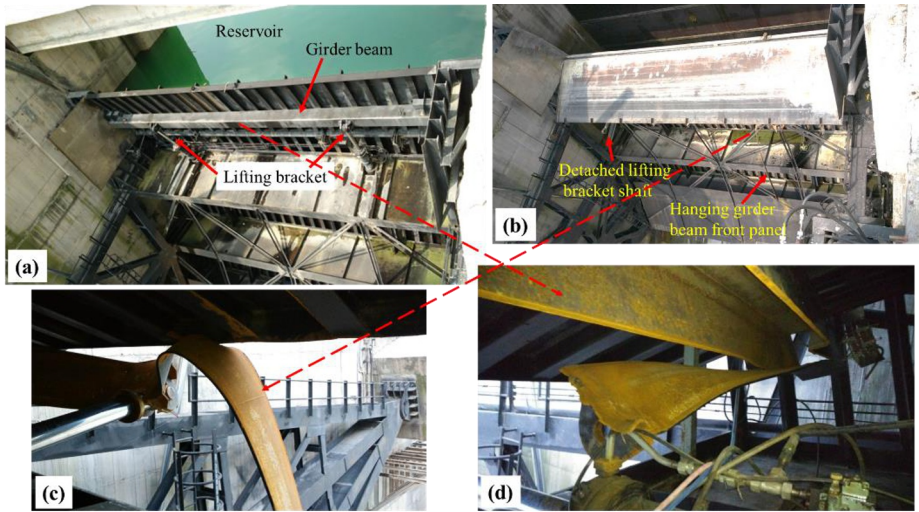
During site visit it was observed that one of the spillway flap gates was fell down. Fig. 1(a) showed one of the operational spillway gates. It is to be noted that in the figure, it has two lifting spindles shaft (or lifting bracket) which support the girder beam of the gate. During flap gate operation, the flap gate suddenly fell down and went inoperative. The failed spillway gate was shown in fig 1(b). It showed the shearing of the front plate of girder beam in between lifting bracket shaft which is shown in fig. 1(c & d). At one end of the lifting bracket, the shaft was found detached, while at the other end, the front panel (or plate) of the girder beam was observed to be hanging. The thickness of the girder beam plate was 14 mm. The front panel of the beam failed in between flange area across the 400 mm width of the plate as can be seen from fig 2(a). The bottom part in between the flange was bend inward. The rear surface of the plate showed weld deposits on the fracture edge just below the top surface which was shown in fig 2(d). Keeping the crack part safe, the flange joints were cut using gas cutter for further analysis (fig. 2(c)). The samples for metallurgical sample were prepared as shown in the fig 2(f).

**Fig. 1.** (a) Image showed the operational spillway gate (spillway side view). It showed the normal condition of girder beam and lifting bracket with two spindles on both side of the gate; (b) Image showing the failed spillway gate. It showed detached lifting bracket shaft and hanging front panel of box beam (indicated by arrow); (c) Bending of front panel of girder beam at one side of the gate; (d) Other side of the gate showed failed flange part and tearing of front panel of girder beam.

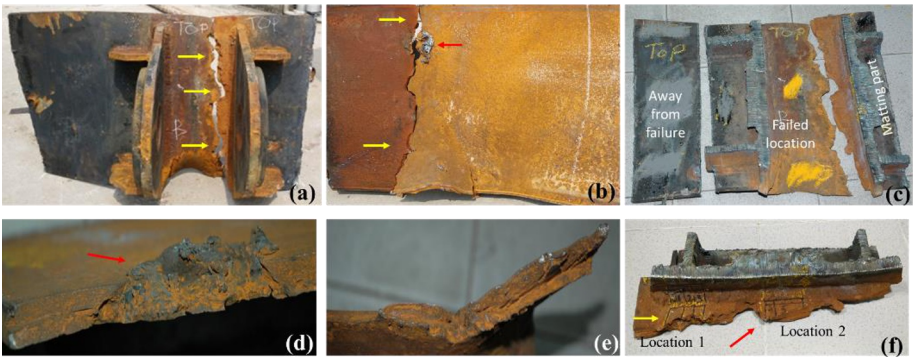
Site visit was conducted to understand the failure, where it was observed that the failure had occurred on the spillway gate of a hydropower project. It has a chute type spillway consisting of six gates. The failure occurred in one of the spillway flap gates during operation. The flap gate suddenly fell down and became inoperative. Visual observation was carried out at failure site and on failed component and documented with several photographs which is shown in figure 1 and 2. The failure was observed in the girder plate between both the flange joint. The flange was taken from the site and cut using gas cutter into smaller parts for laboratory analysis which is shown in fig.2. One side of the girder plate has flange joint while the other side of the girder plate has shown weld spatters at the crack line.

**Fig. 2.** (a) Image showed the crack in between the spindle support flange (marked in yellow arrow); (b) Rear side of the plate showed crack (marked in yellow arrow) and weld spatter (marked in red colour). It also showed bending at the bottom part; (c) The flange joint was cut for obtaining failure location: two mating parts of failure and one away from failure; (d) Fracture edge at mid-section showed blacking appearance weld material deposit; (e) Fracture edge at bottom side showed weld spatter; (f) Image showed the marking for metallurgical sample.

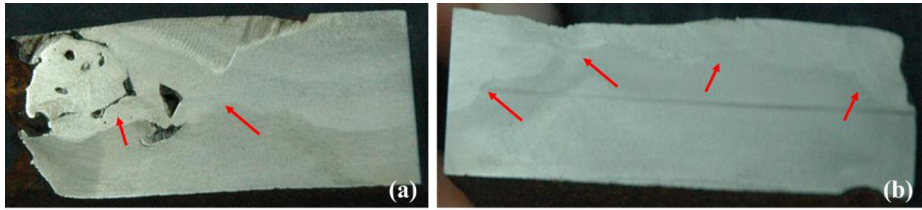
**Fig. 3.** (a) Cross-sectional view of polished surface at failed location shows metal deposit and weld porosity; (b) Cross-sectional view of the tube shows multiple welded structure.

Microstructural analysis was carried out at different locations as marked in fig. 2f. The macrostructure at fracture edge showed presence of weld porosity, multiple weld layers and inhomogeneity (fig 3a). Furthermore, a weld structure with varying layer thicknesses was observed on the surface of the plate. Weld build up was also observed in all the samples along the fracture edge as shown in fig. 3b. Thick oxide scale at the fracture edge was also observed.

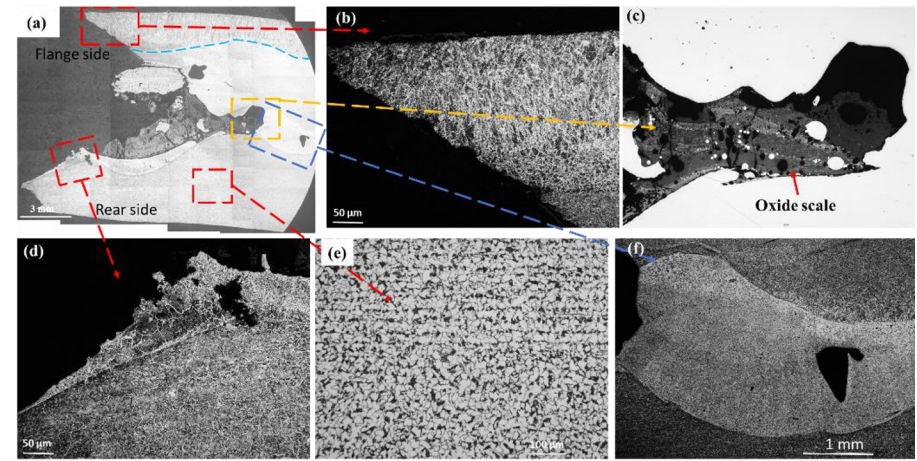
Microstructure at fracture edge on flange side and rear side of girder plate showed welded structure (fig. 4 (a, b & d)) which indicated that a repair welding was carried out at that location. Repair welding is very critical part of operation and maintenance. If it is not done in proper way, it led to catastrophic failure of the component [15,16]. It also showed weld porosity with range varies from 0.8 mm to 1.25 mm. Magnified view (fig. 4c) showed the oxide scale penetration in to the material at fracture edge. Microstructure at mid thickness of the plate showed ferrite-pearlite structure. Microstructure at location 2 (fig. 5) showed sever inclusions in the material at fracture edge. Inclusion was also observed at the weld structure at flange side. The mid-section of the plate showed ferrite-pearlite structure.

**Fig. 4.** (a) Microstructure showed weld structure and thick oxide scale; (b) Magnified view of the marked location indicated the weld structure (etched condition); (c) Magnified view at centre area showed oxide scale penetration (unetched condition); (d) Microstructure at rear side also showed weld structure with weld porosity (etched condition); (e) Microstructure at mid-section showed ferrite-pearlite structure (etched condition); (f) Microstructure at marked location showed weld porosity (etched condition).

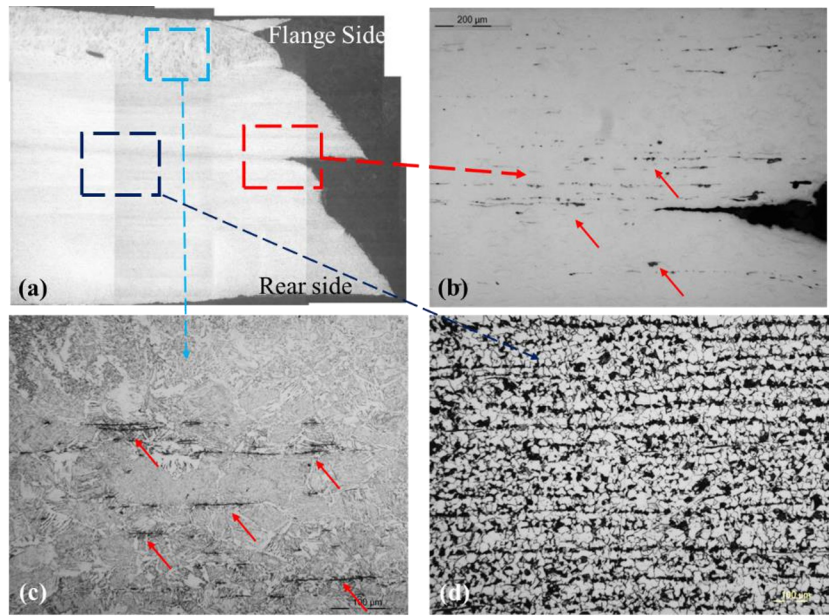
**Fig. 5.** (a) Microstructure at location 2 showed different structure at different location (unetched condition); (b) Microstructure in unetched condition showed inclusion at fracture edge; (c)

Microstructure at flange side showed weld structure and inclusion (etched condition); (d) Microstructure at mid-section of the plate in etched condition showed ferrite-pearlite structure.

The hardness of the sample at fracture edge having weld structure side was in the range of 269 – 280 HV0.5 while the hardness away from failure was in the range of 228 – 236 HV0.5 which is in accordance with the observed microstructure. The yield strength and ultimate tensile strength obtained from the tensile test are 468.2 MPa and 572 MPa respectively.
