# Visual Appearance of Waterwall Tube Failures Due to Hydrogen Damage Mechanism in Coal Fired Power Plants

Deepak Kumar Gope, Anil Kumar Das, Prahlad Halder\*

Advanced Materials Research Lab, NTPC Energy Technology Research Alliance, NTPC Ltd.,  
Greater Noida, Uttar Pradesh, India.

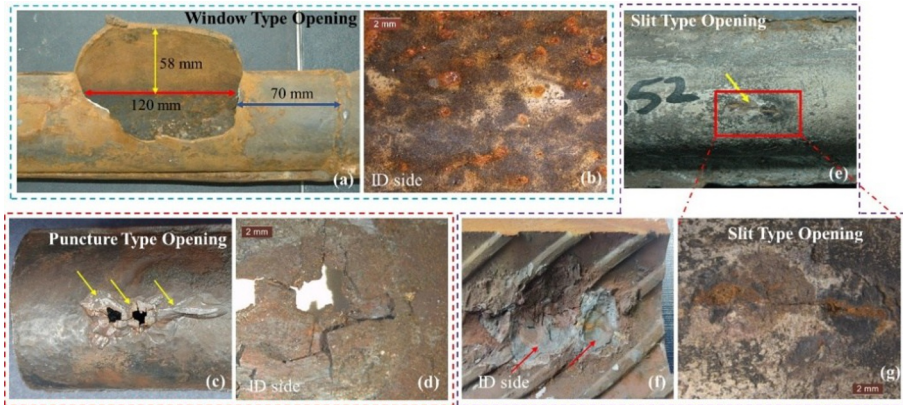
Visual observation of the samples was carried out by unaided eye and stereo microscope (make M/s Leica). Images were captured using Nikon D70S camera. Figure 1 showed the images of the as received samples. Fig 1 (a & b) represents sample number 1 which is a window type opening failure. This sample was taken from 110 MW power plant. Fig 1 (c & d) shows sample no. 2 which is a puncture type opening and taken from a 250 MW power plant. Fig 1 (e, f & g) illustrate the images of sample no. 3 which was failed from a 500 MW boiler.

**Fig. 1.** (a) As received tube showed window type opening failure near to the weld joint; (b) ID side of the tube showed pitting and corrosion; (c) As received tube showed puncture type opening with two punctures and sever erosion marks around it; (d) ID side of the tube after sectioning showed oxide layer and its spallation around the crack; (e) The sample tube showed slit type opening at OD (Outside Diameter) side of the tube; (f) ID side of the tube showed under deposit corrosion in localised region with crater of iron oxide; (g) Magnified view of the tube at marked location showed short and intact crack having length ~25 mm.

The sample tube was failed as window type opening. The failure was at a distance of 70 mm from the circumferential welding as indicated in fig 1 (a). The opening was ~58 mm wide and 120 mm in length. The thickness of the tube at fracture edge was ~4 mm. The side of the tube opposite to the failure did not show any damage. However, the inner wall of the tube opposite to failure showed corrosion and pitting which is shown in fig. 1(b).

The as received tube sample showed two punctures having circular appearance (approx. dia 3 mm). Sever thinning and erosion marks were observed around the failed location. The dip erosion mark was ~26 mm in length along the longitudinal direction of the tube. Magnified view of external surface of the failed location showed multiple cracks around the punctures. The sample was sectioned to open the tube for study of its internal surface. The internal surface at failed location showed under deposits corrosion & spallation of oxide layer. The side opposite to failed location showed no failure.

The water wall tube showed tightly intact crack. The crack was ~25 mm in length. The tube was sectioned to observe the internal surface at failed location. The inner surface showed under deposit corrosion with crater of iron oxide. Thinning of the tube at failed location was also observed. Thickness of tube at failure was ~3.3 mm while the thickness of the tube away from the failure was 7 mm.

**Remedial Mechanism for Hydrogen Damage.** Once water wall tube failure was detected due to hydrogen damage, suitable corrective action should be taken to minimize loss of power generation which includes (a) thickness survey across the affected region, (b) Replace all the affected tubes, (c) Assessment of deposit analysis and corrective measures as per OEM guidelines, (d) Corrosion mapping and (e) NDT technique like UT (Ultrasonic Testing) and Eddy current. This is important because, even though localized, the failures would be found in most of the adjacent tubes. The preventive measures that the power plant should follow in order to avoid loss of power generation due to hydrogen damage are as follow:

- Boiler water chemistry parameters recommended by OEM/Plant should be maintained to avoid internal deposition
- During overhauling or maintenance location prone for deposition to be assessed to avoid any significant under deposit corrosion.
- Periodic assessments to be carried out for deposit analysis as per standard guidelines & accordingly suitable action to be taken.

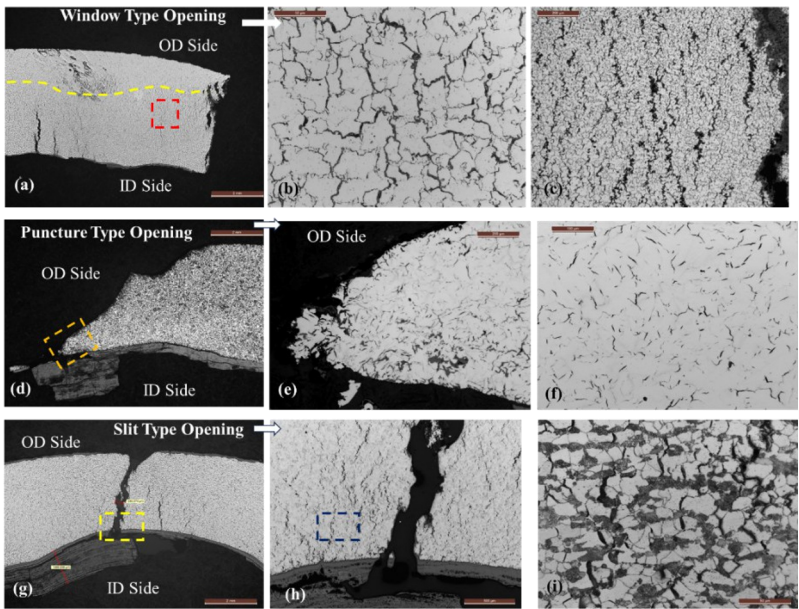
Microstructure showed multiple cracks originating from internal surface. The length of these cracks varies from 0.22 mm to 1.17 mm. Magnified view (fig. 2b) of indicated location showed numerous intergranular micro fissures and degraded structure. Fracture edge also showed numerous micro-fissures as can be observed in fig 2c. Microhardness at failed location was in the range of 124 – 137 HV0.5.

Microstructure at failed location showed thick oxide layer of thickness ~1.76 mm at ID side of the tube. It also showed sever thinning at fracture edge. Tube thickness at failed location was ~1 mm. The magnified view at fracture edge showed numerous micro fissures. Microhardness at failure location was in the range of 172 – 175 HV 0.5.

Microstructure at failed location shows through crack of width 330  $\mu\text{m}$  with thick oxide layer of thickness ~1.4 mm at ID side of the tube. It showed numerous micro fissures around the cracks. Microstructure showed ferritic & pearlite structure with intergranular micro-fissures. Microhardness values at failed location were in the range of 147 – 150 HV0.5.

**Fig 2.** (a) Microstructure for sample no. 1 showed multiple cracks originating from internal surface. The crack length varies from 0.22 mm to 1.17 mm. The yellow dotted line showed the extend of micro fissures from ID side (Unetched condition) (feature at top left side is polishing error); (b) Magnified view at fracture edge (marked by red dotted box in fig a) showed numerous micro-fissures. (Unetched condition); (c) Microstructure at fracture edge, showed numerous intergranular micro fissures. (Etched condition) and decarburization; (d) Microstructure for Sample no. 2 showed thick oxide layer at ID side of the tube (etched condition); (e) At fracture edge, micro-fissures and oxide filled cracks observed (Unetched condition) (Magnification: 50X marked by orange dotted box); (f) At fracture edge (unetched condition) microstructure showed micro-fissures, (Magnification: 200X); (g) Microstructure for sample no. 3 showed thick oxide layer and through crack; (h) Microstructure showed numerous micro fissures on both side of the crack; (i) Microstructure showed numerous intergranular micro fissures.

The samples were sectioned from the failure location and prepared for metallurgical analysis as discussed in methodology part. When the polished samples were examined under an optical microscope, numerous micro-fissures were observed. These fissures were clearly visible in unetched condition which is one of the key microstructural features of hydrogen damage.

The slit type opening is very localized as compared to WTO and PTO type failure appearance. The affected area in the form of micro-fissures is most prominent in the WTO mode and extends to nearly 81% of the tube thickness at the fracture edge. Complete decarburization of pearlite was observed in WTO mode. Also, there is no significant reduction in thickness of tube material at fracture edge as compared to sample no. 3 (STO). The possible reason for thickness reduction in sample no. 3 is the extent of under deposit corrosion. The thickness of under deposit oxide layer at failure in this sample was ~1.4 mm. No comparison regarding thickness reduction can be made for PTO sample, as external steam erosion on the OD side of the tube has influenced the measurement. Therefore, the overall assessment of failure modes should consider multiple contributing factors, including: (a) affected areas, (b) area of under deposit corrosion, (c) thickness reduction due to under deposit corrosion, (d) temperature
