# MARS – Lessons Learned

MARS Report No 376 February 2024

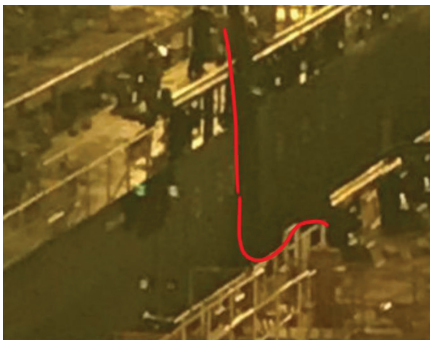
The first attempt to lift the cargo hose was unsuccessful. The hose was lifted only 10m over the upper deck, leaving another 14 metres of hose bent in a U shape between the vessels. Due to the improper lifting and U shape, the cargo line could not drain to the receiving vessel and an excessive bend developed at the hose support of the receiving vessel. This created so much pressure in the hose that the oil remaining in the hose was forced up and back out, escaping the hose at the loosely bolted flange at the supply vessel. An estimated 15L of oil was sprayed on deck, onto the fenders, and into the sea between the two vessels.

Incorrect lift causing U in hose

- STS guidance specifies blanked flanges should be securely bolted to prevent pollution.
- Introducing atmospheric air to the cargo system constitutes an explosion risk.
- A STS Joint Plan of Operations should include all operations such as cargo hose connection, draining, purging and disconnection.

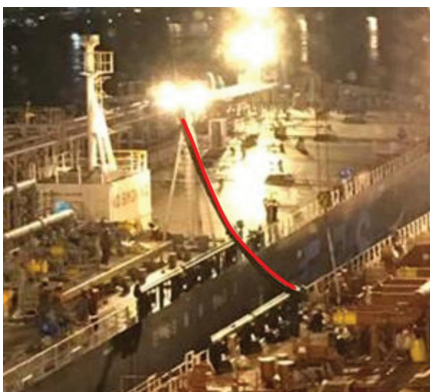
Correct lift for drainage

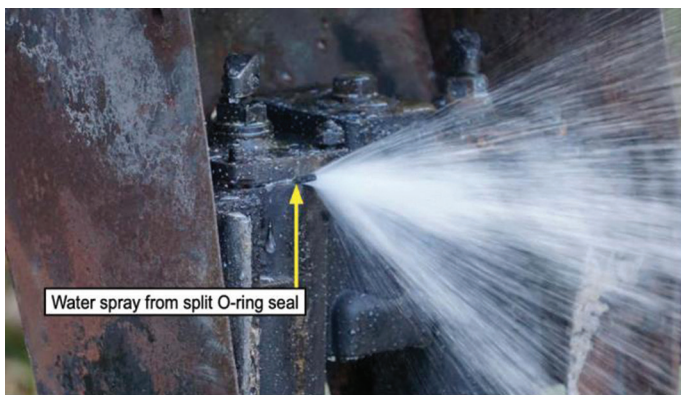
The 3rd engineer decided to clean the AE1 fuel filters as his first task. He undid the two locking screws on the splash shield and removed it from the housing to access the duplex fuel filters. As he was undoing the front right-hand nut of the filter, the fuel pressure (5.5 bar) still present in the system lifted the cover and forced the O-ring seal out of its recess, causing it to split. Marine gas oil sprayed out over a large area, covering the crewmember. The spray also reached the nearby AE2's turbocharger and exhaust pipework about 1m away. These engine parts were very hot. The fuel ignited almost immediately and thick black smoke began to emanate from the AE2 exhaust insulation.

Post-accident test using water to simulate fuel spray

- The victim's action to remove the AE1 fuel filter elements without first isolating the fuel from the filter assembly was the major contributing factor to this accident. How could this mistake have been avoided? A procedure? A checklist? Better supervision? Teamwork? Better training?
- The shore-based search and rescue team located the victim in the smoke-filled space using a thermal imaging camera. This device could be a valuable addition to shipboard emergency equipment.
- A ship fire is an imposing challenge for crew and drills that replicate the difficulties that may be faced, such as searching in near zero visibility, can pay dividends.

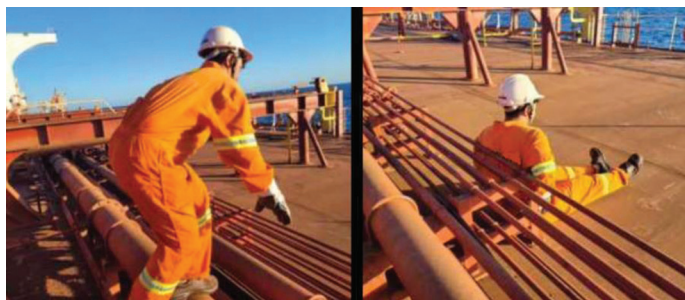
➔ On a vessel at anchor, a crewmember was assigned to replace a leaking hydraulic pipe on one of the hatch covers. Once the job was completed the crewmember attempted to regain the clear deck area by walking over adjacent deck pipes that were about 50cm above deck level, rather than walking to one of the raised walkways allowing access over the pipelines at regular intervals. While walking over these raised pipes he slipped and fell, with his back striking the raised pipes. He suffered disc lesions to his lower spine.

There are raised walkways allowing access over the pipelines at regular intervals on the main deck.

- Decisions made for the sake of expediency are rarely compatible with safety.
- Ask yourself, is there a safer way? If the answer is yes, take the safer way.

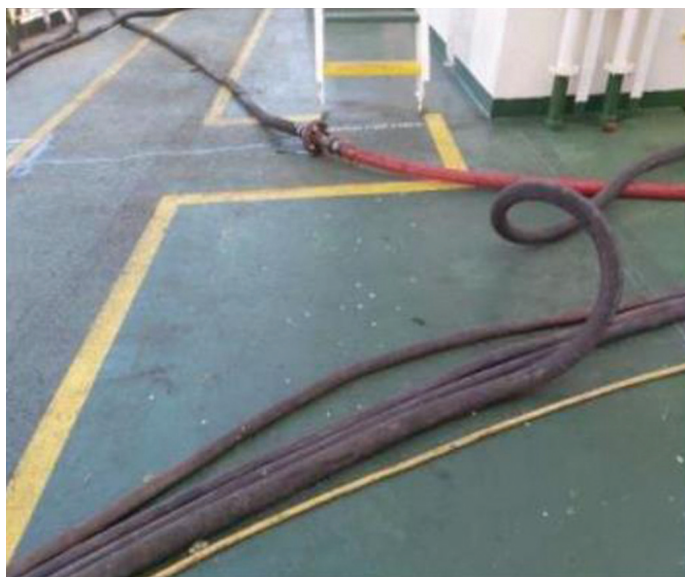
➔ A ship was in dry dock and deck crewmember on the night shift was undertaking a safety round. As he reached the bottom of an exterior stairway and began walking, his foot caught a two-inch hose laid on deck. He tripped and fell, but initially thought he was uninjured. Later, his ankle became swollen and a sprained ankle was diagnosed.

- Dry dock work is notorious for snake-like arrays of hoses and other tripping hazards on deck areas. Keep walkways safe by making them as clear as possible and using high visibility cable ramps (covers) in areas where there is foot traffic over hoses.
- Keep walkways and stair landings well lit during the hours of darkness.
