# MARS – Lessons Learned

MARS Report No 370 August 2023

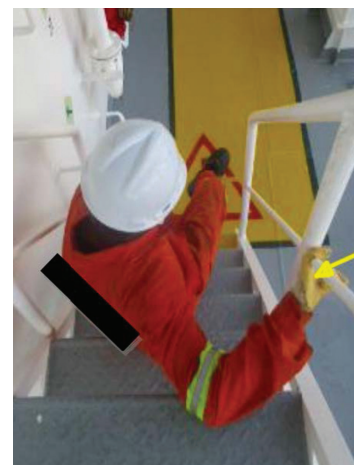
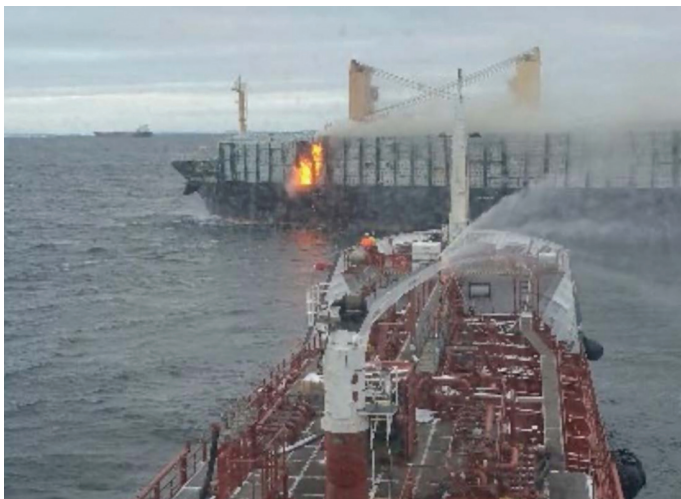
→ A vessel underway at sea was experiencing some rolling under heavy weather conditions. Crew were undertaking normal housekeeping duties. A crewmember slipped while descending a staircase and, with only his right hand lightly gripping the handrail, his efforts to stabilise his body were ineffectual. His small finger was bent back and sustained injury on the vertical post as he fell.

The company investigation found that although he had proper Personal Protective Equipment (PPE), his method of descending was suboptimal, in that, with only one hand on the right handrail, he was ignoring the good practice of having 'three points of contact' at all times. Risks were also more acute due to the rolling of the vessel.

- Everyday tasks and movements can appear less risky over time due to familiarity. Don't let your guard down!
- It is good practice to have a firm grip and use both hands on each handrail while using a staircase.
- **Editor's note** I am personally aware of another incident where an outside staircase had become more slippery over time as the anti-slip paint was gradually worn away. The gradual nature of the wearing away had led the crew to 'adapt' their behaviour and they all took great care while using the staircase – but hadn't yet thought to redo the anti-slip paint! When an outside party came to audit the vessel, she fell on that very staircase due to it being wet and slippery. Luckily, she was not badly injured.

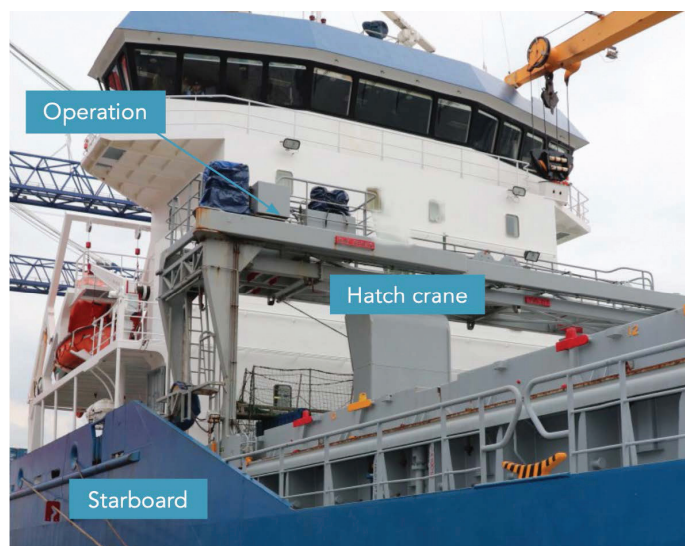
- The crane operator's field of view is severely restricted and does not allow a proper overview of both sides of the crane's track.
- The vessel layout allows persons to cross the track of the gantry crane.
- Communication with others is essential for determining if the hatch crane can be operated in a safe manner. Yet, this introduces the risk of miscommunication which was a contributing factor in at least one fatality.

Various measures have been adopted to control bad outcomes, but these appear to still have unacceptable residual risks. For example, having alarms continuously sounding while the crane is operating is well-intended – but they can become routine. Their efficacy will probably decline with time as crew become desensitised to the alarm and qualify it as 'normal'.

Emergency crane stop buttons are now a common installation. Yet analysis found that in many past occurrences the emergency stop button was not used because it was out of the victim's reach.

- Never cross the gantry crane rails while the crane is in use. If it is necessary to cross the rails, the crane should be stopped.
- Unrelated work on deck or in the holds should not be scheduled while gantry crane operations are taking place. If schedules clash, one or other of the operations should be rescheduled.

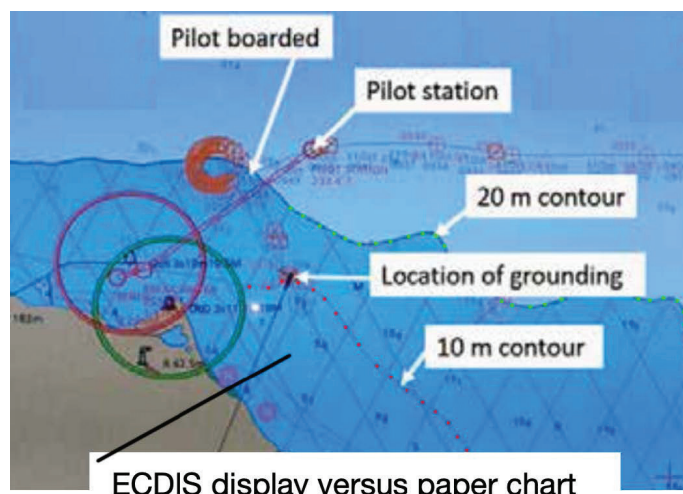
The pilot was not monitoring the radars or ECDIS. Some minutes later the vessel ran aground while making about 3 knots. The bridge team did not realize immediately what had happened. Shortly thereafter, the pilot checked the radar for the first time and realized the vessel was aground.

The official investigation found, among other things, that although there had been a brief exchange of basic vessel information (horsepower and stopping capability) between the Master and the pilot, there was no exchange of passage plans or discussion of the approach to the berth. The pilot did not discuss his intended circular manoeuvre to reposition the vessel for its approach to the port, and the Master did not ask about the pilot's intentions. Furthermore, the Master did not communicate with the pilot the information that he was gathering from the ECDIS and radar, including course, speed, and the rapidly approaching depth contour on which the vessel grounded. Information exchange throughout the pilotage operation was limited to the pilot's helm orders. The pilot did not request feedback from the bridge team, and none was offered.

- Without electronic validation or input from other bridge team members, even an experienced navigator can make errors that can lead to bad outcomes if left uncorrected.
- The 'challenge' is a key principle of good BRM. When one member of the bridge team sees a developing dangerous situation, it must be communicated to the person having the con.
- In this case, the ECDIS shading was set to depict anything shallower than 20m in dark blue, to differentiate it from deeper waters, which were identified with light blue. Had waters with a depth of 10 metres and less been shaded with dark blue and marked distinctly as a no-go zone, the vessel's relatively rapid approach to the 10 metre depth contour would have been more apparent.
