# MARS – Lessons Learned

MARS Report No 373 November 2023

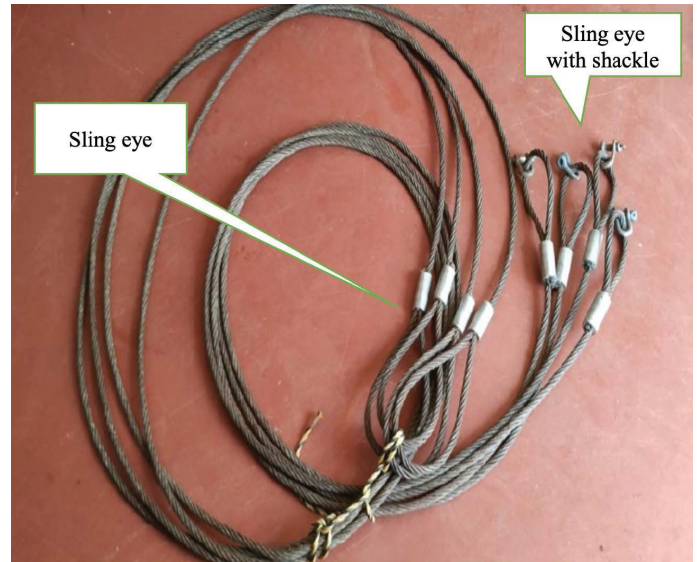
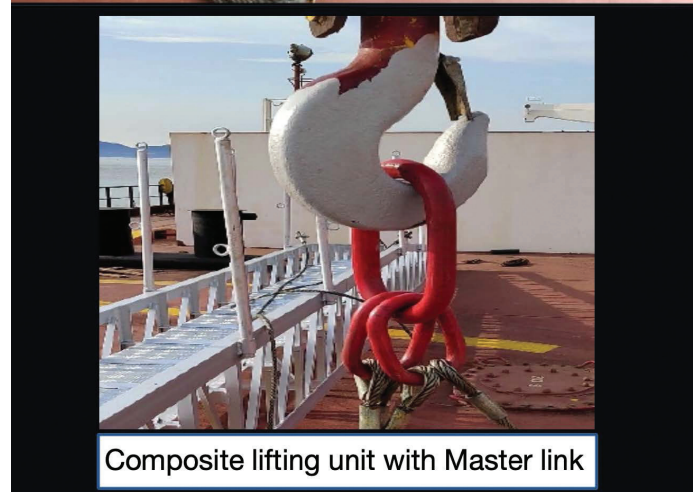
During the lifting operation the gangway was controlled by three people, each with a lanyard to guide the gangway. Two were on deck and one on shore. As the lift commenced, the outboard lifting slings were in tension and the inboard slings were slack. When the gangway reached the level of the deck rail, the inboard sling wires remained slack since the inboard end of the gangway was supported by the deck rail. As the outboard end of the portable gangway was lifted slightly above the deck rail, the tension of the outboard slings caused the gangway to swing inboard towards the vessel. This movement was enough to cause the two inboard slings to slip out of the crane hook and the end of the gangway immediately fell to the deck.

The investigation revealed that the information manual produced by the manufacturer of the portable gangway recommended the use of a composite lifting unit with a master link to connect the four wire rope slings to the crane hook. Had this practice been adopted, in conjunction with a spring-loaded safety latch, it is likely that this accident would have been avoided.

- A manufacturer's information manual contains valuable and essential information. Neglect it at your own risk.
- Everyday tasks may become mundane and tedious, but they can contain unperceived hazards. Always keep an eye out for dangers in plain sight.

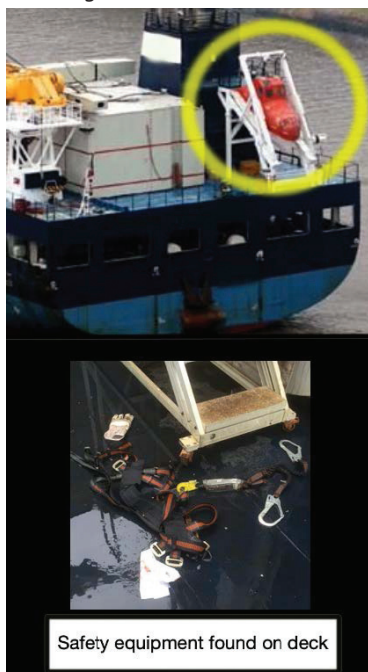
The lifeboat's release device at the helmsman's chair was found untouched and in a closed position. The safety officer's findings of a stuck hook safety pin prior to departure suggest that the hook might have been already in a 'released' state when the crew began their work. The lifeboat manufacturer's user's manual states 'If release hook safety pin cannot be removed off the hook casing without excessive force, the hook might be released. Secure boat release hook and check system.'

The working hypothesis of the investigation is that the service company technician did not properly reset the release mechanism in the closed position. When the crew tried to free the safety pin the hook released fully, allowing the boat to launch in free fall to the sea. The bosun probably fell to the deck while the other crewmember fell overboard and drowned.

- Adherence to the on board safety procedures and other instructions available such as the manufacturer's information manual is a prerequisite for safe operations.
- A toolbox meeting and verbal preparation and instructions are best done at the work location to allow better understanding of the situation and a discussion of the hazards and mitigating strategies.
- Proper supervision is a key element for safer operations.

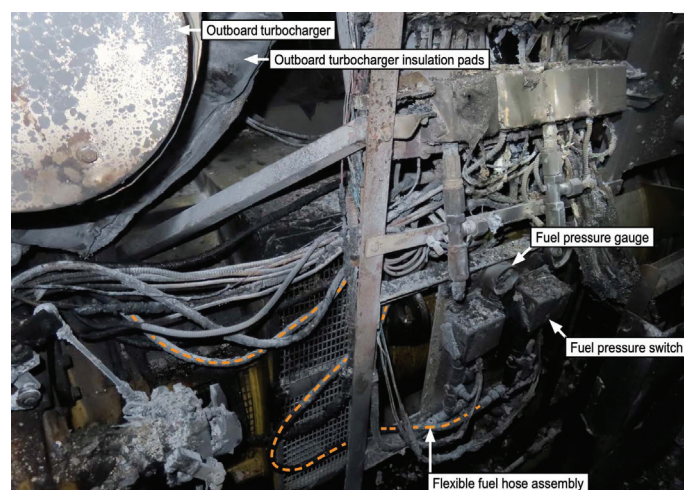
→ While departing port, a RoRo vessel suffered a fire in the auxiliary engine room. The fire was contained and subsequently extinguished without injury to the crew, but the equipment in the auxiliary engine room suffered serious damage. The fire originated below the outboard turbocharger when a small-bore flexible fuel hose failed, spraying marine gasoil (MGO) onto a high temperature surface, where it ignited.

The auxiliary engines had been modified many years earlier, when low pressure fuel alarm pressure switches and gauges were installed using flexible fuel hoses. This was contrary to MSC/Circ.647 – Guidelines to Minimize Leakages from Flammable Liquid Systems, which states that flexible hose assemblies should only be used where necessary to accommodate relative movement between fixed piping and machinery parts. In this case, flexible hose assemblies were not needed for this purpose. Furthermore, the hoses were routed under the turbochargers covered by the insulation pads, exposing them to the risk of contact with high temperatures and making them difficult to inspect.

Damaged auxiliary engine and flexible hose routing

For example, a rigid metal pipe secured with clamps and routed at an appropriate distance from the engine's exhaust might have been a safer option than flexible hoses.

- Flexible hoses have a higher risk of failure than a properly fitted metal pipe. An isolation valve fitted at the point of supply allows a flexible hose to be safely isolated in the event of leakage.
- If you modify a system, inform your classification society. Better safe than sorry.
