## Case study for onboard safety meeting

# Container stack collapse in heavy weather

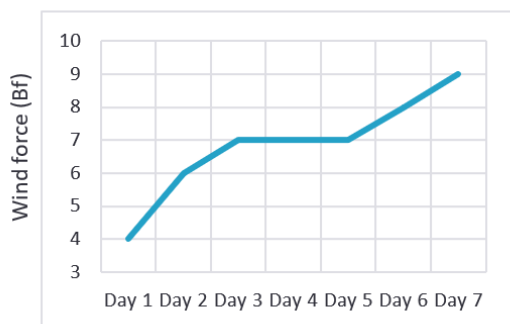
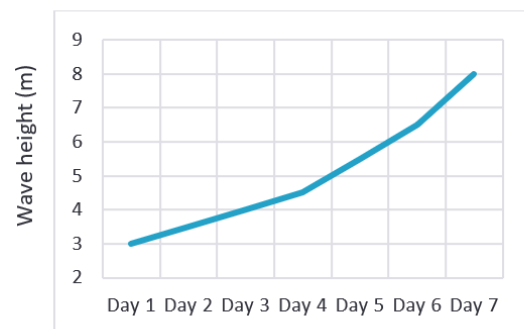
The crew attempted to tighten container lashings but were unable to do so as the vessel was shipping green seas. Over the course of 48 hours, the vessel experienced heavy rolling and pitching. Next morning the crew found collapsed container stacks in several bays. Following the completion of the voyage, the vessel proceeded to dry dock for necessary repairs. Below is a timeline of key events and details of the weather experienced by the vessel in the 7-day period prior to the incident.

- Several base sockets and lashing eyes were found to be severely corroded. The Master had on two previous occasions expressed concerns to the management about the cargo worthiness of the vessel. Repairs had been deferred to dry dock which was in 4 months' time. Meanwhile the vessel continued trading.
- There were no guidelines in the SMS on the threshold for wind force, wave height and swell height which the vessel could incorporate into its voyage planning. The understanding of these thresholds was very subjective, i.e. there was no common understanding across the company.
- The vessel's weather routing software showed that had the vessel taken a more southerly route, the weather would have been much more favourable.
