# MARS – Lessons Learned

MARS Report No 371 September 2023

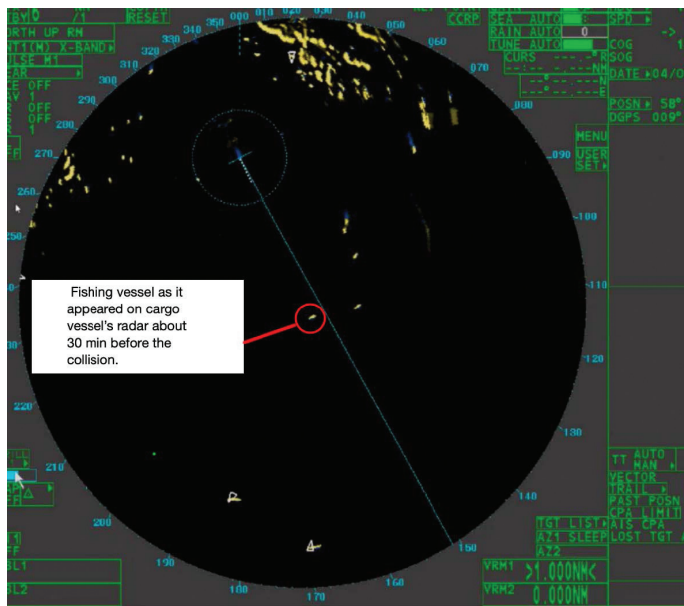
The collision caused the fishing vessel to heel over and turn around almost 180 degrees. Once clear of the cargo ship, the fishing vessel still had propulsion. The crew were unharmed and proceeded to check the status of the vessel, which had sustained considerable damage to the port bow bulwark but otherwise was out of danger.

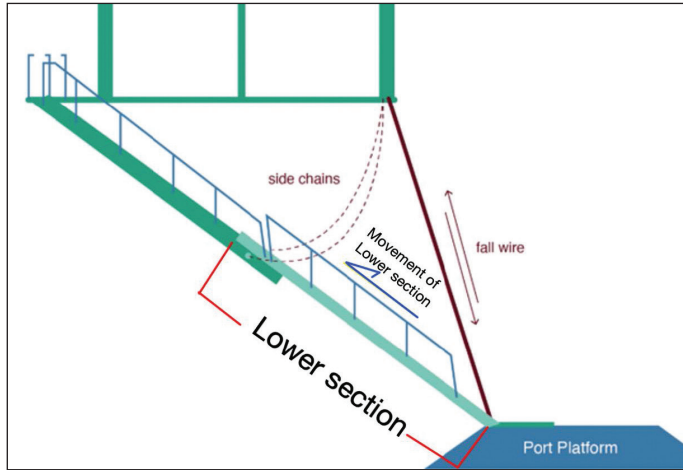
On board, another crewmember resumed heaving on the fall wire to retract the lower section of accommodation ladder. As this was proceeding, the ladder end dropped off the port platform. Because the side chains were slack and not supporting the fixed upper ladder, the weight was transferred from the dock platform and onto the fall wire. This resulted in an unexpected and uncontrolled upward movement of the lower ladder.

The sudden upward movement of the lower ladder trapped the victim's left leg between the top step of the lower ladder and the third step of the fixed upper ladder. All work stopped immediately, and the

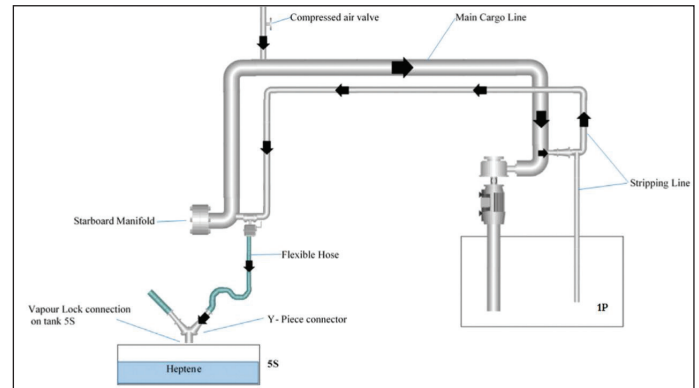
Seconds after the compressed air was blown into the discharge line, an explosion occurred. The investigation was able to discount a pressurisation event as the cause. In all likelihood, an explosive mixture ignited in tank 5S due to static electricity.

No inert gas or closed vapour return system had been used when loading this cargo. During the first outflow of cargo (safety ullage), outside air was drawn in through the pressure/vacuum valve. This allowed an explosive mixture of gas vapours and oxygen to develop in tank 5S.

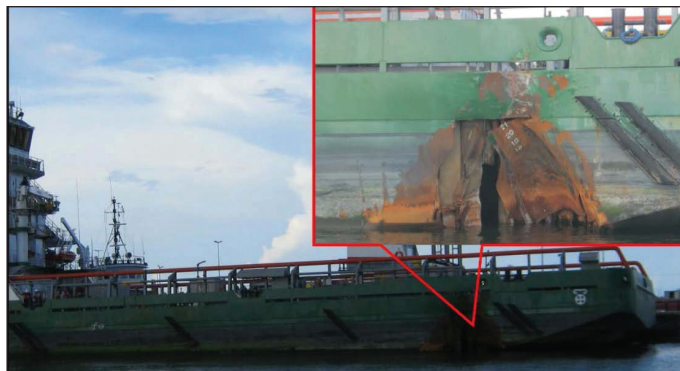
Eventually, the OOW on the OSV became aware of the risk of collision. He disengaged the autopilot, increased the throttles and turned to port to minimise the damage to the vessel as a collision was now inevitable. The bulbous bow of the bulk carrier, which was traveling at about 14 knots, struck the port side of the OSV, which was traveling at 9 knots, and breached the hull. The impact caused the OSV to heel to starboard, and water rushed over the main deck from the starboard side.

The general alarm was sounded on the OSV, and all crew were instructed to go to their muster stations. As a consequence of the collision the port side propulsion room started to flood, and the OSV began to list to port and trim by the stern. The ship's ballast pump was used to dewater the space and to get the breach to the hull out of the water as far as possible. Although the OSV lost propulsion, the electrical generators in the engine room remained operational and provided power to the ship.

OSV Damage

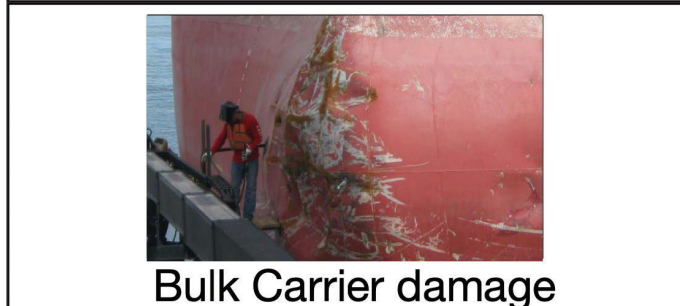
Bulk Carrier damage

The official investigation found that the probable cause of the collision between the bulk carrier and the OSV was distraction of the bulk carrier's OOW due to performing non-navigational tasks and distraction of the OOW on the OSV due to cell phone use, which kept both officers from keeping a proper lookout. Contributing to the casualty was the OOW on the OSV not following his company's watchkeeping policies, which called for two persons on the bridge at all times.
