# MARS – Lessons Learned

MARS Report No 372 October 2023

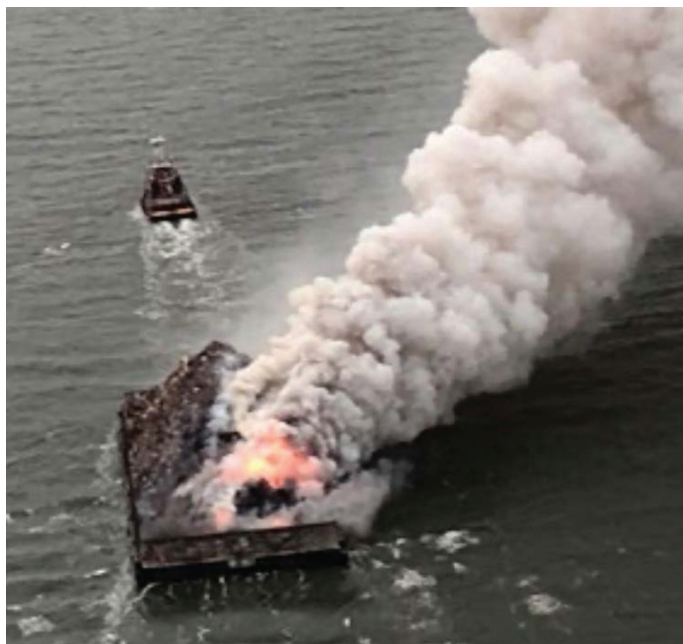
Early one morning a crew member on watch saw smoke and a red glow emanating from the pile of scrap metal on the barge being towed 200m astern. Soon, flames were seen coming from the same area of the barge. The alarm was raised. The fire on the barge was quickly getting larger, and the tow wire was shorted to about 100m to better control the barge.

The NTSB determined that the probable cause of the fire was the ignition of a combustible material by an undetermined source, such as sparking from shifting metallic cargo, self-heating of metallic or nonmetallic cargo, improperly prepared vehicles and appliances, or damaged lithium-ion batteries.

- Scrap metal seems innocuous and is listed as noncombustible in the IMSBC Code, but is nonetheless a fire risk. Another MARS report of this type can be found at 202243 and below, at 202346.
  - Scrap metal fires tend to be hard to extinguish and burn hot and long, often causing major damage. See MARS report below.
- Risk reduction measures for this type of cargo could include:
- Checking the temperature of the cargo regularly to ensure the load is not self-heating. If the temperature is higher than 55°C, the cargo should not be loaded. If, during the voyage, the temperature rises to 80°C, this is a potential fire risk and the vessel should immediately proceed to the nearest port.
  - Appointing a qualified cargo surveying company to assist the vessel's Master before and during loading.

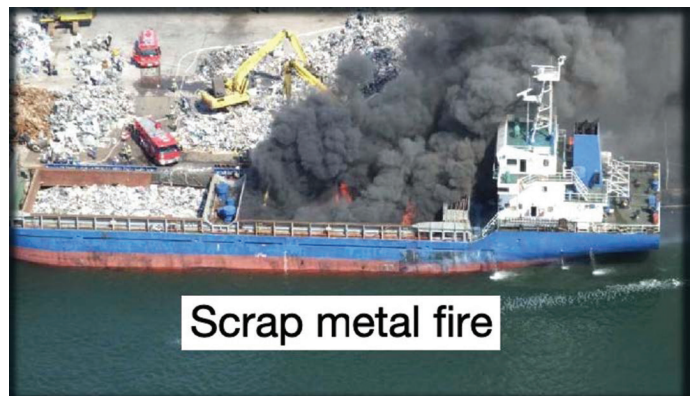
Scrap metal fire

The investigation found, among other things, that the source of the fire was most likely to be a spark created by contact between metal objects, a battery, etc., in the scrap. The source then ignited combustible material mixed in the scrap (eg plastic, rubber, wood chips, paper). It was not possible to determine the exact origin of the fire.

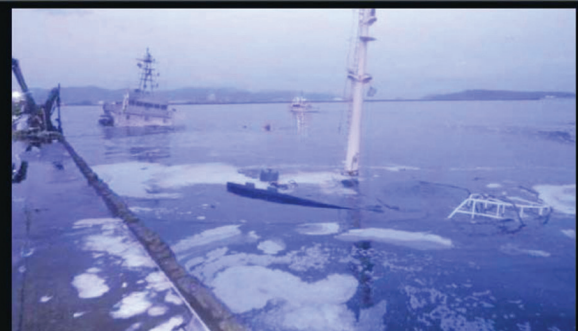
Vessel sunk  
Fire extinguished

The shore fire fighters decided, based on experience in past firefighting of ship fires, to use a protein foam spray delivered from a large aerial-platform chemical-spray fire truck. As they made preparations for the application of the protein foam spray, the vessel listed to port, and the firefighters on the vessel withdrew. The fire continued to increase in size. About an hour after arriving, the shore fire fighters began spraying the protein foam into the aft cargo hold. This technique did not seem to have the desired effect and the shore firefighters asked the Master for permission to continue to use water. Permission was granted, but some 12 hours later, after the application of copious amounts of water, the vessel sank alongside the berth. The fire was then declared extinguished.

The investigation also found that the Master did not think to use the hold's fixed CO<sub>2</sub> firefighting equipment after the fire was first discovered. In fact, this was a moot point because the loader was left with its arm extended above the hatch coaming. This would have prevented the closing of the hold's hatch, a necessary first step before releasing CO<sub>2</sub>.

- As seen in the previous MARS report (202345), scrap metal, while intuitively innocuous and listed as noncombustible in the IMSBC Code, is nonetheless a fire risk.
- Reactions during an emergency are honed with training. Masters and crew should be aware of the most efficient fire fighting methods on their ship and quickly be able to put these into practice.
- Copious and uncontrolled amounts of water poured into a ship will cause a loss of stability and possibly the foundering of the vessel. This will, however, probably succeed in extinguishing any fire on board.

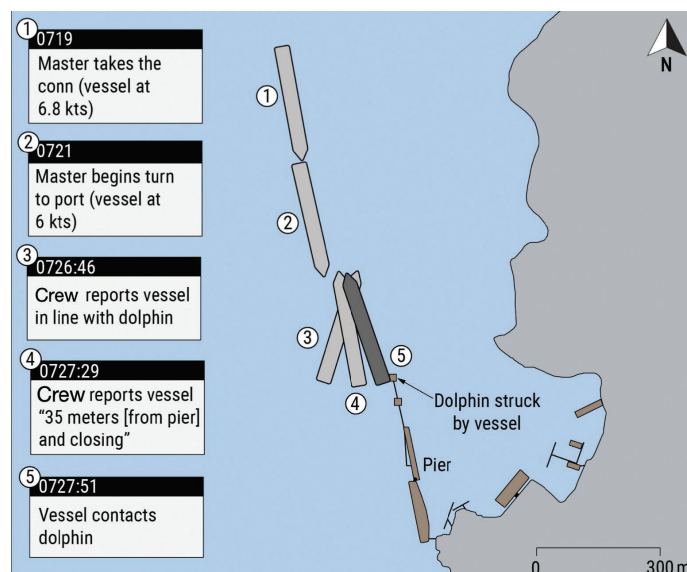
When the vessel was almost completely turned, the crew member aft reported the vessel was in line with the dolphin. Soon after, he reported the vessel was 56 metres away from the dolphin. About 30 seconds later, he reported the distance as 35 metres and closing. Very shortly after, the ship's starboard quarter struck the mooring dolphin at the end of the pier. Vessel damage was minor but damage to the pier was estimated at \$2.1 million.

The investigation found, among other things, that the cruise terminal pier had been extended northward by 120 metres with the addition of two dolphins and a connecting walkway about a year before the accident. However, this change was apparently not communicated to the responsible hydrographic authorities. As a result, the pier was not accurately depicted on any navigational charts. Therefore, the vessel's ECDIS showed the original, non-extended pier. Even so, as the vessel approached the pier, the weather was clear, and visibility was good. The Master and bridge team should have been able to see the extended pier and added dolphins. However, none of the members of the bridge team reported the extension as the vessel approached the pier. Instead, the Master relied on the ECDIS – which showed the old, inaccurate Electronic Nautical Chart (ENC) – to determine the vessel's position relative to the pier.

The investigation determined that the crew member calling out distance aft was giving accurate distances to the pier's northernmost dolphin from the ship's stern. However, the Master incorrectly assumed the bosun was calling out how much clearance the ship would have as

- There is no substitute for clear, concise communication. In this instance, notwithstanding good visibility and daylight, the nine person berthing team either miscommunicated or under-communicated, thus paving the way for a negative outcome.
- Although an excellent navigational tool, ENC's can be inaccurate for a wide range of reasons. In this case, we observe that the berth extension of 120m completed about a year earlier was not reported to the hydrographic authority. As such, the ECDIS image the Master was referencing was not a reflection of reality.
- It is good practice in navigation and manoeuvring to use more than one source of position data input.

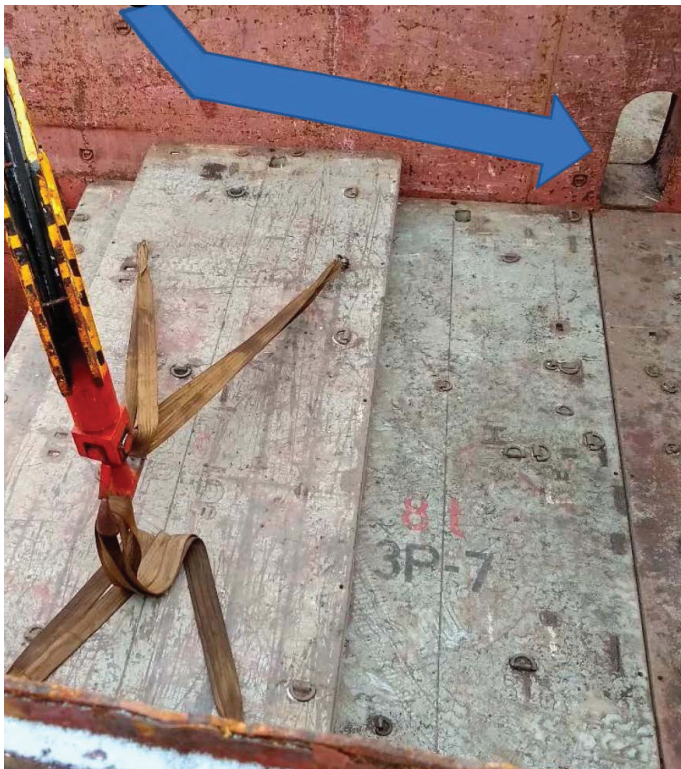
Designated safe area

The investigation found, among other things, that because the pontoon itself had blocked a proper and full view of the work area, neither the signalman nor the crane operator had been able to see that the victim had entered the danger zone between the bulkhead and the hoisted pontoon. Although the victim knew to stay in the designated shelter area until the pontoon was safely down, it is possible he attempted to quickly remove some cargo debris as the lift was under way.

- Human nature is such that we want to get the job done – the 'can do' attitude which probably explains the victim not remaining in the designated safe area. The 'can do' attitude can be perilous if we ignore established procedures in the process.
- The victim did not have a VHF radio so he would have been unable to stop the operation, had he seen this was necessary.
