# MARS – Lessons Learned

MARS Report No 374 December 2023

## MARS 202354

### Low situational awareness has high impact consequence

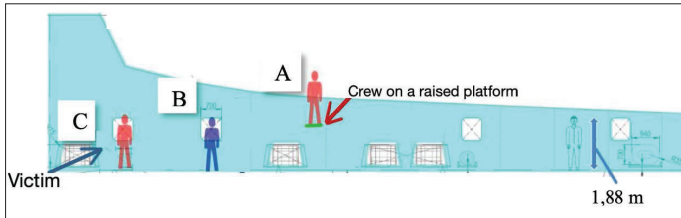
In order to set the berthing lines with their appropriate heaving lines, the deck crew were passing the heaving line outboard from position A, where the deck crew were standing on a platform due to the high bulwark, to position C, via position B. A gaff was used to catch the line through a bulwark port at position B. The line was then passed outboard to position C. A deck crew at position C had his arm out of the bulwark port holding a gaff to catch the heaving line.

A few seconds before the line passing manoeuvre began, one of the bow thrusters came offline due to an overpower surge. There was no alarm to warn the bridge team of this situation. The ferry was quickly pushed back to the berth, and the bridge team, realising the situation too late and preoccupied with the manoeuvre, gave no warning to the deck crew, who were unaware that the ferry was closing on the

berth. The ferry's starboard side struck a berth fender at the level of the bulwark port at position C just as the deck crew had his arm outstretched and outboard. His arm was instantly severed.

The victim was treated immediately for profuse bleeding. Within minutes the vessel was re-berthed and the victim sent ashore for professional medical attention. The official investigation found that, among other things, the ferry, which was a new build still under guarantee, had suffered numerous bow thruster and electrical problems since beginning service a few months prior.

- Following the accident, a task analysis made it possible to establish a work method which eliminated the risks due to the use of a gaff outboard.
- Everyday practices, when conditions are benign, can hide hazards in plain sight. Take the time to re-analyse current work methods using the 'what if' risk assessment methodology. Can risks be further reduced by eliminating hazards or questionable procedures?
- New vessels can be subject to a 'breaking in' period where numerous minor or even major anomalies are discovered. These should be corrected as soon as possible to avoid unwanted negative consequences.

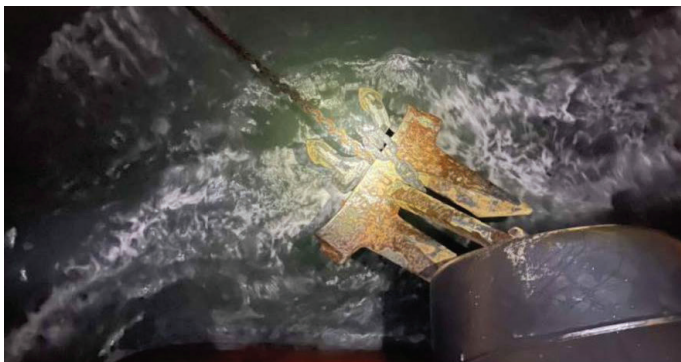
→ A loaded tanker had dropped anchor in a designated anchorage in depths of 30 m, using six shackles in the water. Upon receiving clearance to berth the deck crew began recovering the anchor but the windlass was experiencing considerable strain. The hydraulic motor was damaged due to the heavy load, so the operation was stopped and VTS informed accordingly. A spare hydraulic motor was installed and about 12 hours later clearance was again received to heave anchor.

On this attempt the anchor was successfully lifted out of the water. The crew observed the vessel's anchor was fouled with another anchor and chain. After careful consideration and with the exercise of good seamanship, this abandoned anchor and chain was freed from the vessel's gear and the vessel continued normal operations. The local VTS was informed.

Anchor fouled with abandoned anchor and chain

- If you lose an anchor and/or chain in a designated anchorage always report such an incident to local VTS, as it will then be identified as a possible foul ground area.
- If your windlass is struggling to lift the anchor in otherwise normal conditions consider the possibility of it being fouled. Divers may be needed to inspect.

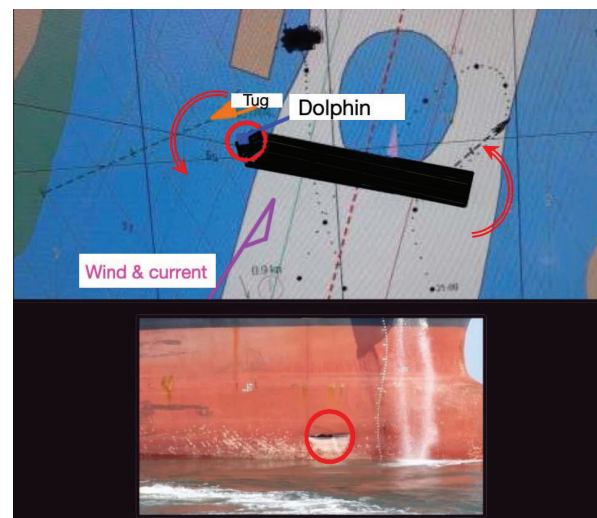
The tugboat aft was ordered to move to vessel's starboard bow to better assist in the rotation. With the tug pushing at the starboard bow, the vessel was now moving aft with a Speed Over Ground (SOG) of 2.4 knots. Soon, the vessel had turned about 60° to port, but the current and wind were moving the vessel to the north. The main engine was set to half ahead while rudder was hard to port.

As the vessel achieved approximately 90° of the turn, it was reported to be 10 metres from a dolphin on the starboard bow. The tug was at full power, but could not control the vessel's set toward the dolphin and had to abandon its position for fear of being crushed. The vessel's main engine was set at full astern, but the starboard bow brushed against the south corner of the mooring dolphin. Within minutes the vessel completed the turning manoeuvre and commenced the outbound passage to the anchorage, where damage to the hull was observed.

- In a very restricted waterway and with wind and current conditions that made for a complicated 180° turn, the use of one tug is, in retrospect, a hazardous decision.
- Only one tug was available in this port, so the hazards were 'normalised' by the Master and pilot as 'acceptable'.
- Plan a manoeuvre beforehand and think about the forces acting on your vessel. In this case the vessel had to come 180° after leaving the berth and at one point was perpendicular with the current in a restricted channel. The tug could not overcome the forces acting on the hull pushing it to the North.

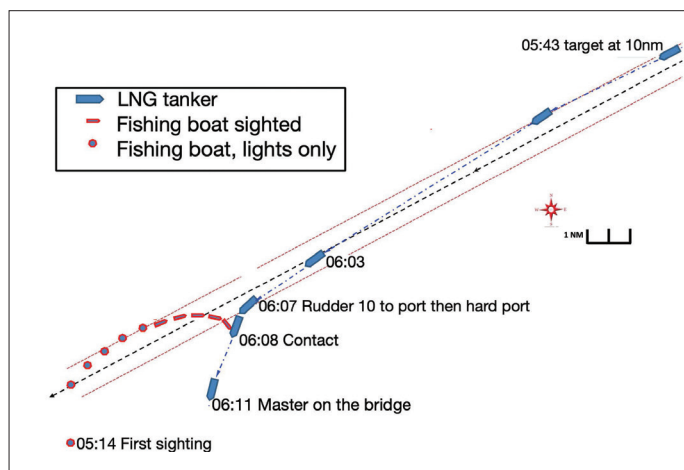
At 06:03, the fishing boat now only 1.7nm away, was seen to alter course further to starboard showing only its red light. The OOW deemed this to be an attempt by the fishing boat to cross ahead of them. Finally, the OOW ordered hand steering engaged and ordered 10 degrees to port and then hard port. Shortly after the fishing boat disappeared from view from the conning position.

The OOW went out onto the starboard bridge wing and observed the fishing boat in contact with their vessel mid-ships. He ordered the helm hard to starboard to help move the stern away from the fishing boat. The fishing boat's port bow came in contact again in way of the tanker's starboard engine room water ballast tank and then cleared. The OOW called the Master, and it was confirmed that the fishing boat was intact, and the crew were not injured.

- The OOW did not use all available means to determine if risk of collision existed. For example, he did not take compass bearings of the light when it was first reported to port and as the range decreased.

- At a critical decisional moment, with the fishing vessel 7.6nm away and clearly on a reciprocal course the OOW decided to alter course to port – but only by a few degrees. With a closing speed of about 26 knots this meant the vessels would meet in about 3.5 minutes. Now was the time for an alteration to starboard large enough to be readily apparent to the fishing vessel.
- Hand steering was not engaged until virtually the very last moments before contact. Given the situation and the levels of risk, it would have been more appropriate to do so much earlier.
