# MARS – Lessons Learned

## MARS Report No 375 January 2024

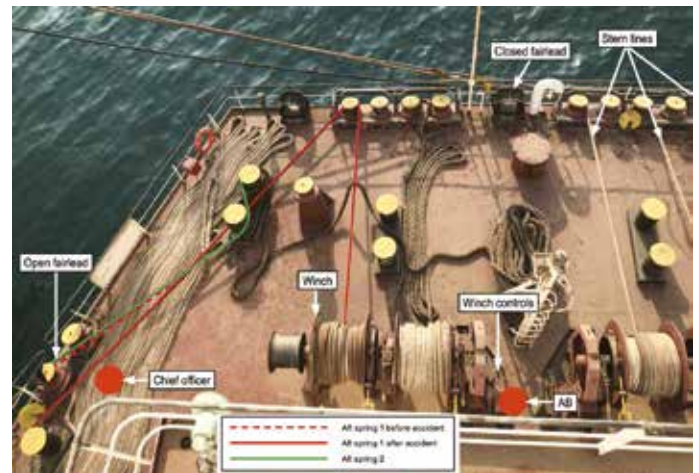
The three crew on watch and the chief officer of the receiving vessel manned the forward and aft mooring decks to warp the vessel forward using the spring lines. The Master decided not to wake the off watch crew to assist as this would disrupt their hours of rest. On the aft mooring deck, the chief officer was standing close to the vessel's side with the other crew standing by the winch ready to heave in the aft spring. As the forward springs were slackened, the winchman aft began to haul in on one of the aft springs to heave the vessel forward. Almost as soon as the mooring line came under tension, it sprang out of its open roller fairlead and struck the chief officer's head as it snapped tight. The victim fell unconscious to the deck.

The accident investigation found, among other things, that the chief officer was standing in a hazardous location but, almost certainly, had not appreciated the risk of the spring line jumping out of the fairlead. The investigation also found that, although the chief officer's working hours were compliant with STCW requirements, he was likely to have been in a fatigued state. This may have influenced his actions and motivated him to complete the job quickly so he could rest.

- An operation to shift a vessel involved in an STS transfer should be assessed for the development of potential new hazards over the course of the operation – for example, the change in relative vertical reference due to draft changes of each vessel.
- During STS transfer operations, mooring lines will develop increasingly vertical leads as the discharging vessel's freeboard rises and that of the loading vessel falls. To ensure containment of mooring lines that have or develop more vertical leads, closed fairleads should be used.
- Always evaluate your physical position at a mooring station and stay clear of potential snap-back or other energy release zones.

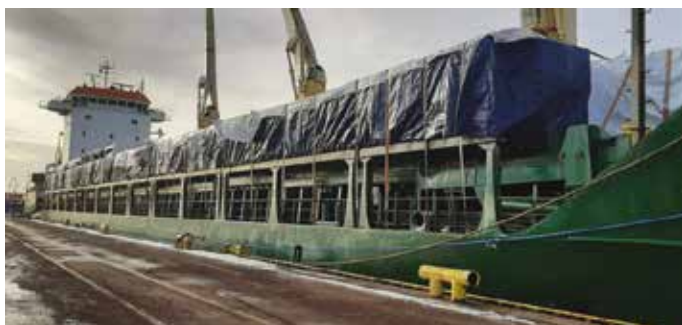
Person A, who was moving aft along the edge of the deck, was caught in the tarpaulin, which then caught the wind and acted as a sail. The other crew present were likewise unable to withstand the forces that acted on the tarpaulin. As a result, person A was pushed over the edge of the deck and fell to the dock. The crew immediately administered first aid to the victim until port rescue personnel arrived. The victim was transported to hospital by helicopter but was declared deceased the next day from injuries sustained.

Several strong gusts of wind force person A under the tarpaulin and push him close to the edge

Person A is pushed over the ship's side and falls to the dock

- Time pressure is no reason to relax safety standards, as tempting as it may be to 'get the job done'.
- Safety leadership means ensuring good practices and that the vessel's SMS is always put into practice.
- A checklist mentality – where you consider ticking the boxes more important than the task they relate to – must be avoided. Remember, most checklists are the result of a risk assessment that was done to reduce harm. Only check 'yes' on something if you have actually done it!

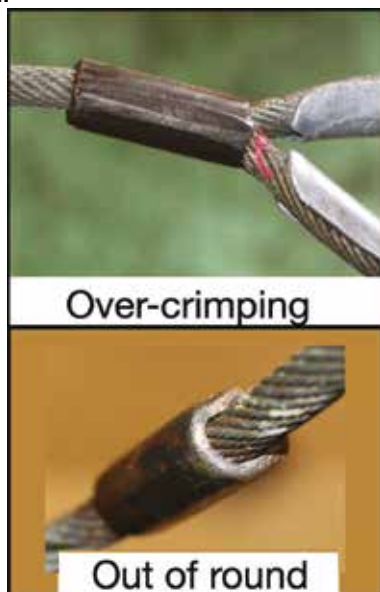
→ A vessel suffered extensive damage to equipment when a wire rope swaged splice termination failed. The investigation reiterated the importance of verifying the condition and appropriateness of wire rope terminations used in a load-handling capacity. This includes lifesaving appliances, cranes, and lifting slings, among others.

Improperly applied swaged fittings could result in unintentional damage to the wire rope, resulting in failure of the termination. Different types of fittings/end terminations might decrease

the safe working load (SWL) of the wire rope. For example, a swaged sleeve in a common turnback eye results in a 90% or better efficiency of the termination (i.e. 10% or less reduction in the SWL of the wire rope) when properly installed in accordance with manufacturer's recommendations.

- When renewing material such as wire rope and fittings, materials should be selected to match the specifications of the original equipment manufacturer.
- Visually examine wire rope terminations for abnormalities that may indicate improper installation such as out-of-roundness or over-crimping.
- Ensure that the termination type does not reduce the SWL of the wire rope below the minimum safety factor for the type of service.
