**INSPECTION REPORT OF 60-YEAR OLD
4-INCH CAST IRON PIPE ENCASED IN LOOSE POLYETHYLENE
LAFOURCHE PARISH WATER DISTRICT NO. 1
LAFOURCHE PARISH, LOUISIANA
AUGUST 7, 2018**

DUCTILE IRON PIPE RESEARCH ASSOCIATION
P.O. Box 190306
Birmingham, Alabama 35219
(205) 402-8700

INSPECTION REPORT OF 4-INCH CAST IRON PIPE ENCASED IN LOOSE POLYETHYLENE LAFOURCHE PARISH, LOUISIANA

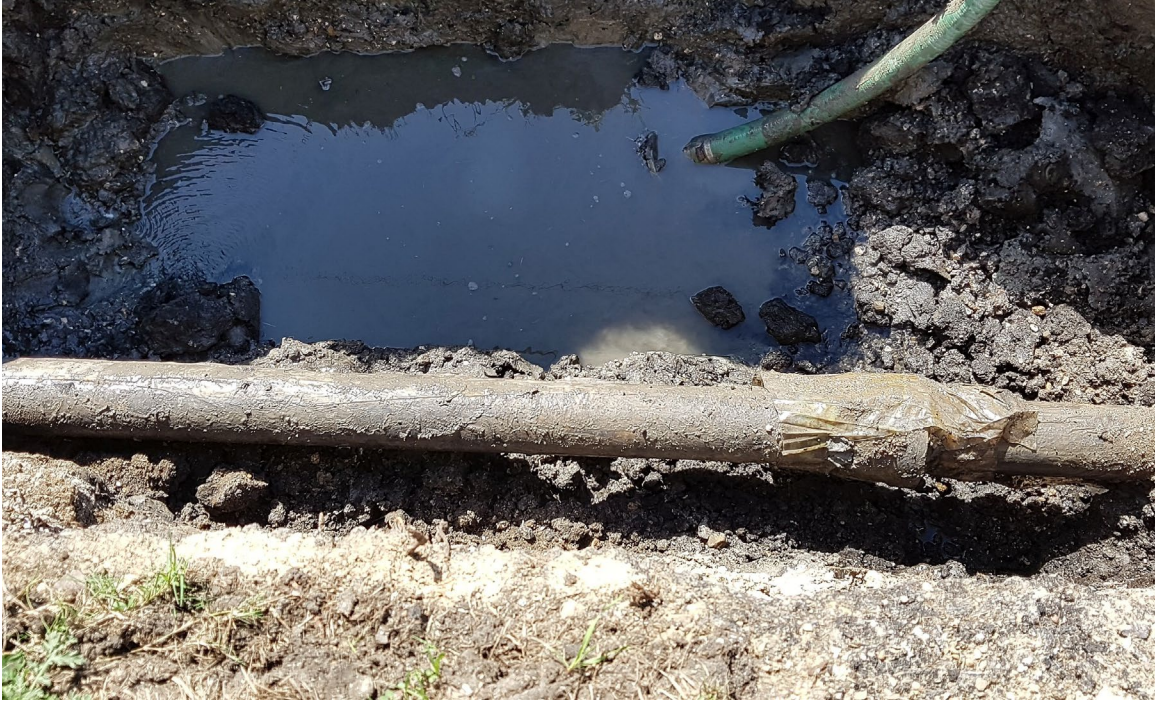
A: Pipe exposed prior to removal of polyethylene film

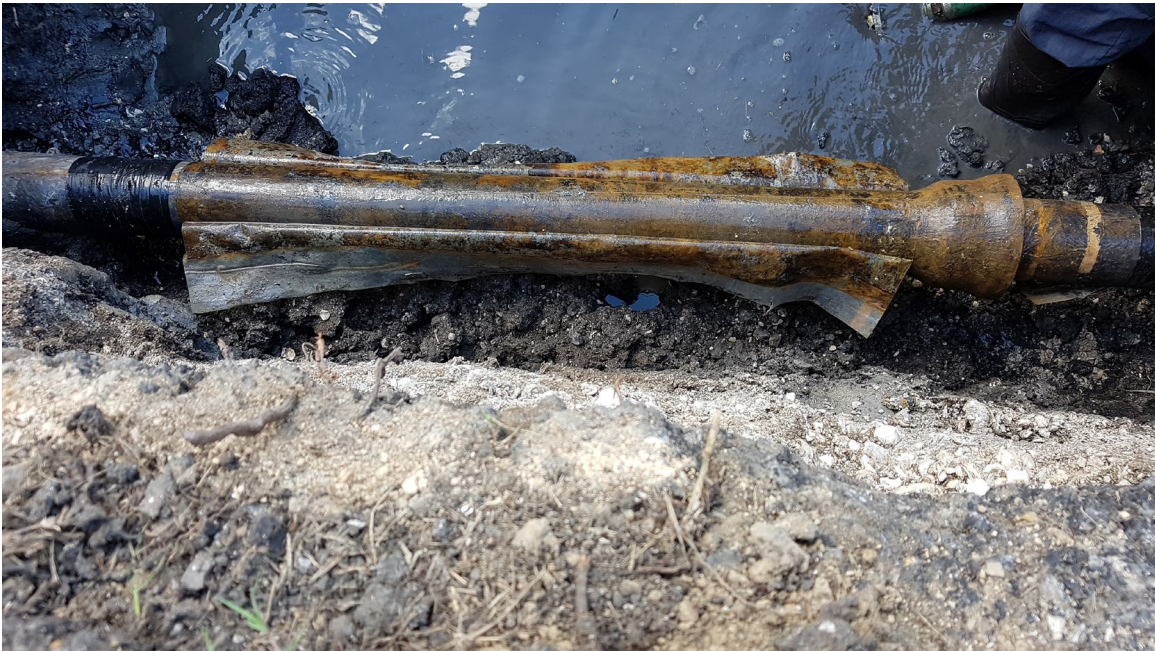
B: Polyethylene sleeving partially removed

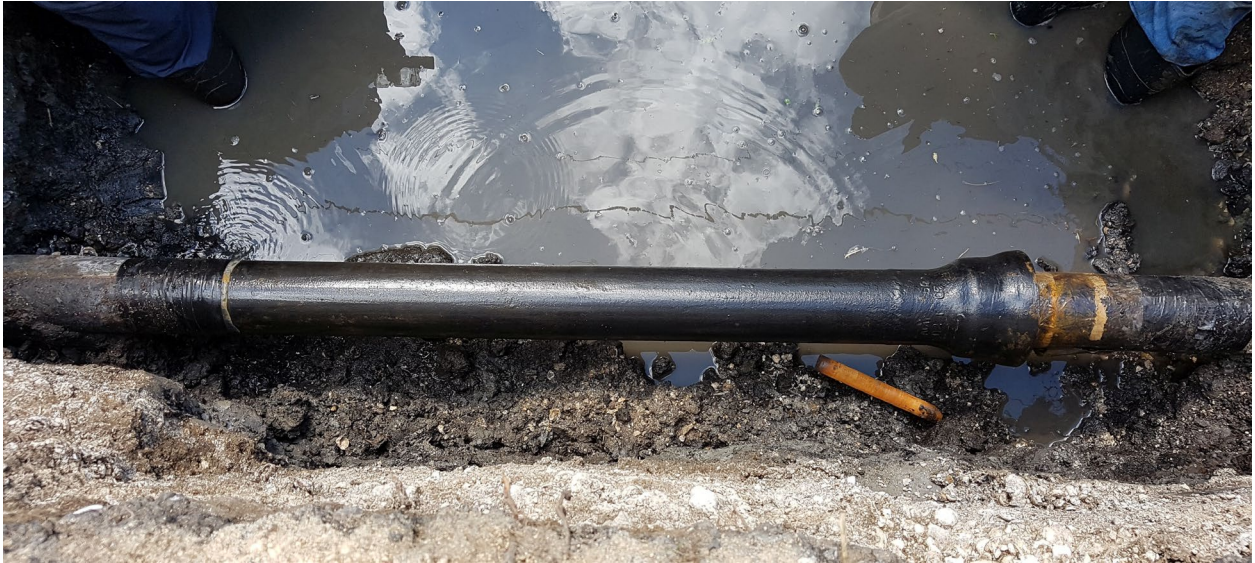
C: Encasement removed; after cleaning and sounding of the pipe surface. The oxidation was found to be completely superficial, with no pitting observed at any point along the exposed length of pipe.

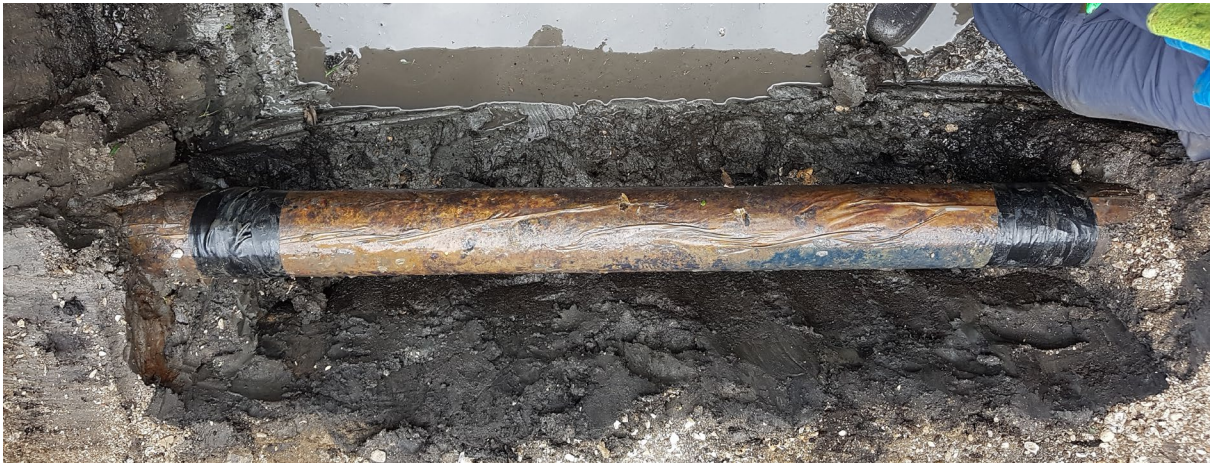
D: Site 2 - Prior to removal of polyethylene film

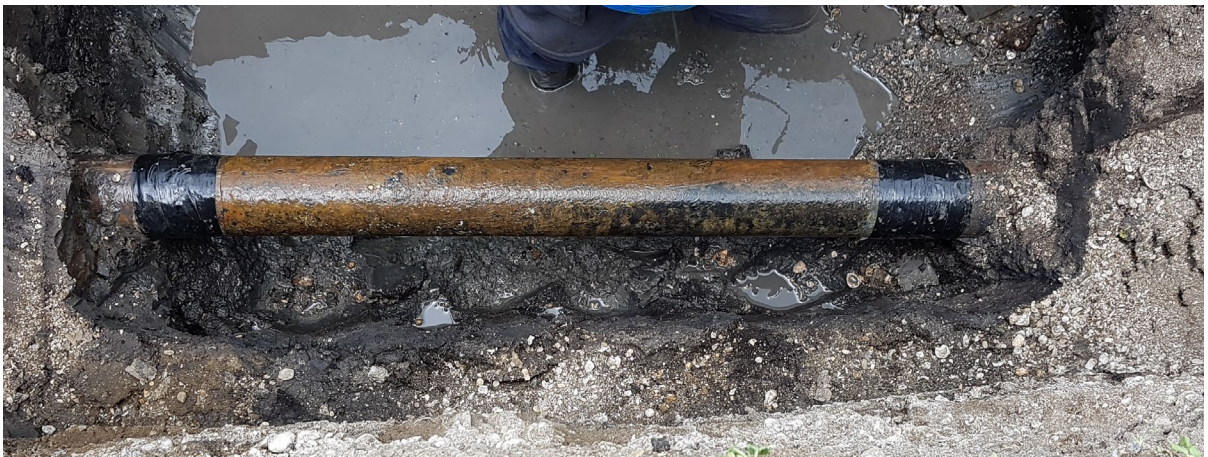
E: Polyethylene removed, prior to cleaning exterior of pipe

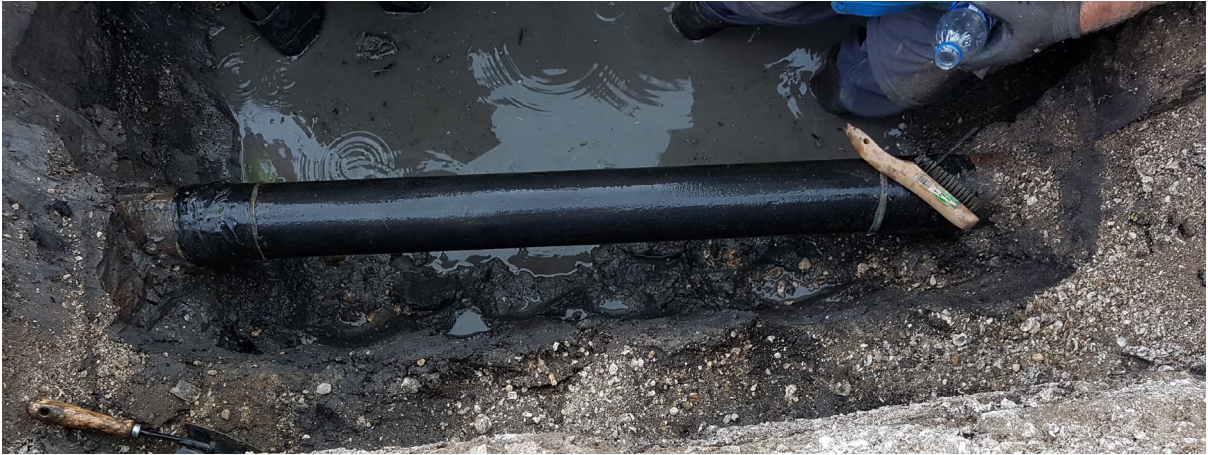
F: After cleaning and sounding of the pipe surface

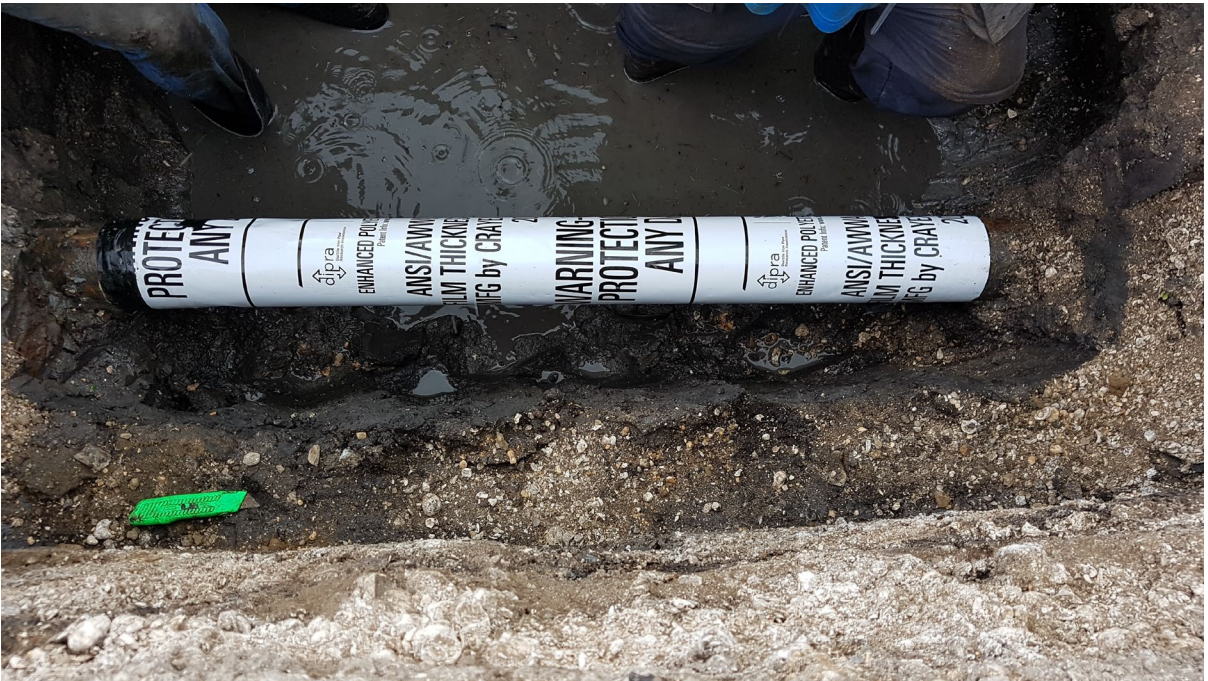
G: Pipe encased in V-Bio[®] enhanced polyethylene encasement prior to backfilling
