Title: Impact testing a sample of GRC Panels for S7 & S8 Stratford TIQ

Certificate of Test Number: 21493

Date: 3 February 2015

Contract :
S7 & S8 STRATFORD
TIQ

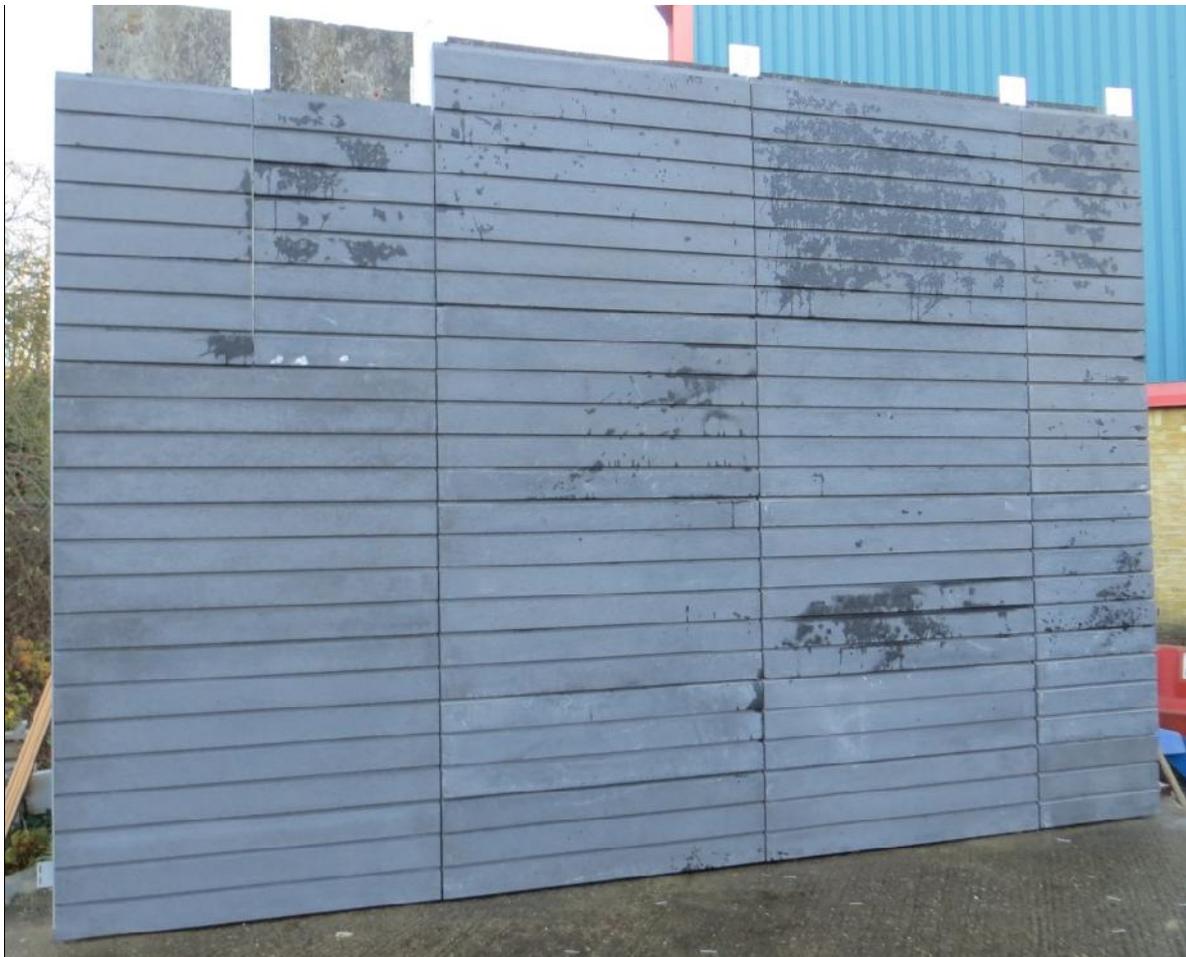
PHOTO 6555

TEST SAMPLE PRIOR TO TESTING

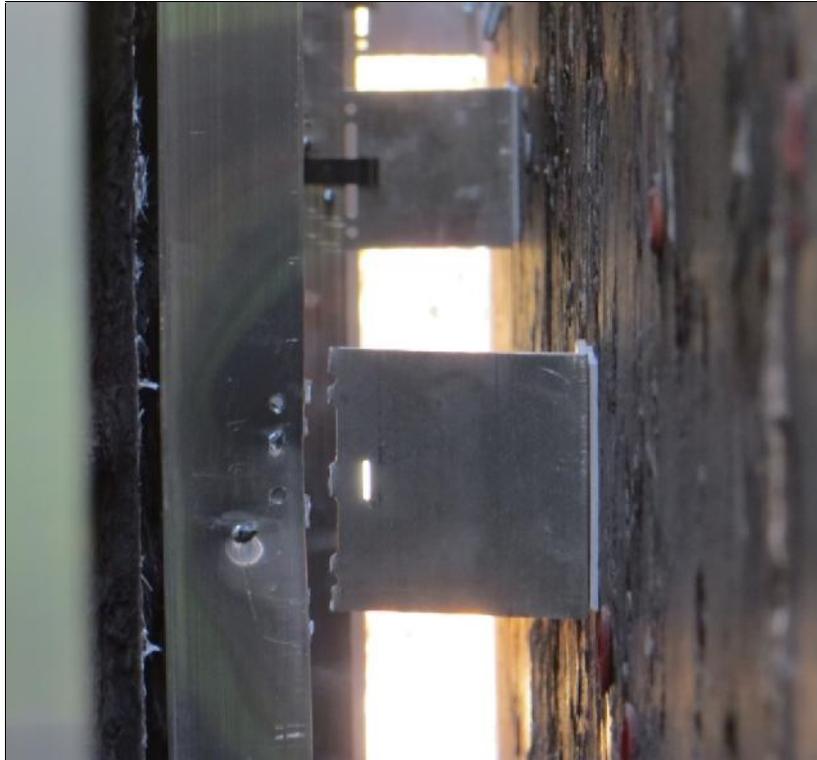
PHOTO 6560

Location	Impact energy (Nm)	Observations
1	120 (x3)	No damage observed.
2	120 (x3)	No damage observed.
3	350 (x3)	Bracket snapped at pack of panel. Panel OK.
4	350 (x3)	No damage observed.
5	500	Bracket snapped at pack of panel. Panel OK.
6	500	Bracket snapped at pack of panel. Panel OK.
7	500	Bracket snapped at pack of panel. Panel OK.
8	500 (x3)	Small crack at top of panel after first impact. Further cracking after second and third impacts but still secure.
9	500	Vertical rail bent in. Panel secure.
10	613	Panel cracked but remained secure.

FIXING BRACKET AFTER IMPACTS AT LOCATION 3

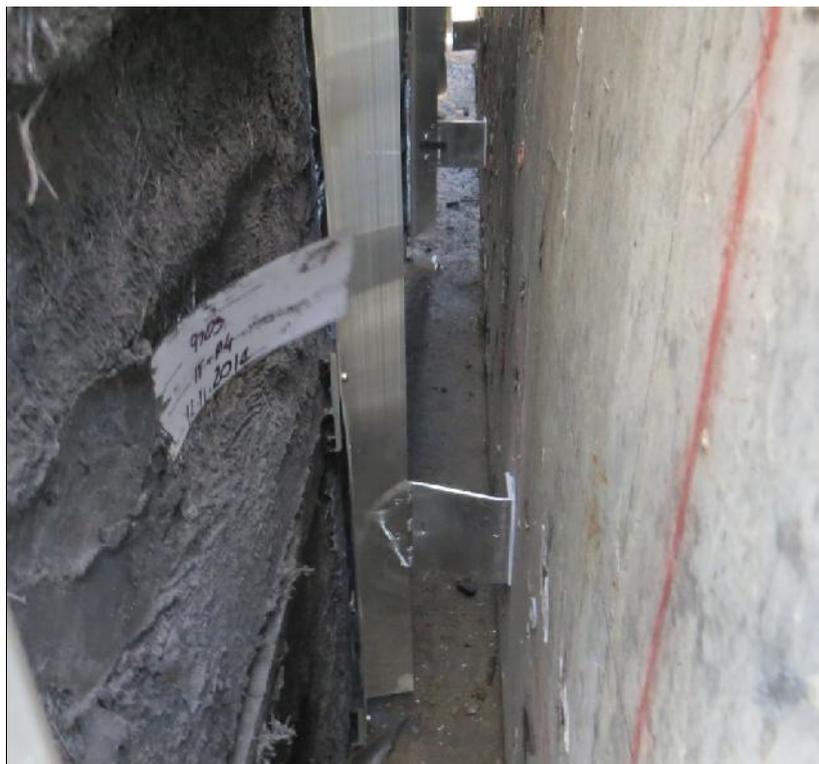
PHOTO 6562

FIXING BRACKET AFTER IMPACT AT LOCATION 7

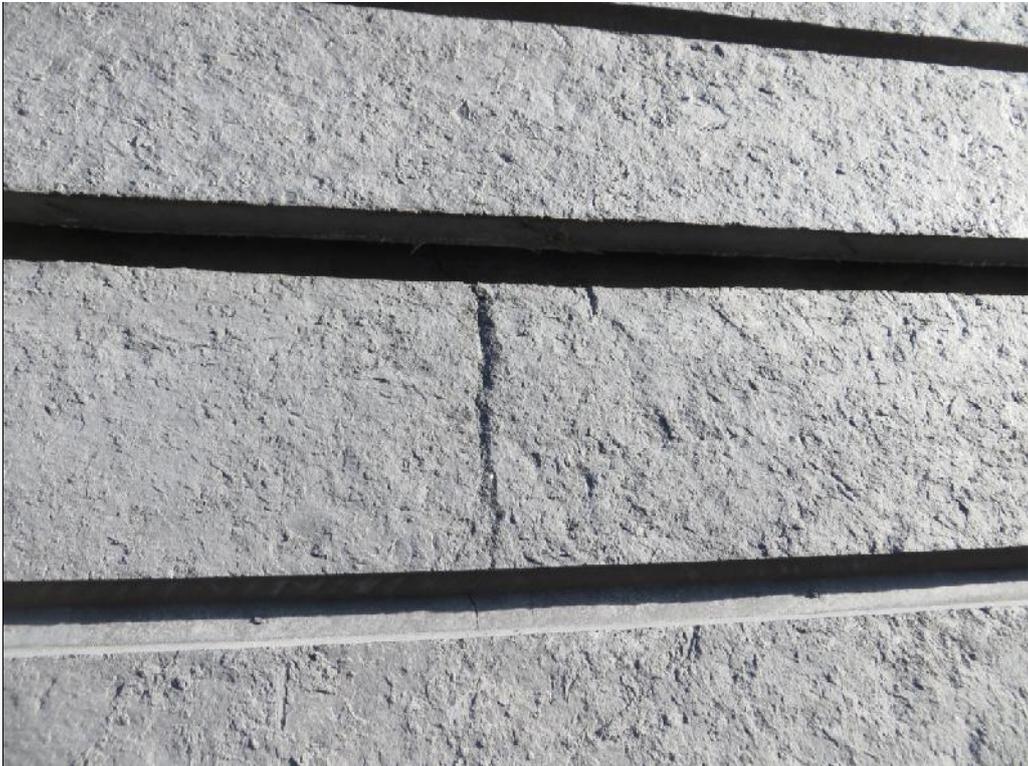
PHOTO 6564

IMPACT LOCATION 8 AFTER FIRST IMPACT

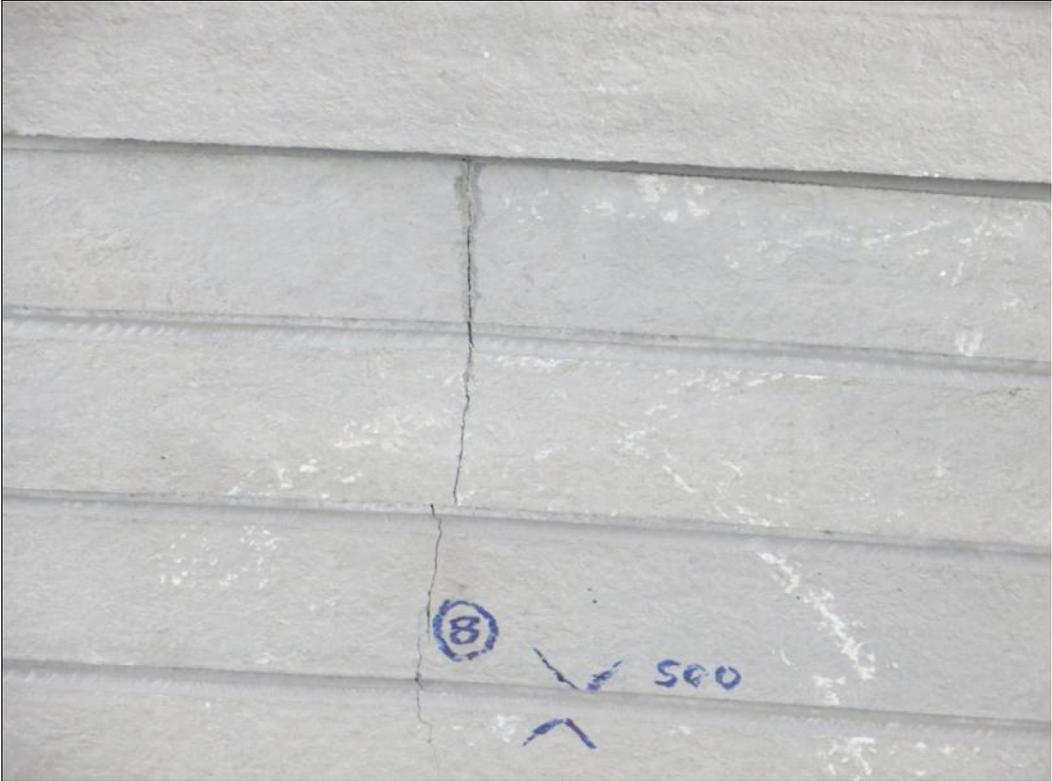
PHOTO 6582

IMPACT LOCATION 8 AFTER SECOND IMPACT

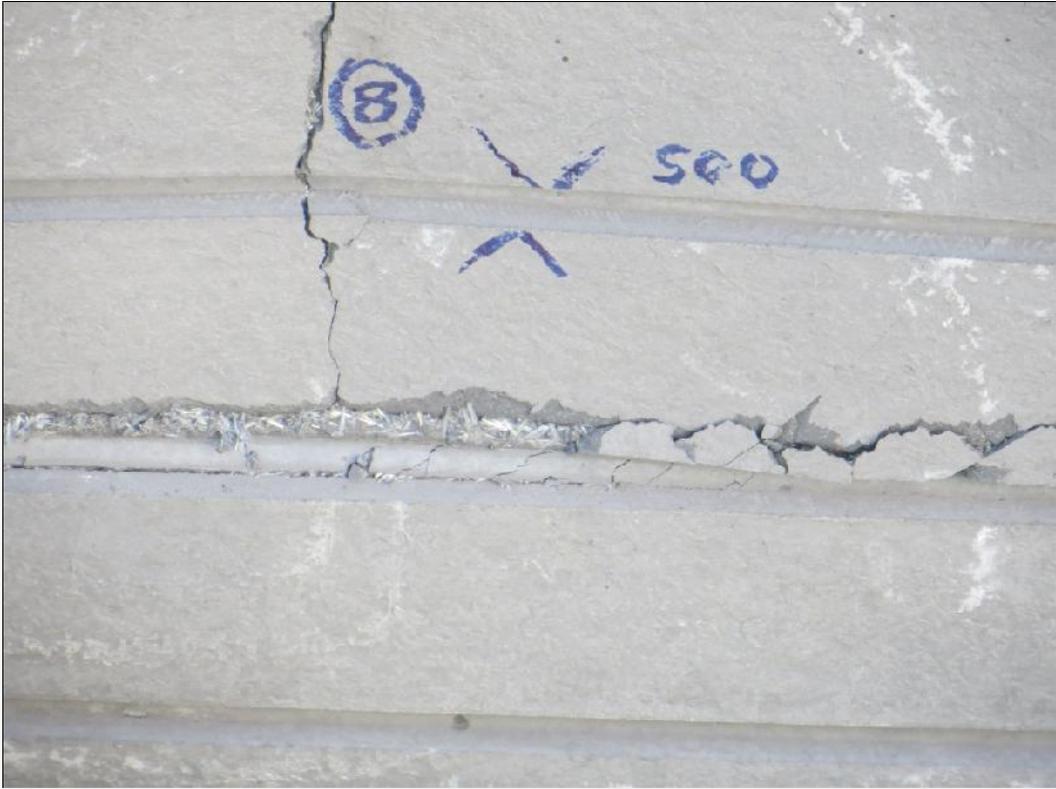
PHOTO 6589

IMPACT LOCATION 8 AFTER THIRD IMPACT

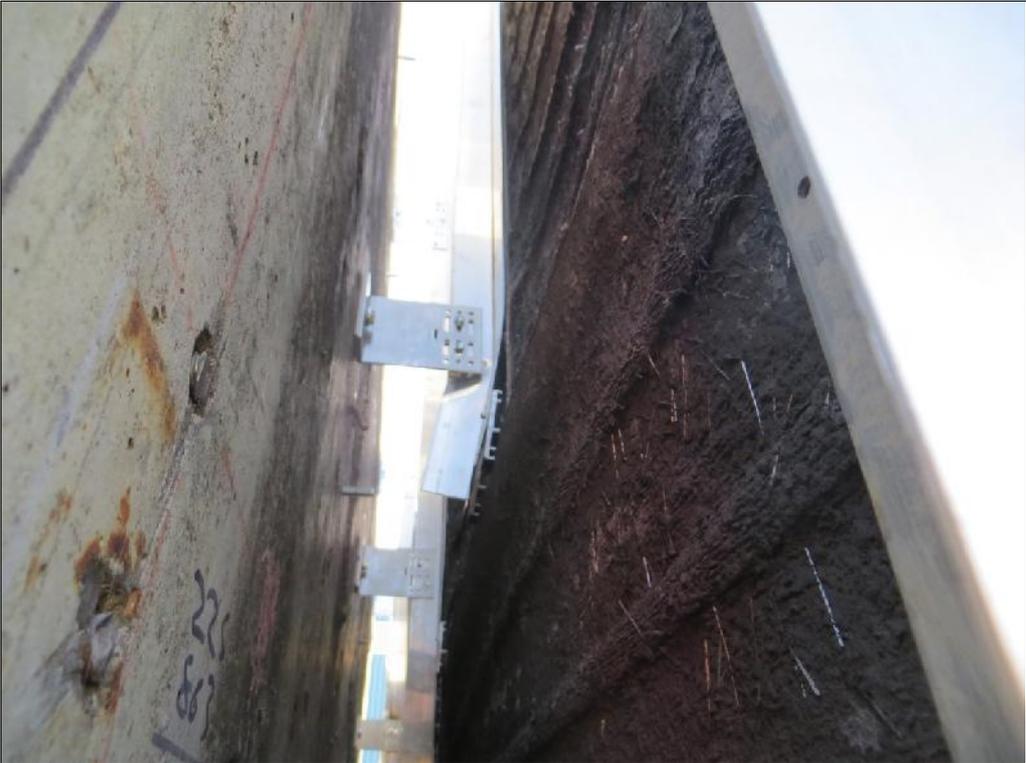
PHOTO 6570

During the dismantling of the test sample, no additional damage on the rear of the panels was observed.

VIEW AT BACK OF PANELS

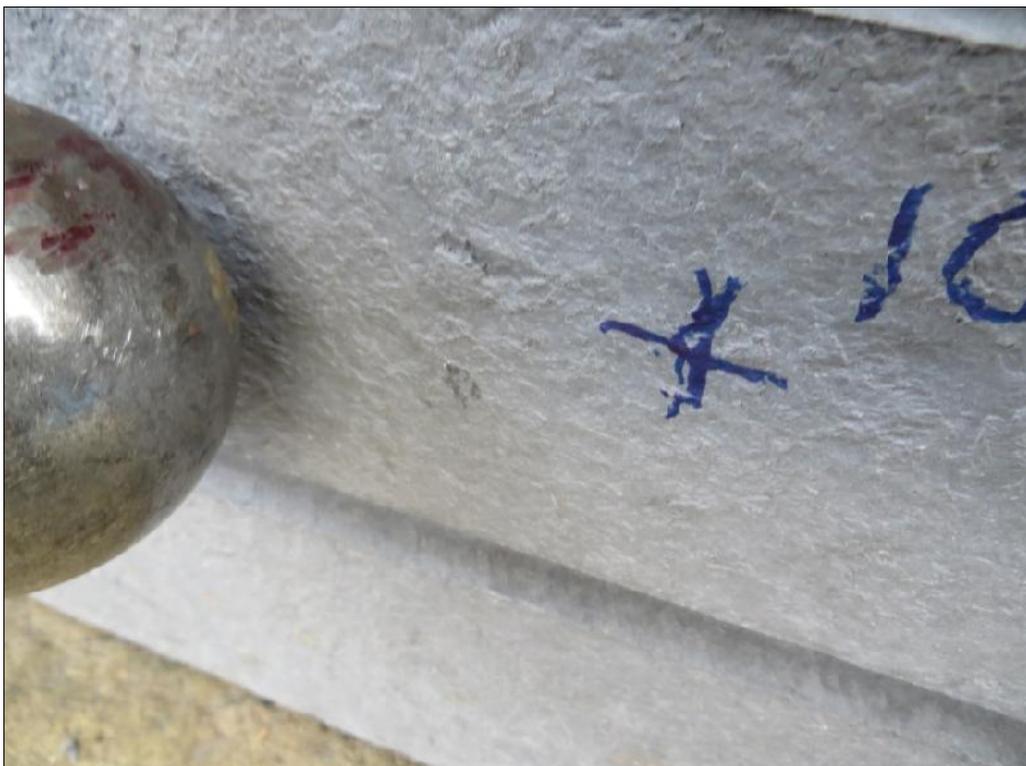
IMPACT LOCATION 11

Location	Impact energy (Nm)	Observations
11	10	Small indent in panel.
12	10	Small chip in edge of panel.
13	10	Small chip in edge of panel.
14	10	Minor edge damage, small crack.
15	10	Small chip in edge of panel.
