TEST REPORT

Project Title: Hygrothermal Testing in Accordance with ETAG 034:2012 Kits for External Wall Claddings

Client: Telling Architectural Ltd
7 The Dell
Enterprise Drive
Four Ashes
Wolverhampton
WV10 7DF

Telling Architectural Ltd required a programme of testing in order to investigate the durability of a Grade 18 Brick Faced GRC panel, proposed for 19 Colville Estate Balcony Soffits for Higgins Construction. The sample was subjected to Accelerated Weathering in accordance with ETAG 034:2012 followed by a Freeze Thaw regime in accordance with TS EN 772-22.

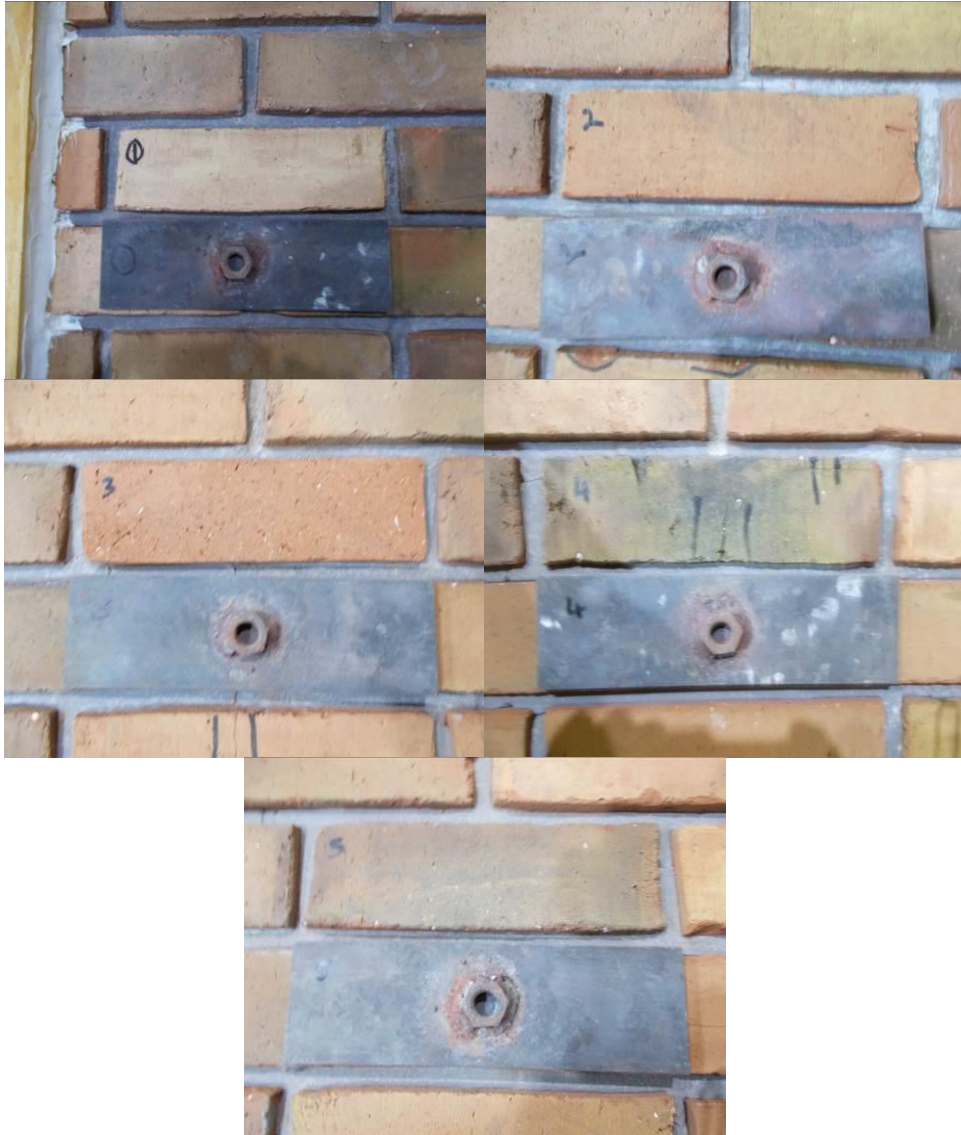
Plate 1 - Typical Failure Modes Bond Strength

Plate 1 shows the failure mode of the brick slips and test locations seen in Plate 7. In all instances failure occurred within the face of the brick slip. This indicates that the bond between the brick slip and substrate is stronger than that of the brick slip itself.

Test Specimen	Maximum Failure Load (kN)	Tensile Strength (N/mm ²)	Failure Mode
1	5.38	0.40	Within the face of the brick slip
2	5.29	0.39	Within the body of the brick slip
3	5.17	0.38	Within the body of the brick slip
4	7.13	0.53	Within the body of the brick slip
5	6.87	0.51	Within the face of the brick slip
Mean	5.97	0.44	-

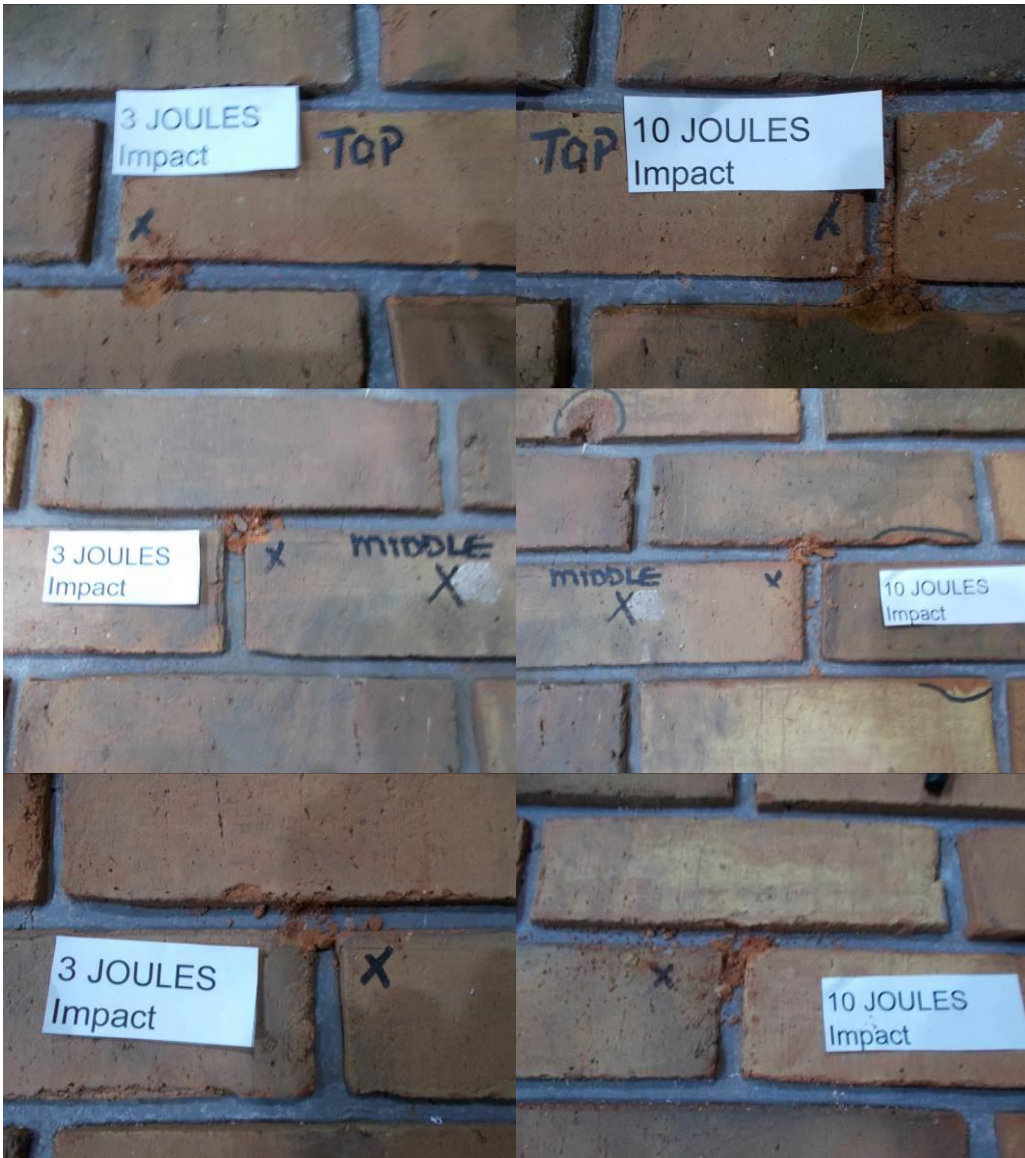
Plate 2 - Typical Damage Hard Body Impact Testing

The results of the hard body impact testing carried out at both 3 Joules and 10 Joules energy are given in the Table 4. Typical damage can be seen in Plate 2 with test locations seen in Plate 7.

Location	Diameter under 3 Joules Impact Energy (mm)	Cracking	Circumference of Cracking (°)	Diameter under 10 Joules Impact Energy (mm)	Cracking	Circumference of Cracking (°)
1	17.89	Corner of Brick Slip	360	21.67	Corner of Brick Slip	360
2	17.00	Damage to Edge of Brick Slip	360	23.87	Cracking of adjacent mortar joint	360
3	9.82	Damage Corner of Brick Slip	360	11.07	Cracking of adjacent mortar joint	360

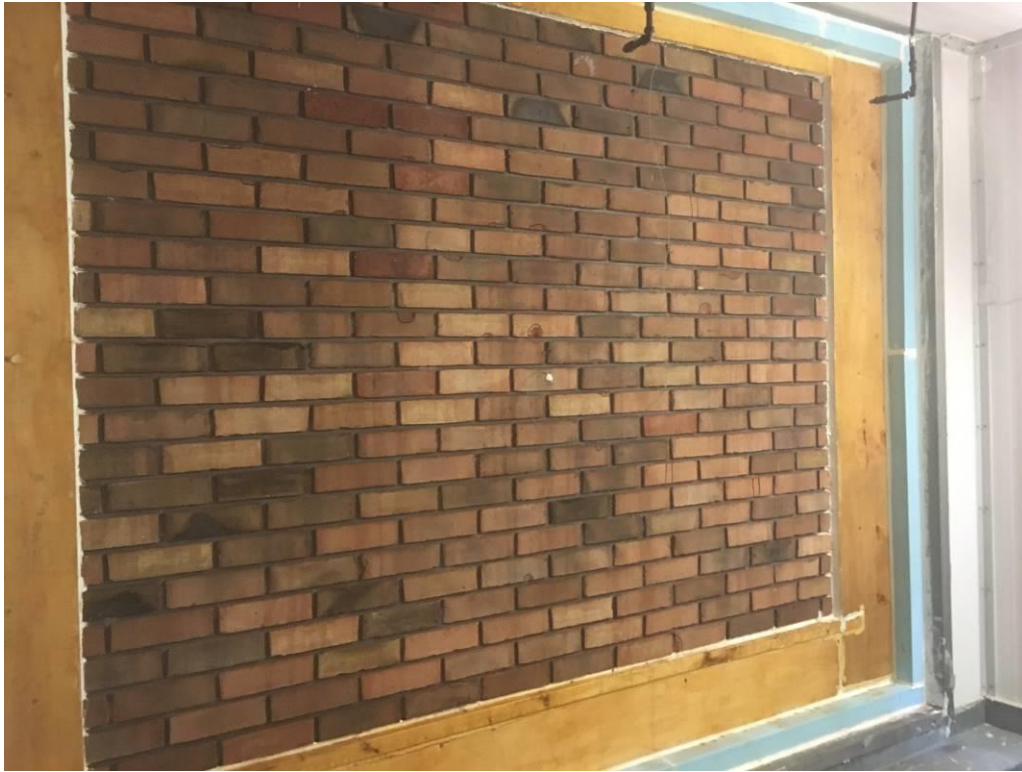
Plate 5 - Front of Panel after Test

Visual inspection concluded that there was no damage to the Grade 18P GRC Panel.
