Pictures for question 25

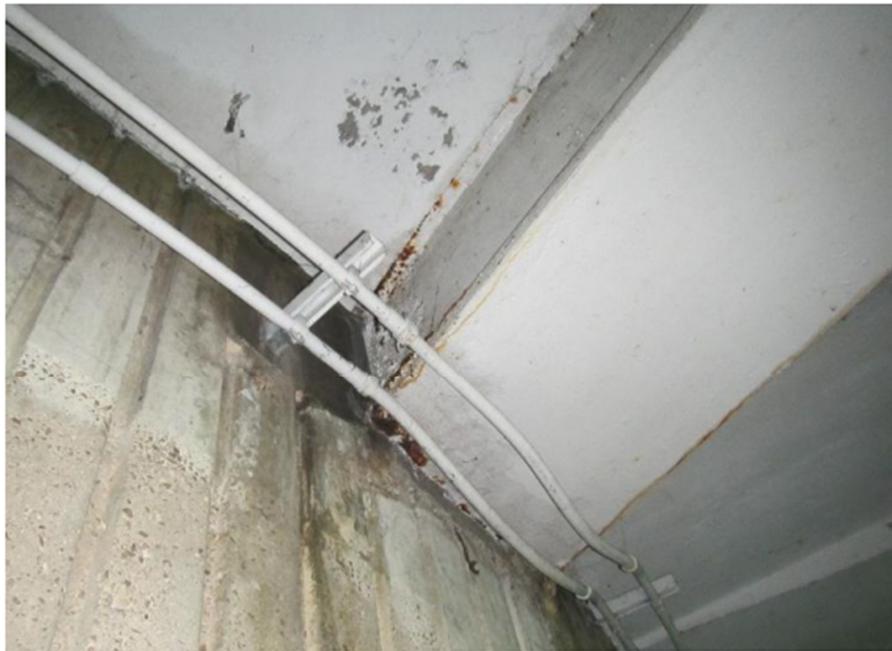
21

Corrosion of steel girder at connection to helix ramp core wall at the Level 4 north bridge

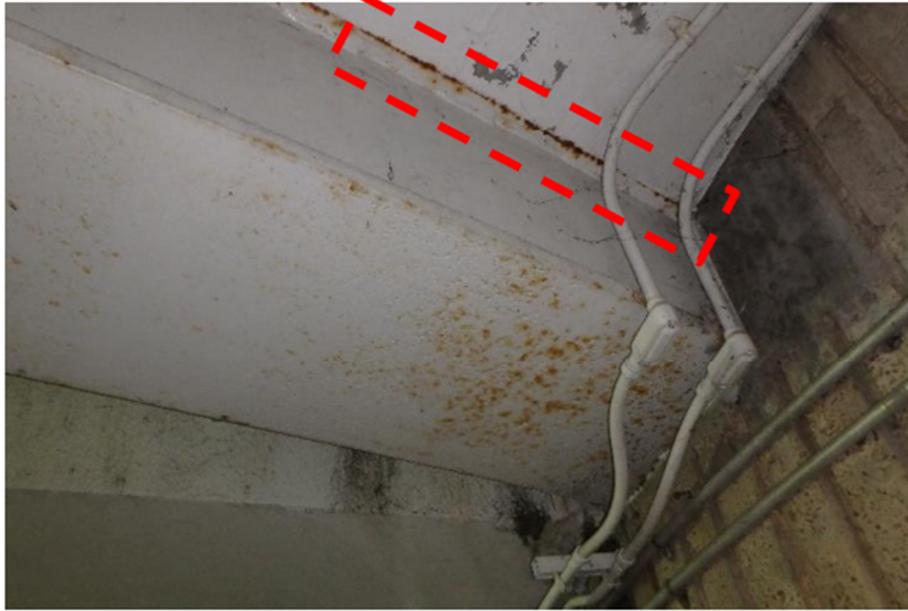
22

Corrosion of steel girder at connection to helix ramp core wall at the Level 4 north bridge

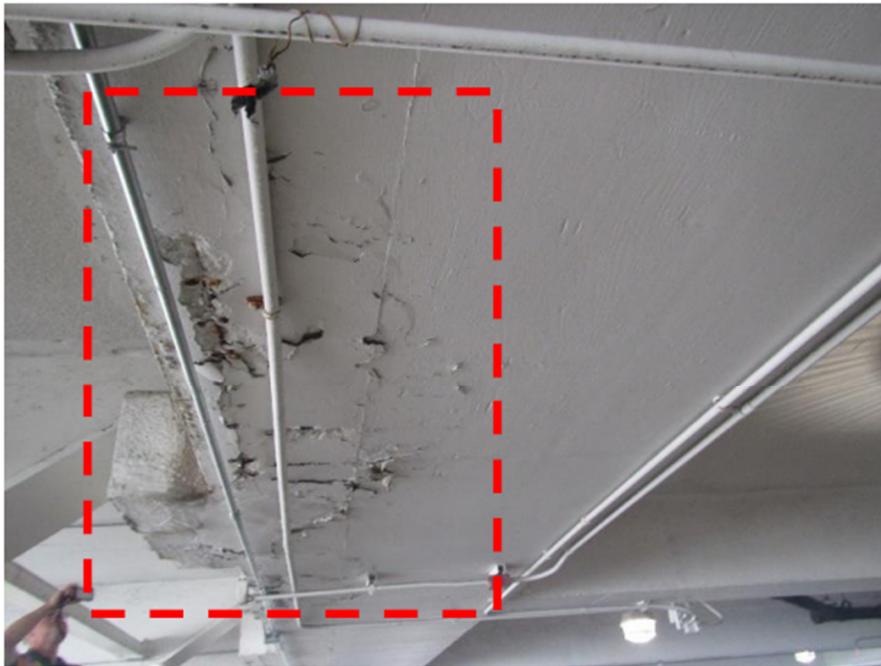
23 Corrosion of steel box girder
