# Inspection Report

**Asset:**  
Asset\_3

**Reported by:**  
FURAY Photogrammetry Solutions

Type: Energy utility

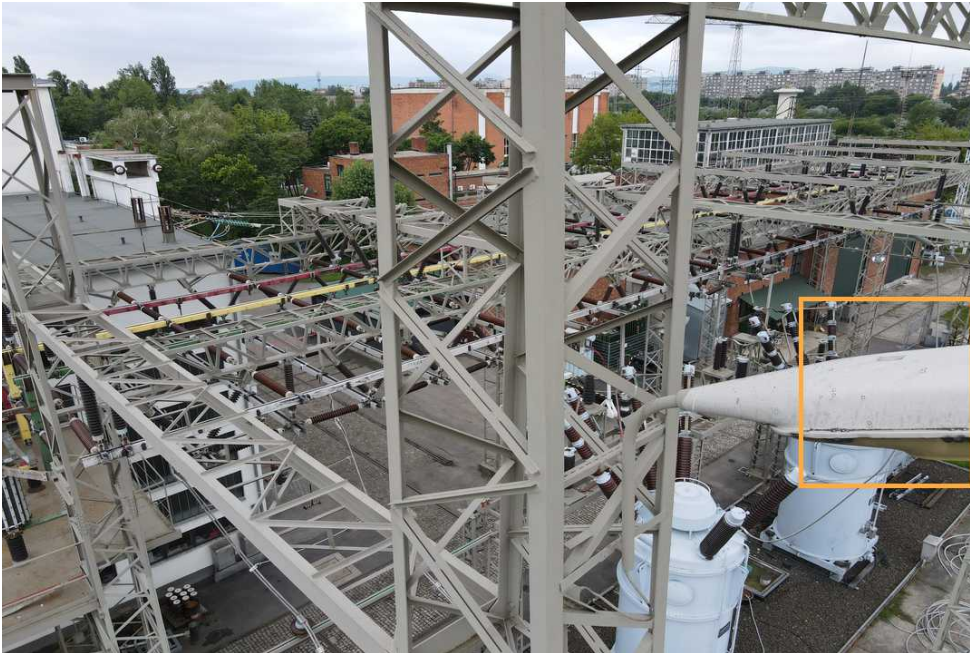
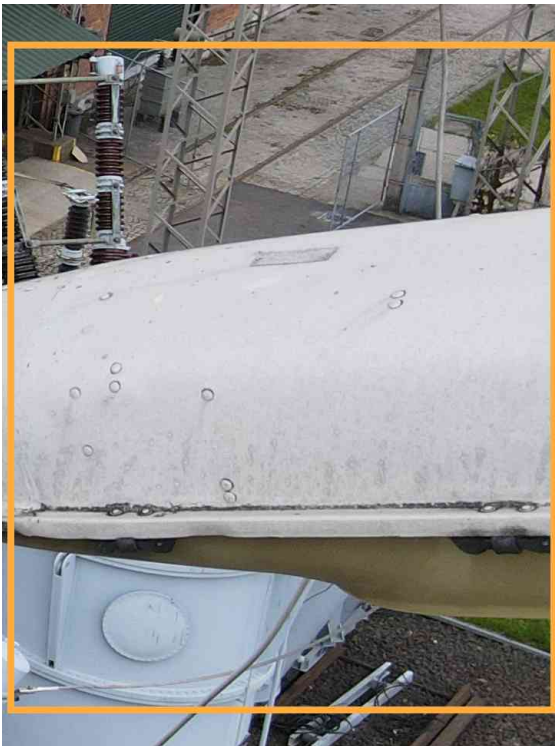
**100\_DJI\_0644.JPG**

### **Annotation 1**

**Severity level: 4**

**Description: Burnt out light bulb**

**Annotation type: To be repaired**

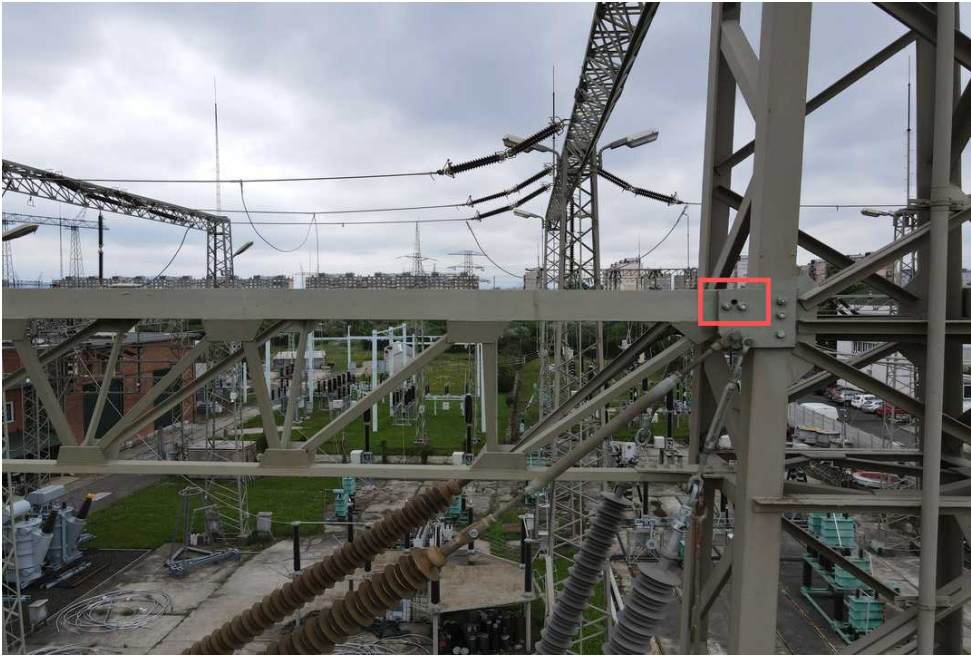
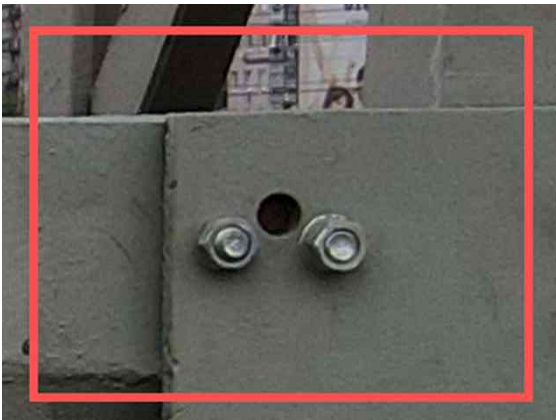
**100\_DJI\_0765.JPG**

**Annotation 2**

**Severity level: 5**

**Description: Missing bolt**

**Annotation type: To be fixed**

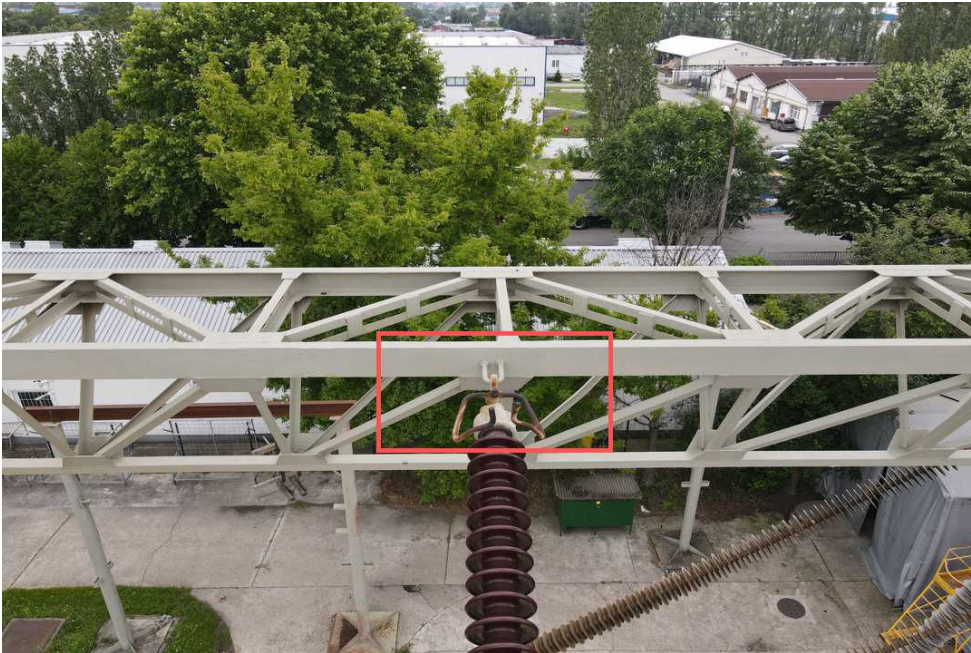
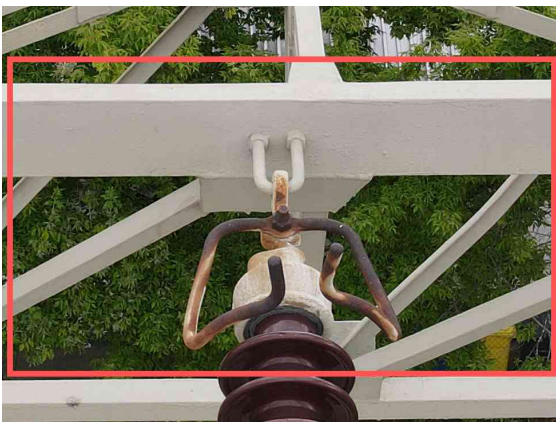
**101\_DJI\_0065.JPG**

### **Annotation 3**

**Severity level: 5**

**Description: Rusted grounding joint**

**Annotation type: To be replaced**

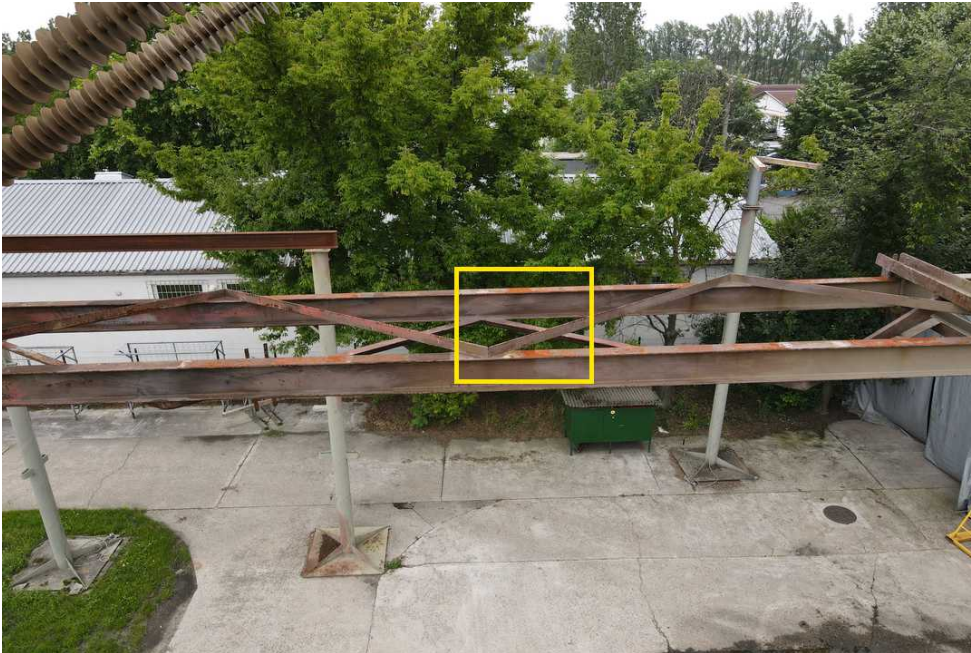
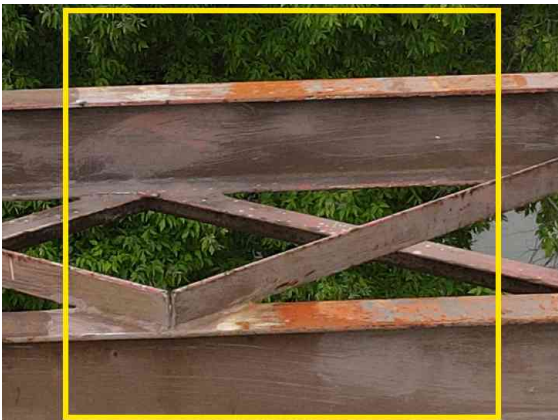
**101\_DJI\_0128.JPG**

**Annotation 4**

**Severity level:** 3

**Description:** Lack of surface treatment

**Annotation type:** To be fixed

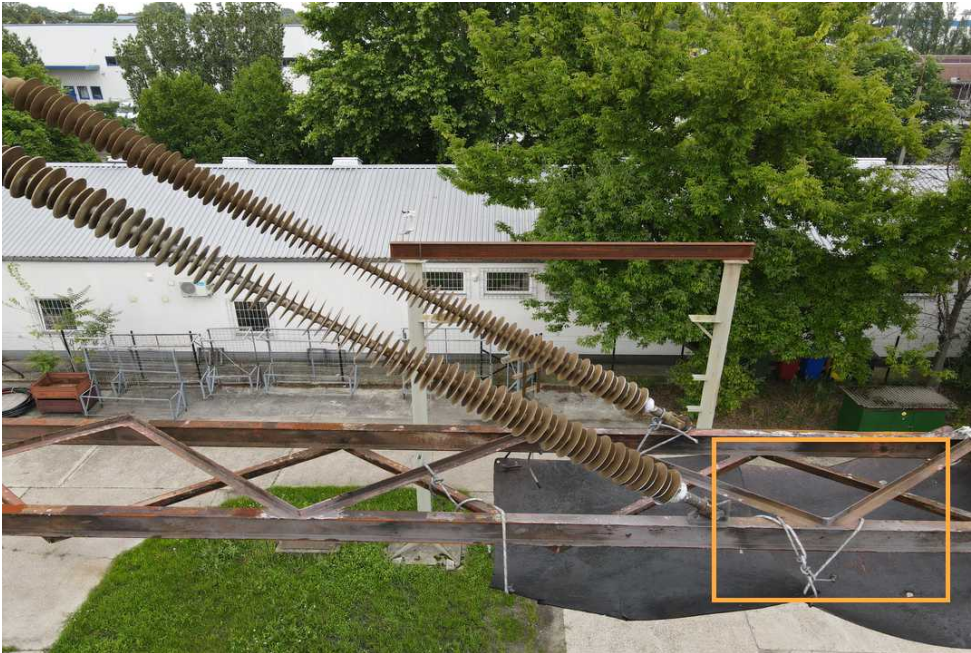
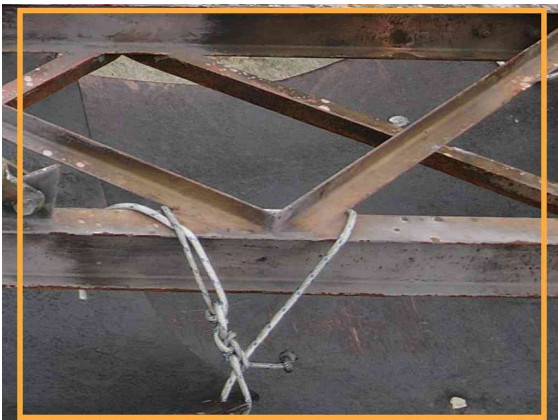
**101\_DJI\_0344.JPG**

**Annotation 5**

**Severity level:** 4

**Description:** Torn insulation fixing

**Annotation type:** To be replaced

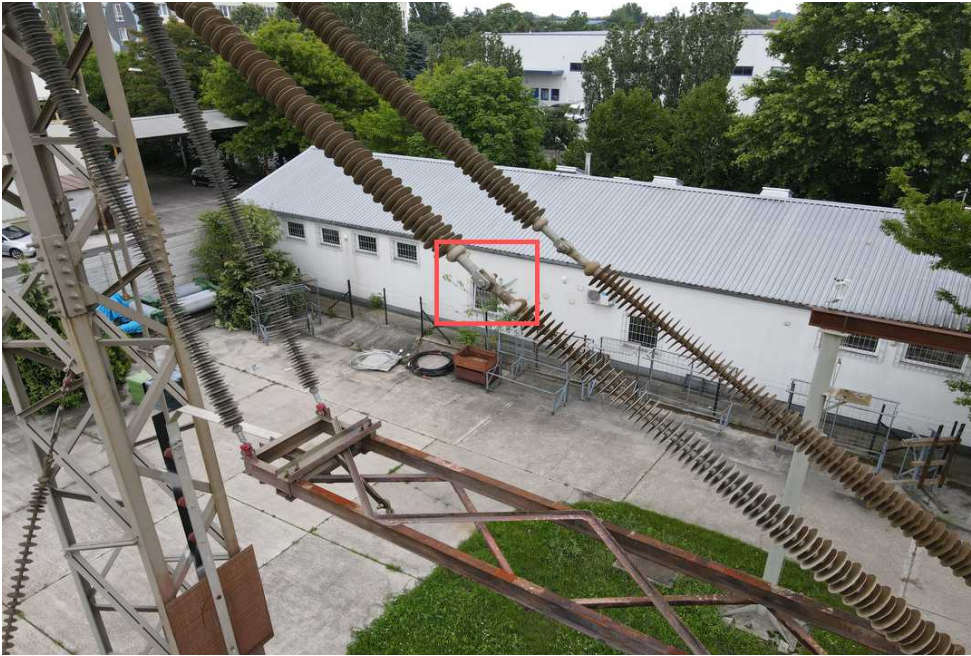
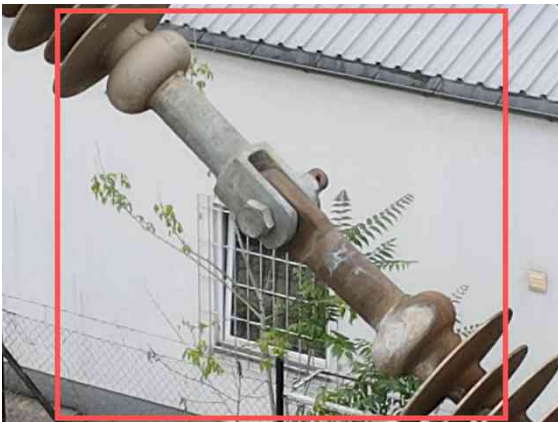
**101\_DJI\_0370.JPG**

**Annotation 6**

**Severity level:** 5

**Description:** Loose joint between insulation

**Annotation type:** To be fixed

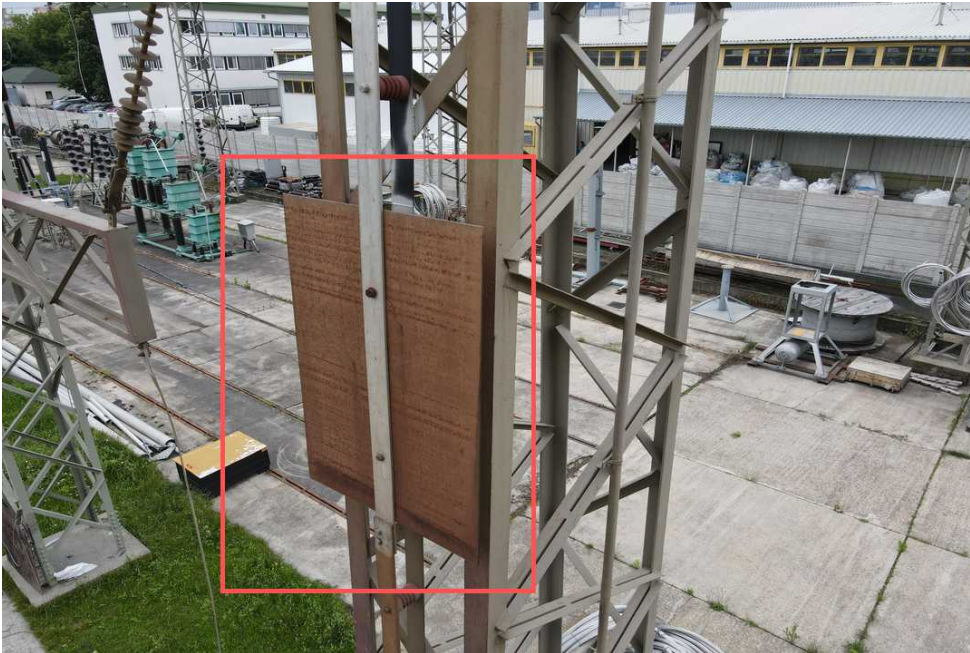
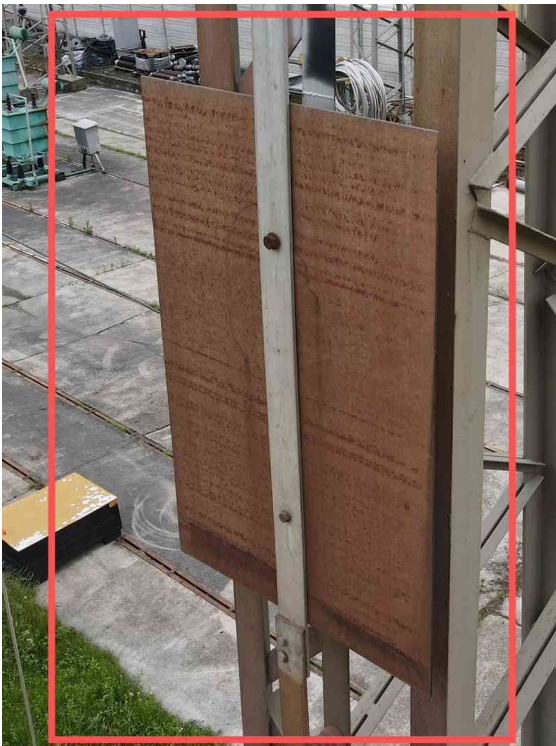
**101\_DJI\_0858.JPG**

**Annotation 7**

**Severity level:** 5

**Description:** Rusted insulation sheet

**Annotation type:** To be replaced
