# Inspection Report

Asset\_3

**Type:** Energy utility

**Description:** Pilon

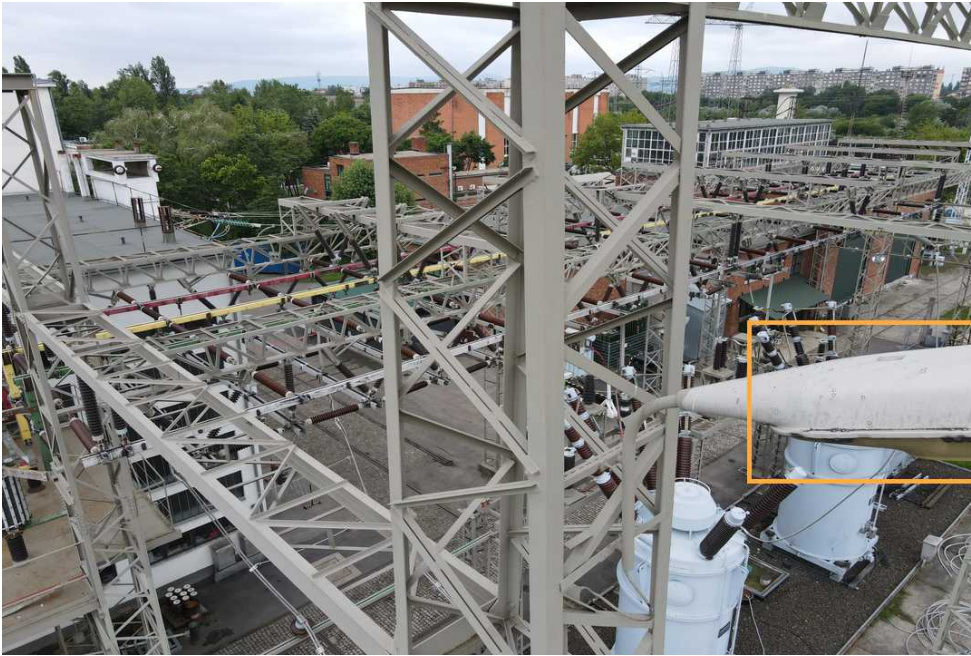
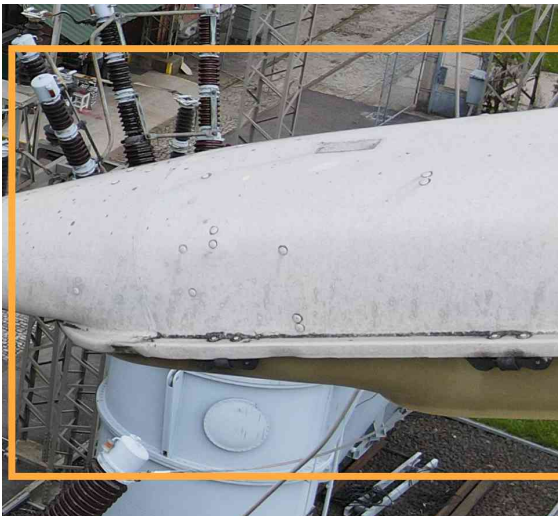
**100\_DJI\_0644.JPG**

**Annotation ID 1298**

**Annotation type: To be repaired**

**Severity level: 4**

**Description: Bunt out light bulb.**

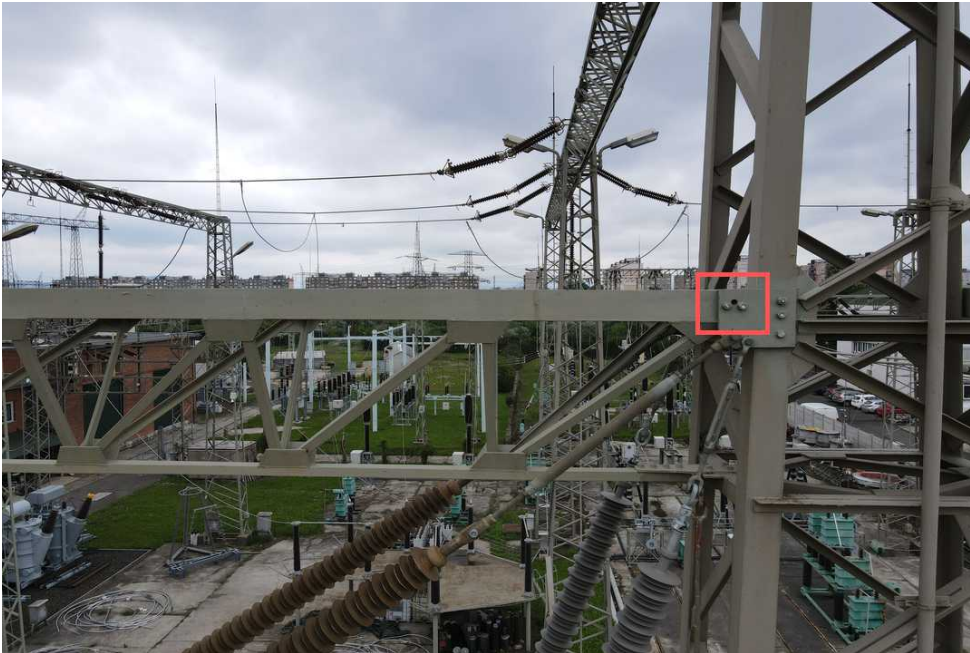
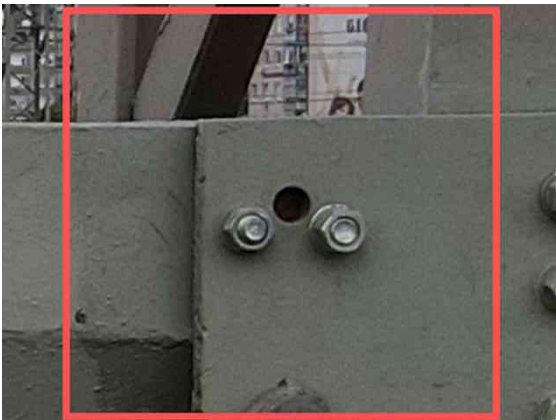
**100\_DJI\_0765.JPG**

**Annotation ID 1304**

**Annotation type: To be fixed**

**Severity level: 5**

**Description: Missing bolt.**

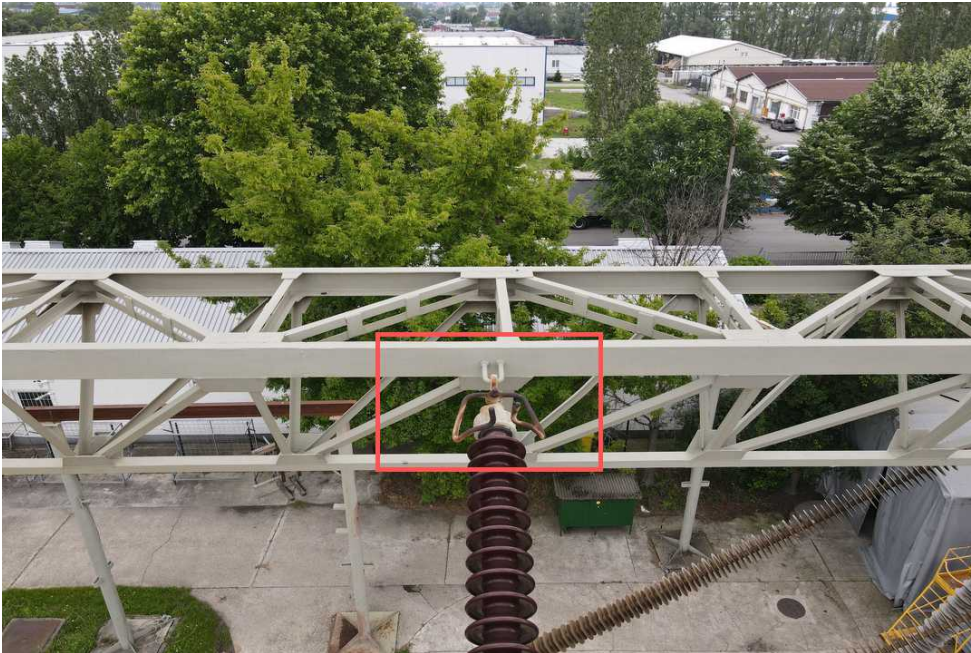
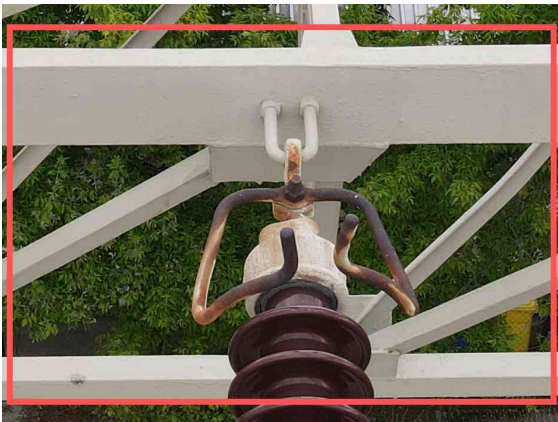
**101\_DJI\_0065.JPG**

**Annotation ID 1296**

**Annotation type:** To be replaced

**Severity level:** 5

**Description:** Rusty grounding joint.

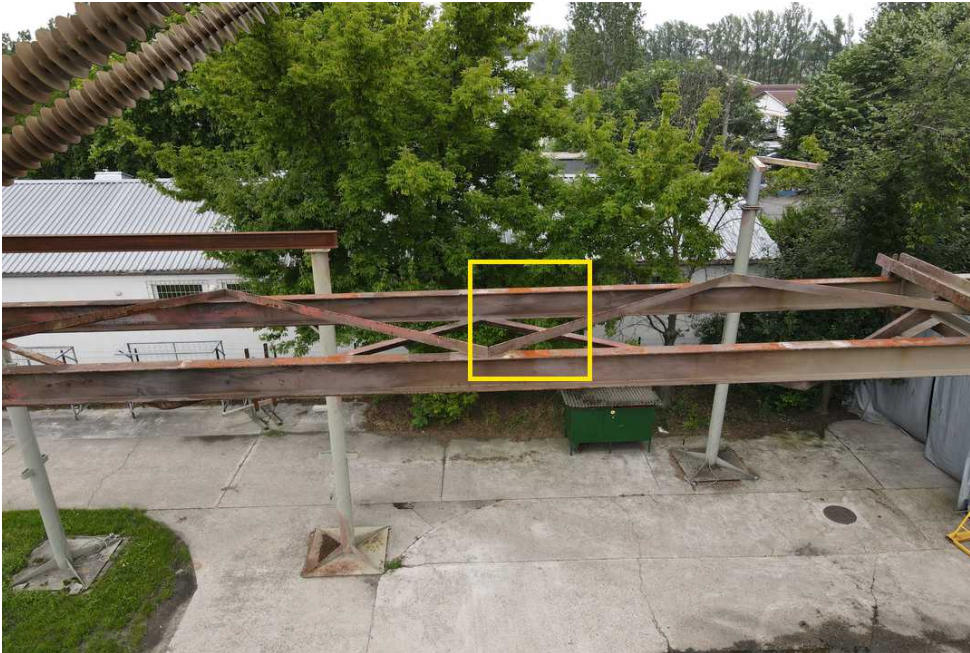
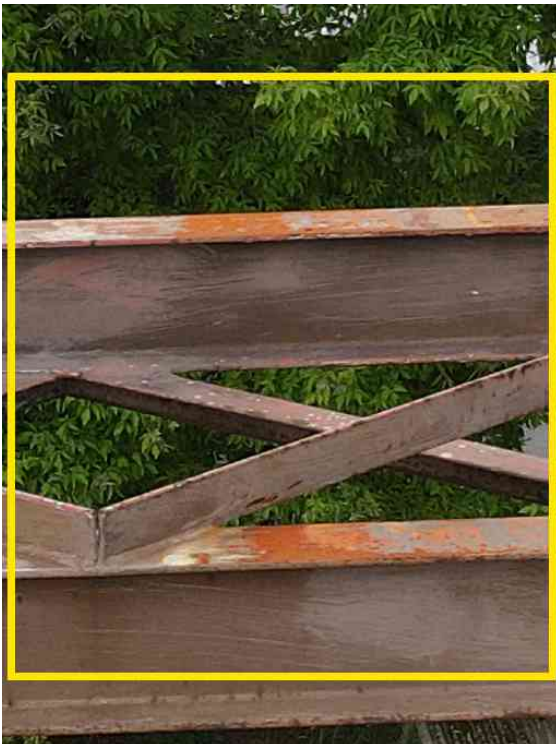
**101\_DJI\_0128.JPG**

**Annotation ID 1302**

**Annotation type:** To be fixed

**Severity level:** 3

**Description:** Lack of surface treatment.

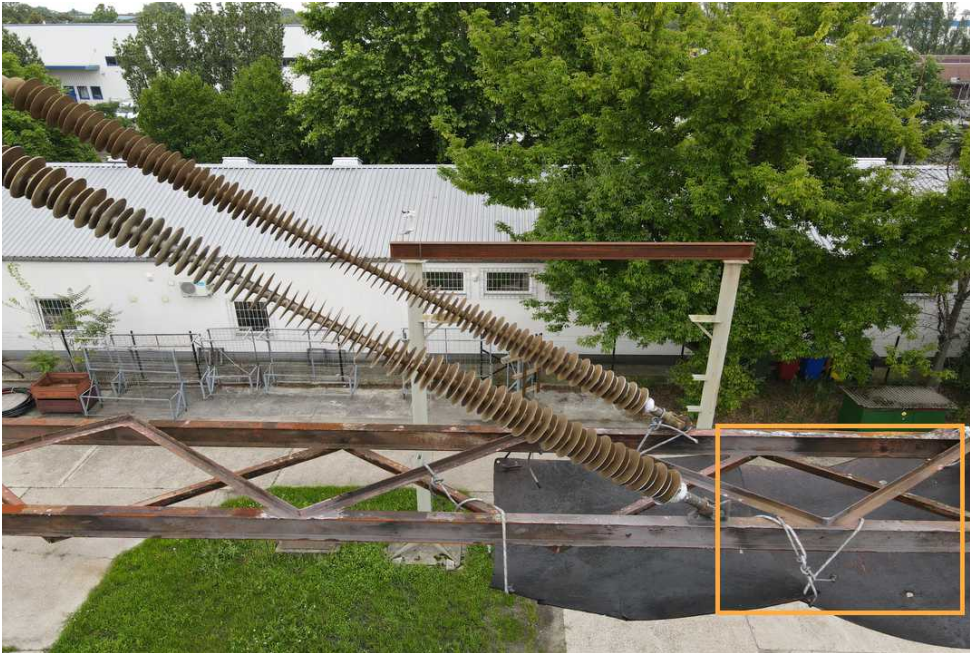
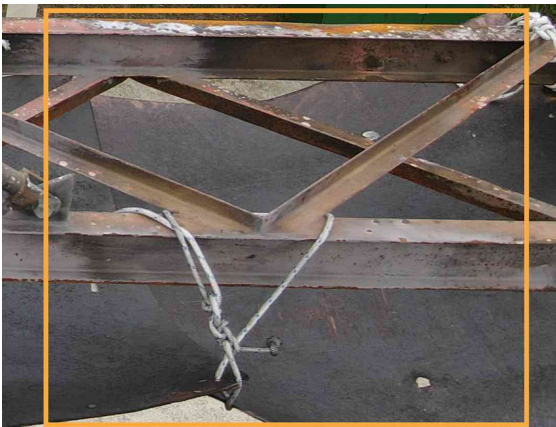
**101\_DJI\_0344.JPG**

**Annotation ID 1303**

**Annotation type:** To be replaced

**Severity level:** 4

**Description:** Torn insulation fixing.

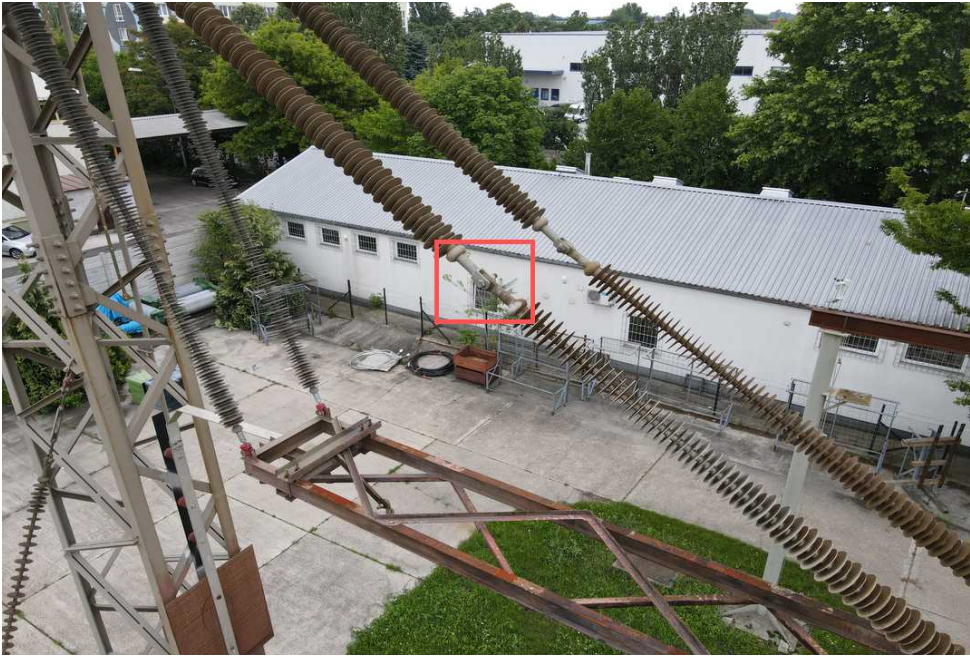
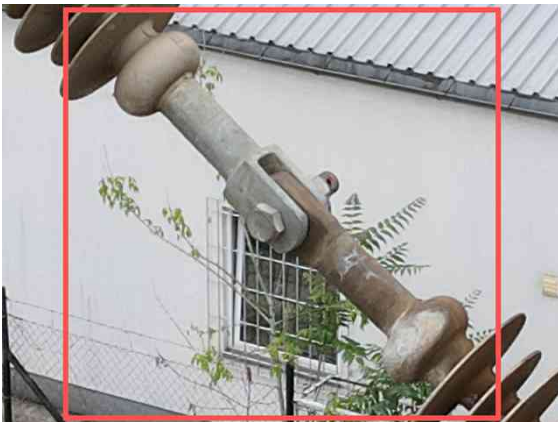
**101\_DJI\_0370.JPG**

**Annotation ID 1300**

**Annotation type:** To be fixed

**Severity level:** 5

**Description:** Loose joint between insulation.

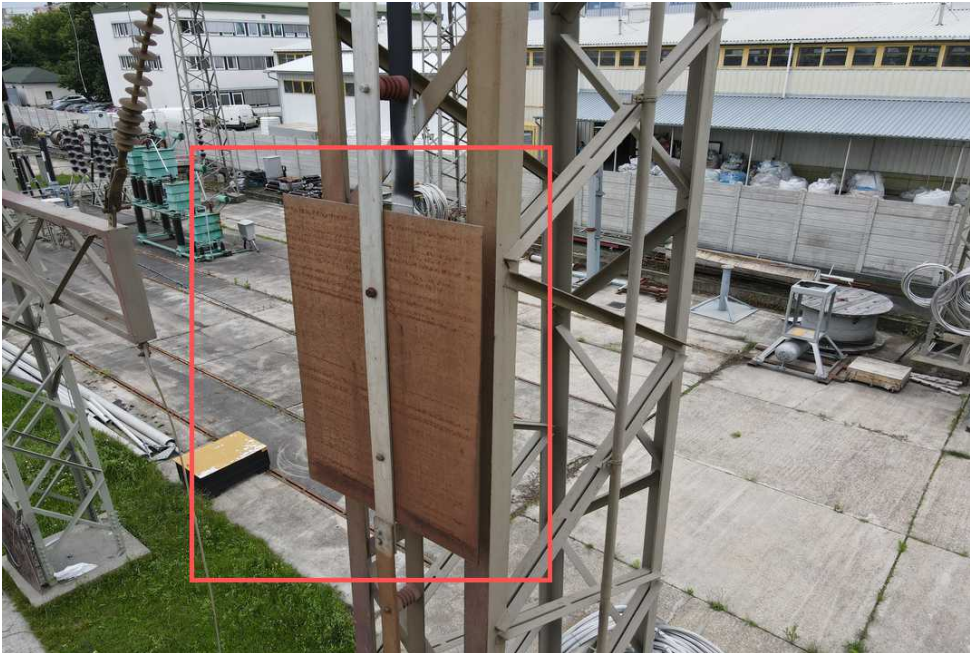
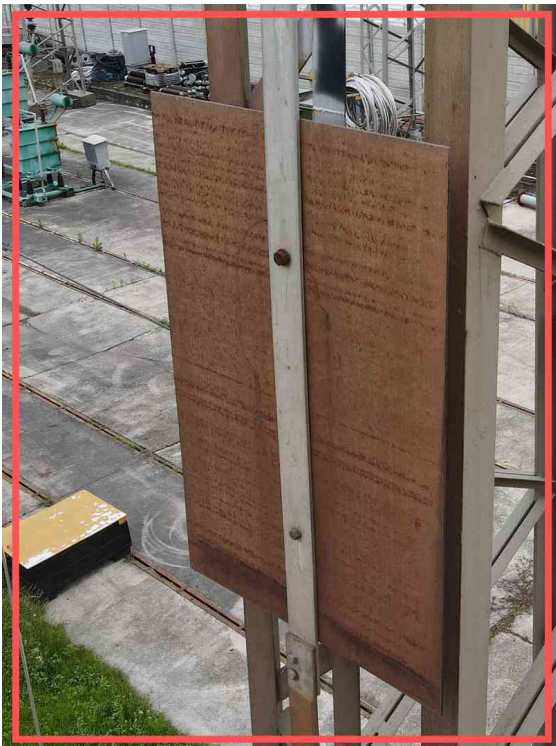
**101\_DJI\_0858.JPG**

**Annotation ID 1299**

**Annotation type:** To be replaced

**Severity level:** 5

**Description:** Rusted insulation sheet.
