Inspection Report

Asset: Lattice Cell Tower. Skyvue Solutions

Lattice Cell Tower. Skyvue Solutions

Type: Cell tower **Position:** 4.02012900, 9.80536800 **Tower height:** 37.75 m **Inspection date:** September 17th, 2020 17:09 CEST

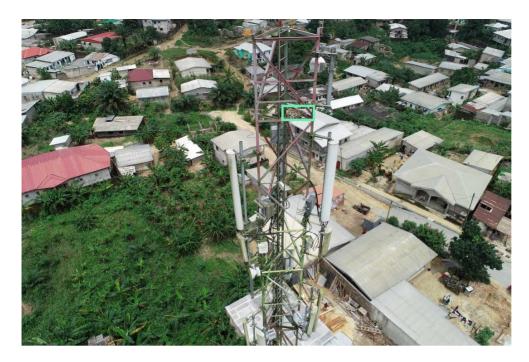
DJI_0389.JPG

Annotation type: Bird nest Severity level: 1 Description: Bird nest to remove

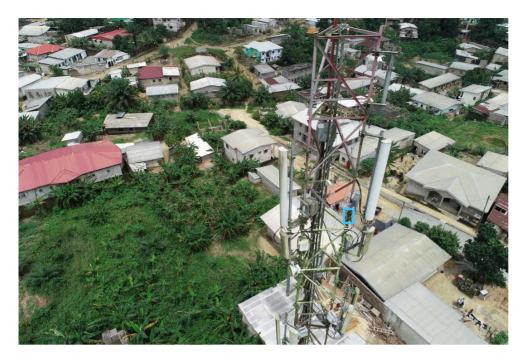
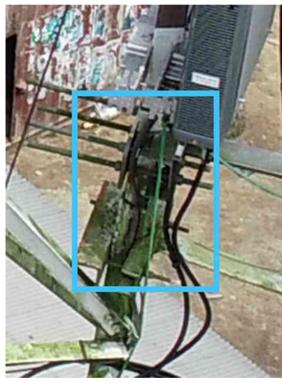
DJI_0391.JPG

Annotation type: Rust Severity level: 2 Description: Rusted supports and screws

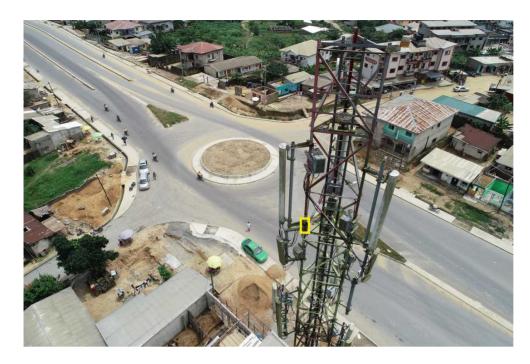
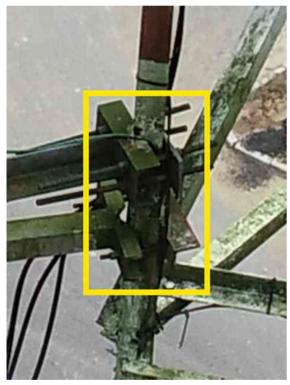
DJI_0417.JPG

Annotation type: Uncategorised Severity level: 3 Description: Rusted supports and screws

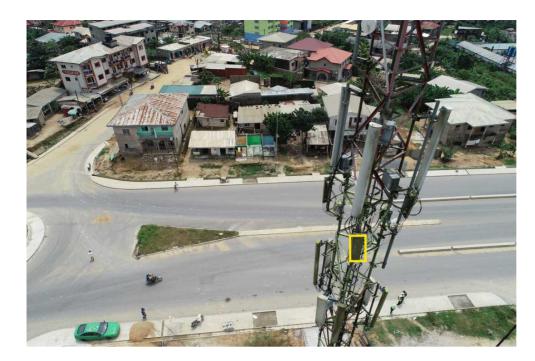
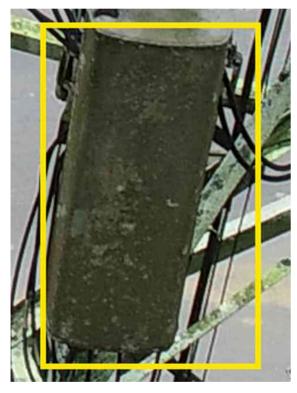
DJI_0431.JPG

Annotation type: Uncategorised Severity level: 3 Description: Antenna to be cleaned

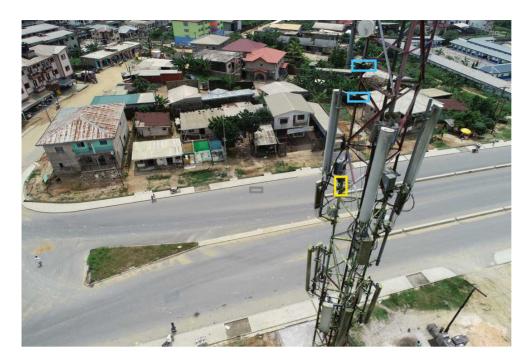
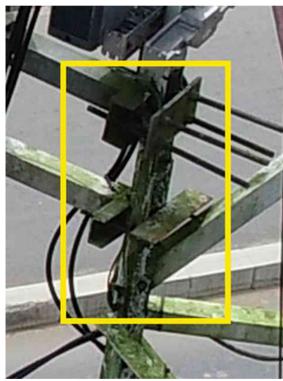
DJI_0434.JPG

Annotation type: Rust Severity level: 3 Description: Rusted support and screws

Annotation type: Uncategorised Severity level: 2 Description: Rusted support and screws

Annotation type: Rust Severity level: 2 Description: Rusted support and screws

Annotation type: Uncategorised Severity level: Unknown Description: Rust

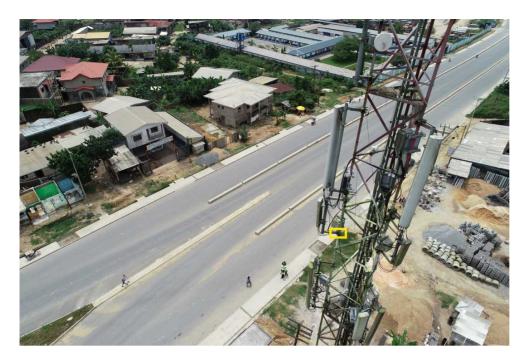
DJI_0442.JPG

Annotation type: Uncategorised Severity level: 3 Description: Rusted support and screws

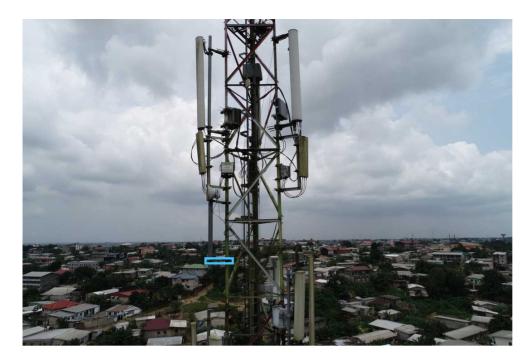
DJI_0499.JPG

Annotation type: Rust Severity level: 2 Description: Rusted support, bar and screws

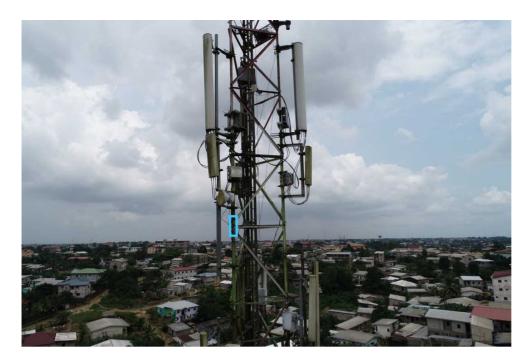
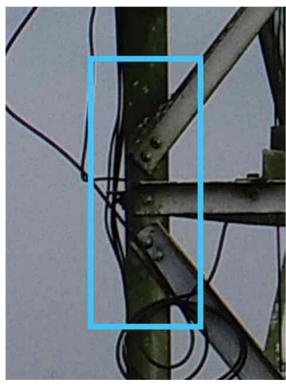
DJI_0500.JPG

Annotation type: Rust Severity level: 2 Description: Rusted bar and screws

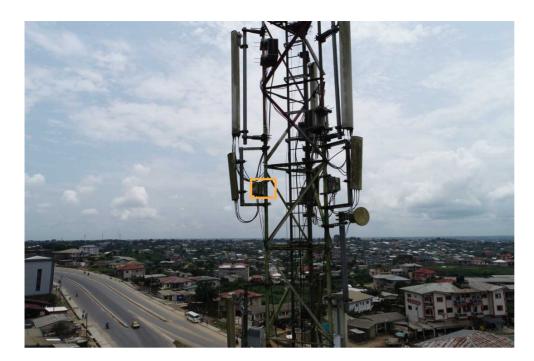
DJI_0505.JPG

Annotation type: Uncategorised Severity level: 4 Description: Equipment to be cleaned

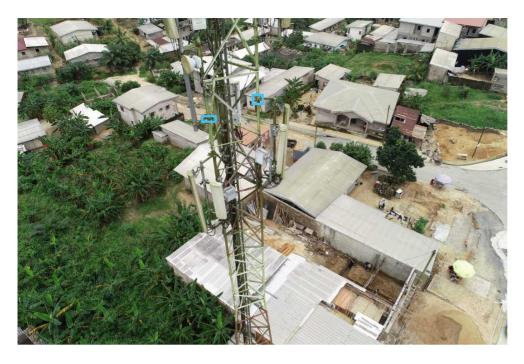
DJI_0519.JPG

Annotation 20 Annotation type: Rust Severity level: 2 Description: Rusted screws

Annotation type: Rust Severity level: 2 Description: Rusted screws

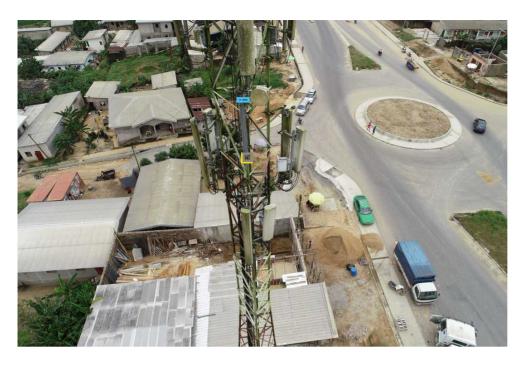
DJI_0531.JPG

Annotation 34 Annotation type: Rust Severity level: 3 Description: Rusted screw

Annotation type: Rust Severity level: 2 Description: Rusted screw

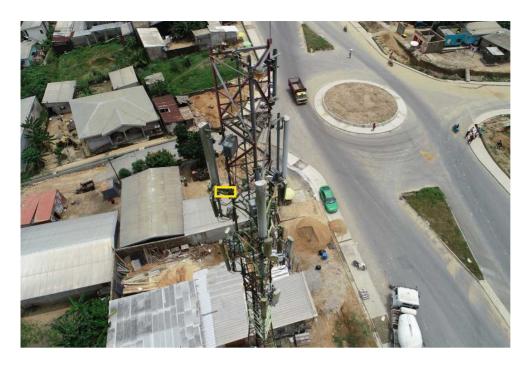
DJI_0662.JPG

Annotation 16 Annotation type: Rust Severity level: 3 Description: Rusted support and screws

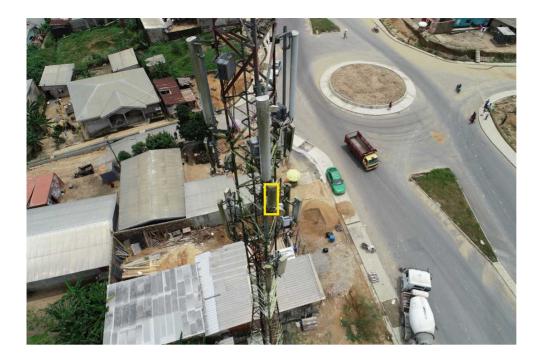
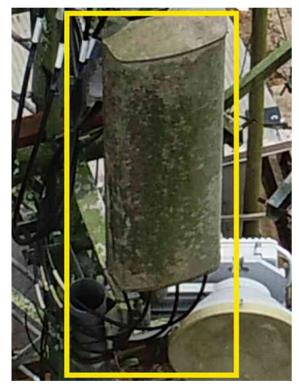
DJI_0663.JPG

Annotation type: Uncategorised Severity level: 3 Description: Rusted antenna

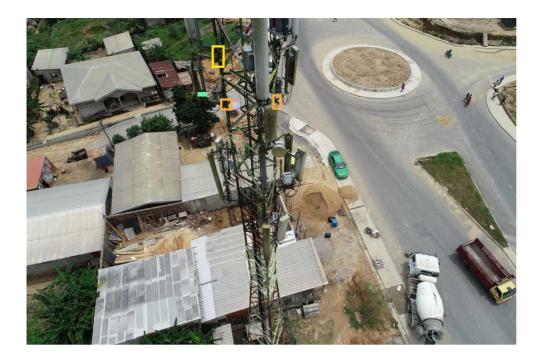
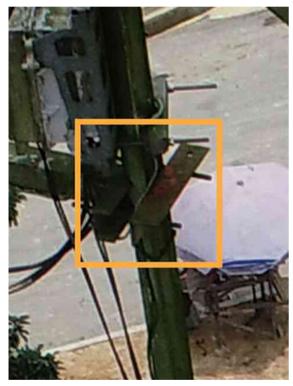
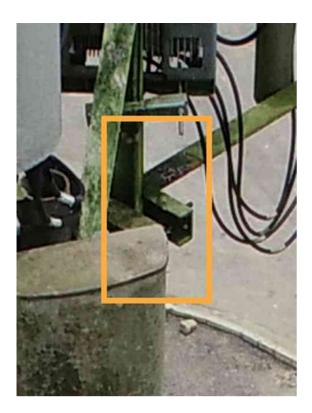
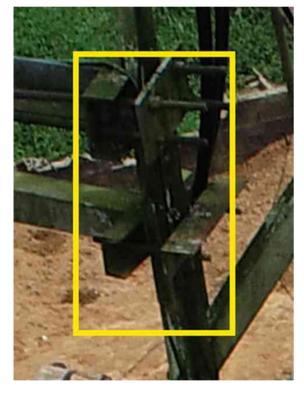
DJI_0664.JPG

Annotation type: Uncategorised Severity level: 4 Description: Rusted supports and screws

Annotation type: Uncategorised Severity level: 4 Description: Rusted antenna support

Annotation type: Rust Severity level: 3 Description: Rusted support and screws

Annotation type: Uncategorised Severity level: 1 Description: Screw to tighten

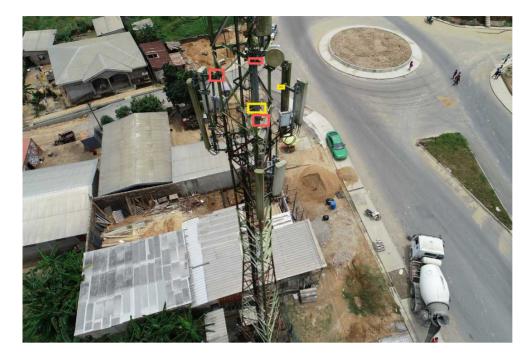
DJI_0665.JPG

Annotation 57 Annotation type: Uncategorised Severity level: 5 Description: Rusted screws and support

Annotation type: Rust Severity level: 5 Description: Rust screw

Annotation type: Uncategorised Severity level: 5 Description: Rusted screw

Annotation type: Rust Severity level: 3 Description: Rusted screws

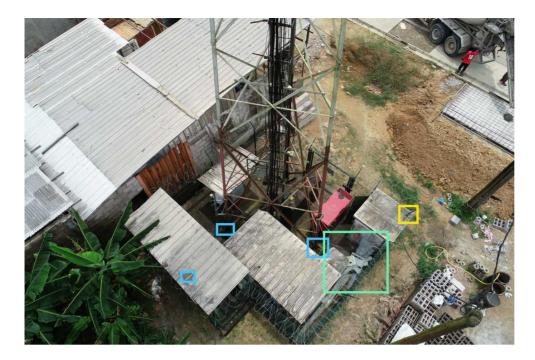
DJI_0674.JPG

Annotation type: Uncategorised Severity level: 3 Description: Rainwater that stagnates and may seep in

Annotation type: Uncategorised Severity level: 2 Description: Deformed roof and stagnant water

Annotation type: Uncategorised Severity level: 2 Description: Moldy and rusted tower base concrete

Annotation type: Rust Severity level: 2 Description: Moldy and rusted base concrete

Annotation type: Uncategorised Severity level: 1 Description: Waste to be removed

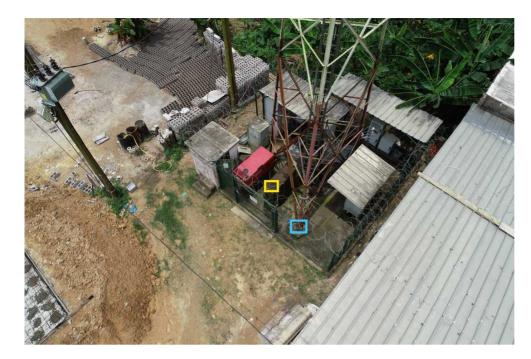
DJI_0763.JPG

Annotation type: Rust Severity level: 3 Description: Rusted equipment with stagnant water on top

Annotation type: Uncategorised Severity level: 2 Description: Molded and rusted tower base concrete

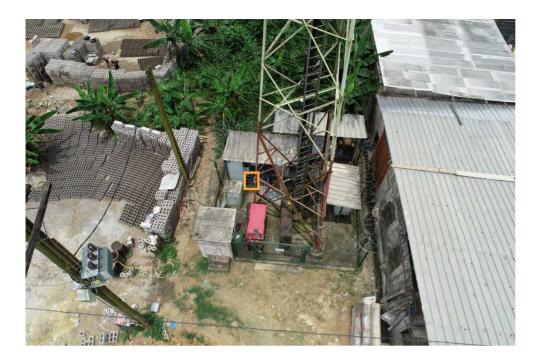
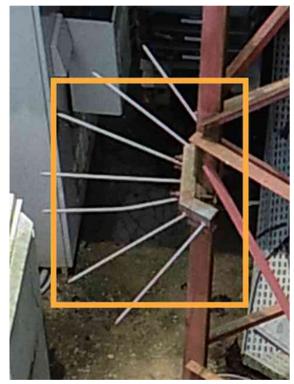
DJI_0765.JPG

Annotation type: Uncategorised Severity level: 4 Description: Stagnant water close to electric cables
