Reference Number	Bulletin 2023 01
Affected Product	Caterpillar 9U-7763 150T Puller Studs with date code 10 20 or 12 20
Risks Identified	Certain 9U-7763 Puller Studs with date codes '10 20' or '12 20' may fail at less than the rated capacity of 150 tons (136 metric tonne). Risk of tooling assembly failing resulting in personal injury
Release Date	30 March 2023

Caterpillar 9U-7763 Puller Studs with date code '10 20' or '12 20' – potential for failure at less than rated capacity.

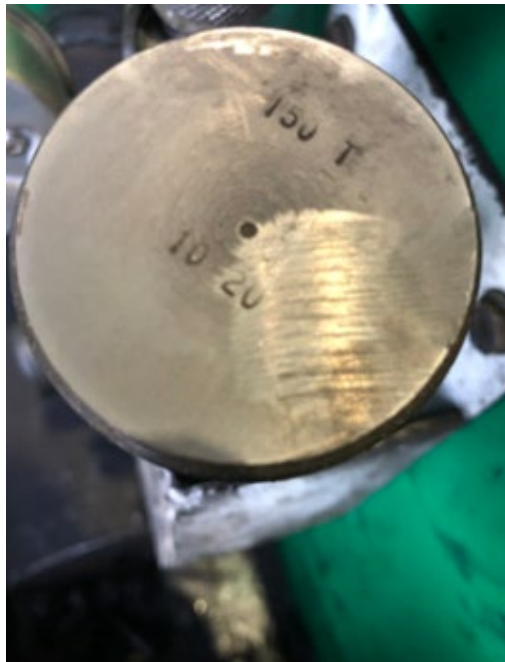
The date code is marked on one end of the stud (refer to Figure 1). The date code is a sequence of two groups of two numbers. A date code that has the sequence '10 20' or '12 20' are the date codes which are relevant to this bulletin.

Figure 1 Date Code '10 20' location on end of stud.

If a 9U-7763 stud with the date code '10 20' or '12 20' is found, immediately withdraw the part from use or storage and hold in a quarantine location so that there is no risk of the puller stud being used or repurposed. Contact a Hastings Deering Mining Support Representative immediately upon identifying affected parts for further advice.
