| <b>Reference Number</b> | Bulletin 01 - 2016 |
| <b>Affected Product</b> | D11T Tractors with AMA / MDG serial number prefix, fitted with the latest version of the optional high pressure hydraulic screen group |

## Chafing and Failure of 421-7245 Hydraulic Hose

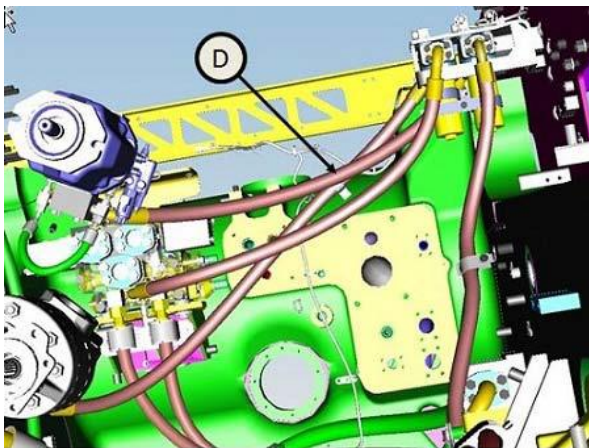
In some cases, the 421-7245 hose assembly may contact the 247-9961 accessory drive shaft guard and lead to early hose failure due to chafing wear. If this hose fails, there is a possibility that hydraulic oil may spray onto hot engine parts, resulting in a fire.

Figure 1. Location of 421-7245 Hose - D (guard not shown).

To eliminate the chafing problem, Caterpillar have recently increased the specified length of the 421-7245 hose by 25.4 mm to 1195 mm overall length. This will assist in ensuring hose does not contact the 247-9961 accessory drive shaft guard.

2. If the existing 421-7245 hose is chafing on the power train pump drive shaft guard, replace the hose with a new dealer fabricated 421-7245 hose, built to the latest Caterpillar specifications, with an overall length of 1195 mm. It is essential to ensure that the existing or newly fabricated hose, does not contact the drive shaft guard, or other components.

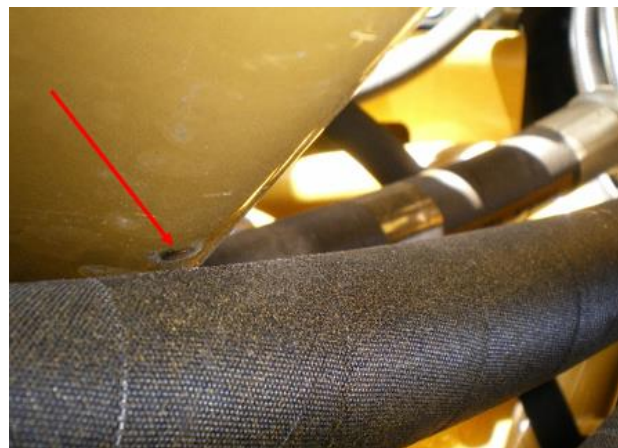
Figure 2. Chafe point on accessory drive shaft guard.

1. On receipt of this bulletin, carry out a visual inspection of the 421-7245 hose on affected D11T product to establish whether the hose has been contacting the 247-9961 accessory drive shaft guard.

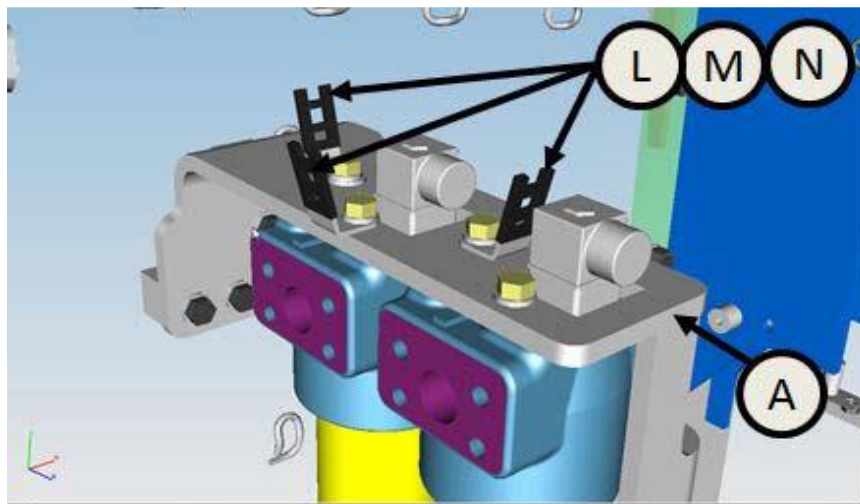
There have been known cases where the six bolts that attach the two hydraulic screens to their mounting bracket have been found to be loose, missing, or the threads stripped. This has resulted in the subject hose having additional unintended movement.

Figure 3. Hydraulic screen mounting bolt locations. NB: ladder clips (locations L, M, N) require longer 4L6454 bolts.

3. Inspect the security of the hydraulic screens to the 421-7250 mounting bracket. There should be six bolts securing the two screens to the mounting bracket. Three mounting bolt locations have a ladder clip and require a 4L-6454 bolt [3/8" x 1" long], and the other three locations require a 5S-7379 bolt [3/8" x 7/8" long] – refer to Special instruction REHS8552-02 for details. If a shorter bolt has been incorrectly fitted where a longer bolt is required, the thread in the screen may be damaged. Inspect each bolt for correct length, and correct any defects, and torque the six bolts to 47 Nm [35 ft lb].
