Reference Number	Bulletin 02 – 2018
Affected Product	All Terex/Unit Rig MT3700 & MT4400 trucks with 1"-14TPI front wheel studs
Risks Identified	Potential separation of front tyre and rim from wheel hub, or rim rotation on hub.
Release Date	November 20 2018

MT3700 & MT4400 front wheel fasteners: potential for insufficient rim clamping

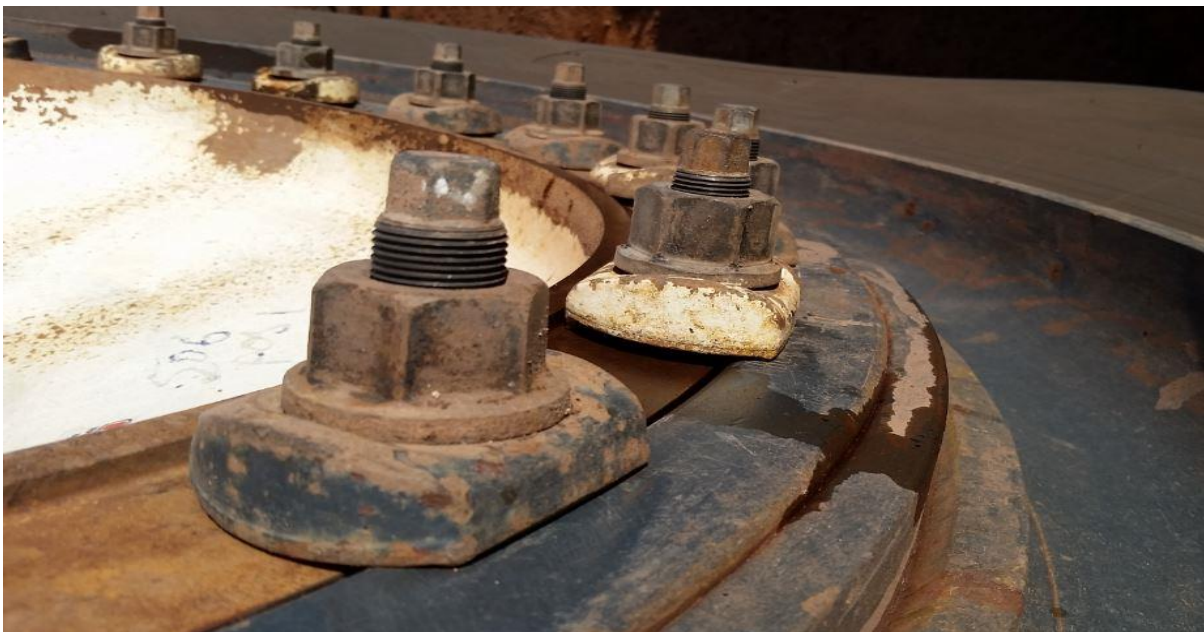
Figure 1 - Note the thread projection on wheel stud closest to camera is greater than the adjacent stud. The nut seating surface of the clamp appears flattened. The wheel nut in this position may be binding on the unthreaded stud shank, reducing the clamp force imparted to the wheel.

As a guide, if there is 10mm or more of stud thread projection above the nut, the clamp and the stud should be inspected to ensure the nut can NOT bottom-out at the end of the threaded section of the stud before the clamp can be effective.

If the nut can bottom-out, the defective stud, nut or clamp must be replaced. It is good practice to replace all components at an individual wheel position with new components as a set.

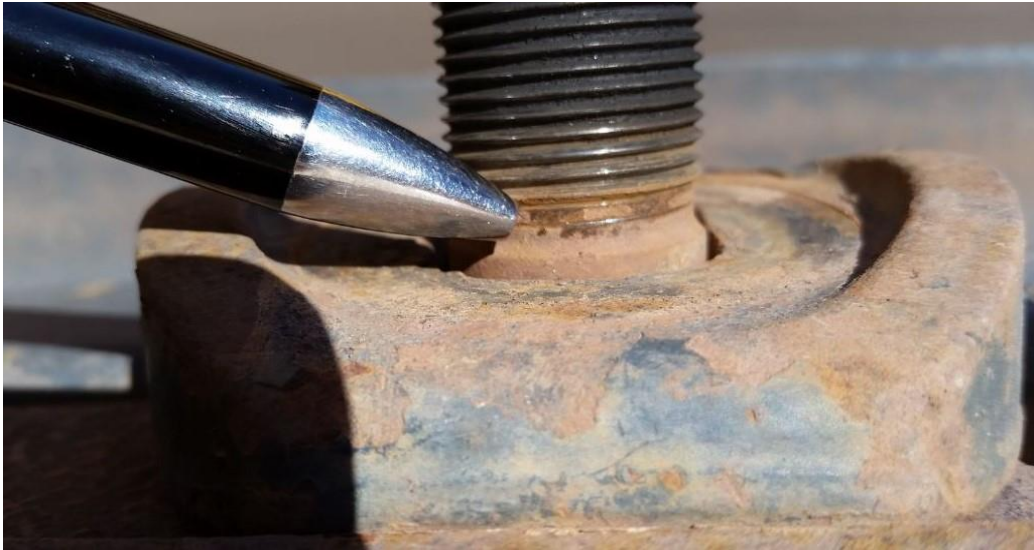
Figure 2 - UNACCEPTABLE stud and clamp combination, the stud thread ends above the nut seating surface of the clamp.

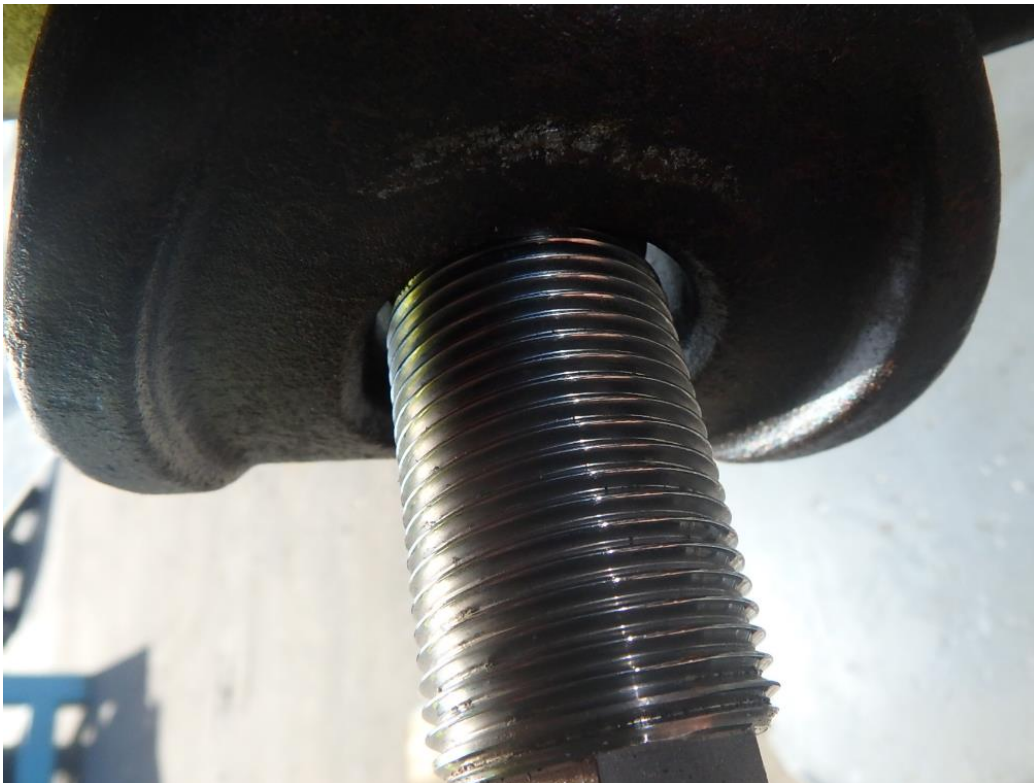
Figure 3 - ACCEPTABLE stud and clamp combination, the stud threads extend below the nut seating surface of the clamp.
