Bulletin 02/2015

Subject: C27 Engine fuel hoses & clamps - AD55B/AD60 machines

Affected Product: Current field population of AD55B¹ and AD60¹ Machines

Identified Risks: Fuel leakage and potential fire hazard from chafed flexible hoses.

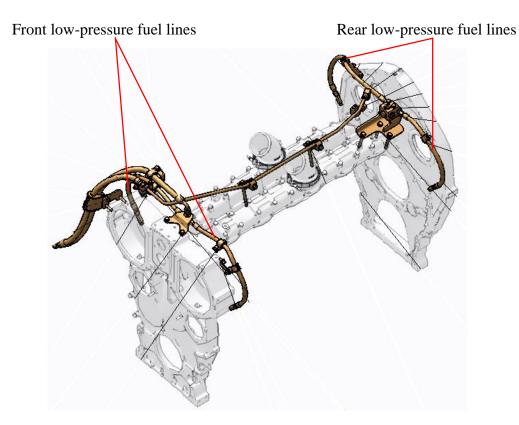
Figure 1. Fuel Line Identification

The flexible fuel lines installed in the engine compartment of the affected products listed above are subject to movement and abrasive wear before full engine life is achieved. If the flexible fuel lines contact anything other than the standard fitment Caterpillar rubber grommets, fuel leakage and fire hazards may occur due to abrasive wear. Wear, and subsequent movement between the contact surfaces of the rubber grommets and the flexible lines, can also lead to excess movement and abrasive wear of the flexible fuel lines. Figure 1 shows the location of the affected lines.

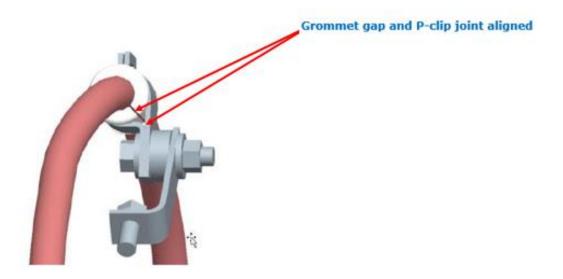
Figure 2. Ensure correct alignment between grommet opening and P-clip joint

- Look for signs of fluid leaks, hose chafing, contact marks, and rubbing that may indicate excessive hose movement or poor installation.
- All P-clips must have the rubber grommets fitted with the opening in each grommet aligned with the joint in the P-clip. Refer figure 2.
- The hose should not have clearance in the grommet move the hose to check for clearance. Movement is usually the result of wear on the internal diameter of grommet and external surface of the hose. Refer figure 3. Replace worn, hardened or damaged hoses and grommets. NB Dirt and other contaminants can accelerate the wear process, and cause corrosion of fittings.
- Ensure the hoses do not contact anything other than the rubber grommet in the P-clips.
