General Equipment Safety Bulletin

Bulletin 012/2013

Subject:	Caterpillar 797F Off Highway Truck (OHT) Engine Pre lubrication (Prelube) motor electrical circuit may experience overloads
Affected Product:	797F Off Highway Trucks serial prefix LAJ1 - up
Risks Identified:	Electrical fires or thermal events Personal injury Property damage

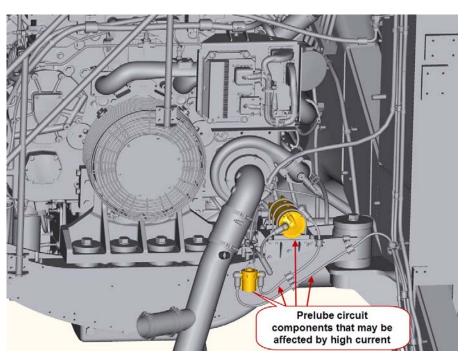
Electrical overloads can occur in the main electrical cables supplying current to the engine prelube pump motor on 797F off highway trucks. The wiring, or wiring insulation, can be damaged by excessive current flow. In two instances known to Hastings Deering, a fire has occurred. In some cases of faulty operation, the prelube pump may continue to run after the pre-lubrication cycle is completed.

A circuit protection arrangement has been designed and tested by Hastings Deering. This arrangement includes a 300 amp fuse, arc suppressor, cable, harness, mounting bracket, and all necessary mounting hardware. After the system is fitted, an electrical overload will cause the fuse to blow [create an open circuit] and prevent further current flow.

Install the circuit protection kit available from Hastings Deering.
