| Reference Number | Bulletin 01 – 2026 |
| Affected Product | 9U-6698 Puller Stud |

## 9U-6698 Puller Studs Could Have a Reduced Capacity

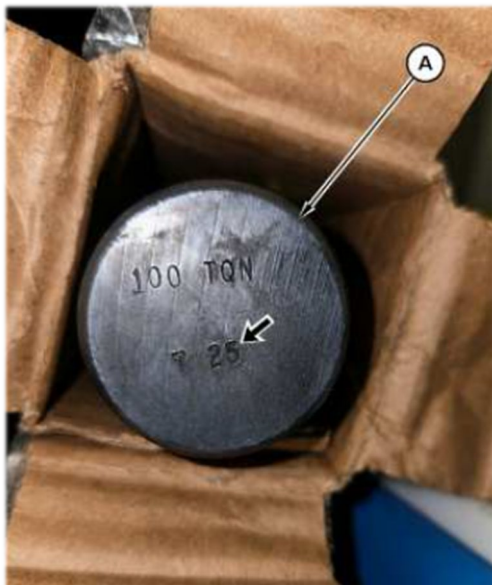
(A) - a 9U-6698 Puller Stud.

Arrow indicates the date code

Some **9U-6698** Puller Studs could have a reduced capacity

Please inspect all inventory of **9U-6698** Puller Studs.

All **9U-6698** Puller Studs with the date code of **7-25** and **5-26** should be taken out of service and labelled as "do not use/defective". Parts should be retained until further instructions are received from the Original Equipment Manufacturer.
