Bulletin 005/2013

Subject: Incorrectly Manufactured Hydraulic Hoses (80bar)
Affected Product: Cat6060/6060FS (RH340, RH340B)
Serial numbers: 340094 to 340125
Risks Identified: Defective hoses may result in serious injury or death.

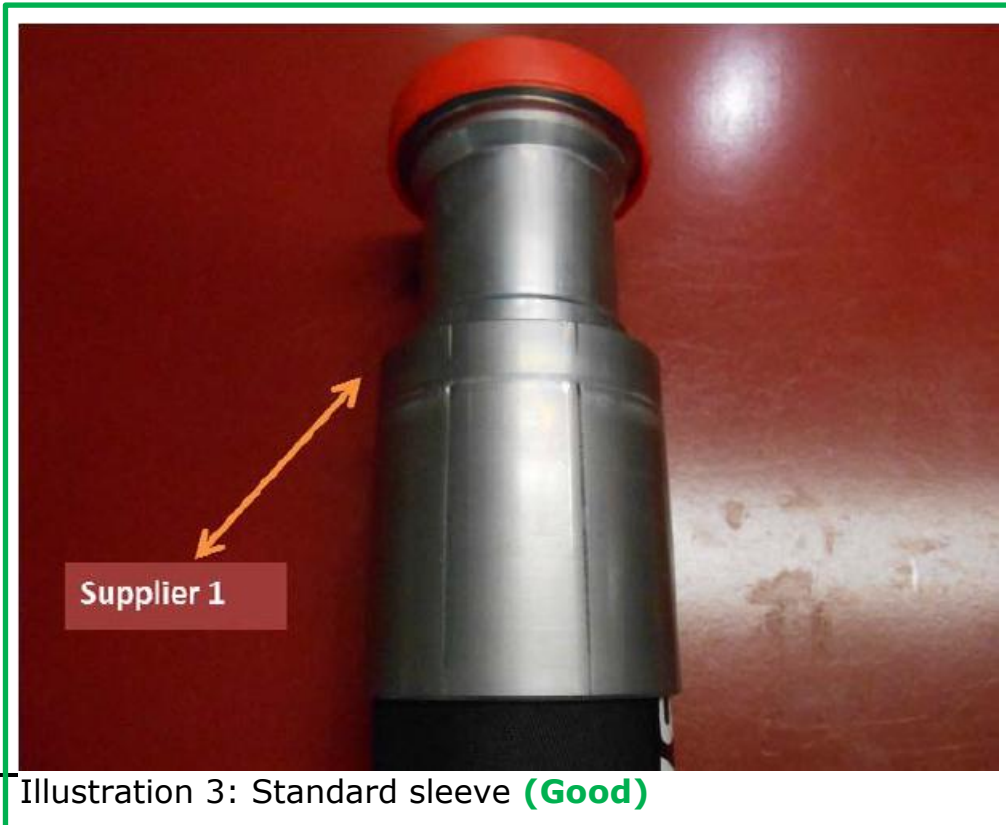
Illustration 3: Standard sleeve (**Good**)

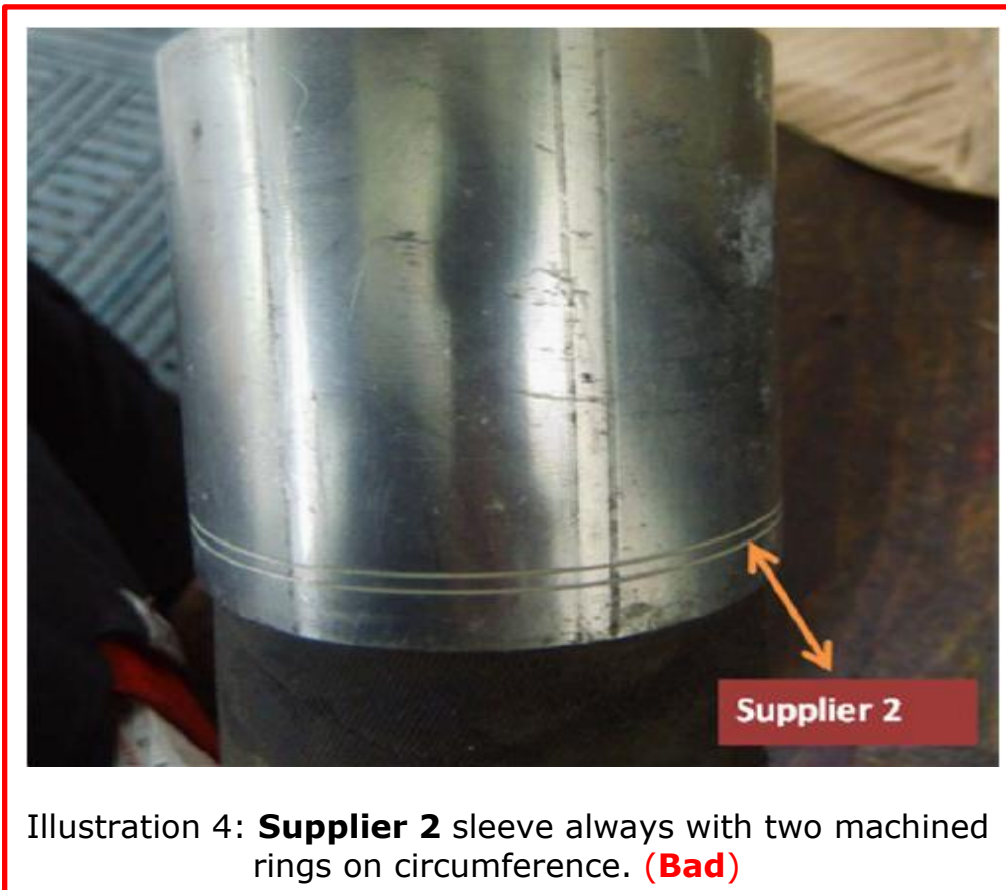
1. The part number and manufacturing date of the hose are stamped on the crimped sleeve - refer illustrations 1 & 2. The date stamped on the sleeve must fall in the range October 1 2010 to October 31 2011.
2. Affected hoses contain either a sleeve or nipple from supplier 2. Supplier 2 fittings can be identified by two rings on the sleeve circumference, as shown in illustrations 4 and 7 of this bulletin.

Illustration 4: **Supplier 2** sleeve always with two machined rings on circumference. (**Bad**)

1. Inspect machines in the affected serial number range. If the inspection shows defective hoses are fitted, replacement hoses must be ordered and fitted immediately.
2. Inspect parts stock holdings of affected part numbers shown in this bulletin. Defective hoses identified in this inspection must be replaced.
3. Destroy defective hoses by cutting the hose at the crimped fittings at each end to render the hose unusable and attach a picture of destroyed hose to the warranty claim.
