Reference Number	Bulletin 02 - 2016
Affected Product	177-7860 Hose assembly
Risks Identified	Potential risk of injury and/or property damage due to failure of defective 177-7860 hose assembly
Release Date	August 4 2016

Potential Failure of 177-7860 Hose Assembly

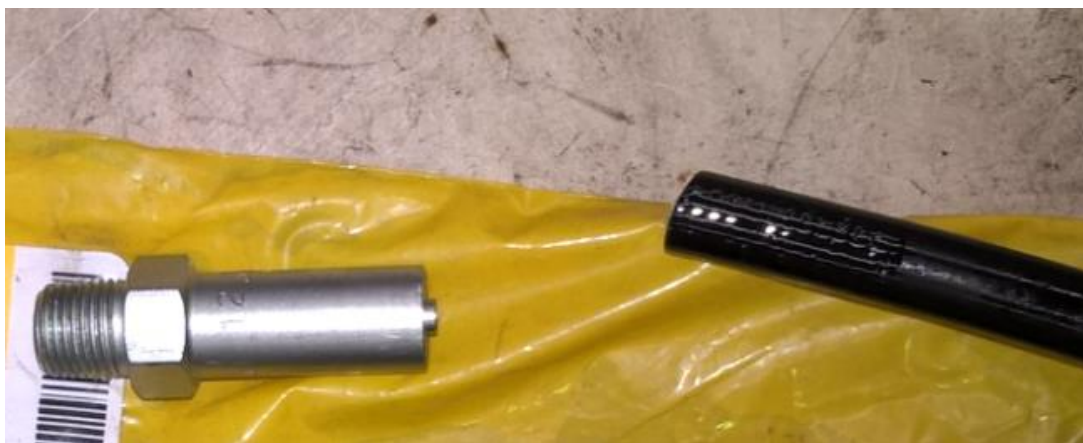
The 177-7860 hose assembly is a Caterpillar 'dealer tool' and is specified for use in a large number Caterpillar service procedures. A report has been received that a hose purchased by a customer failed when oil pressure was applied to hose. Examination showed that one end fitting had not been crimped during the manufacturing process, allowing hose to separate from fitting - refer Illustration 1.

Illustration 1. Hose separated from fitting due to missed crimping process during manufacture.

1. On receipt of this bulletin, identify any 177-7860 hose assemblies that may be in parts and tool stores, personal tool kits, and service vehicles. When located, carry out a visual inspection of the hose assembly to establish whether both end fittings have been crimped as shown in Illustration 2.
2. If a fitting has not been crimped – refer Illustrations 1 & 3 for examples, **do not use** the 177-7860 hose assembly. Return the hose assembly to a Hastings Deering parts department, and make a reference to this bulletin.

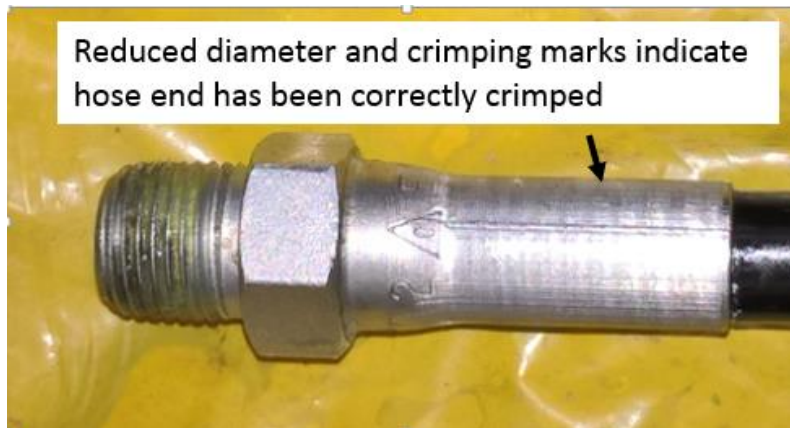
Illustration 2. Correctly crimped fitting – no action required.

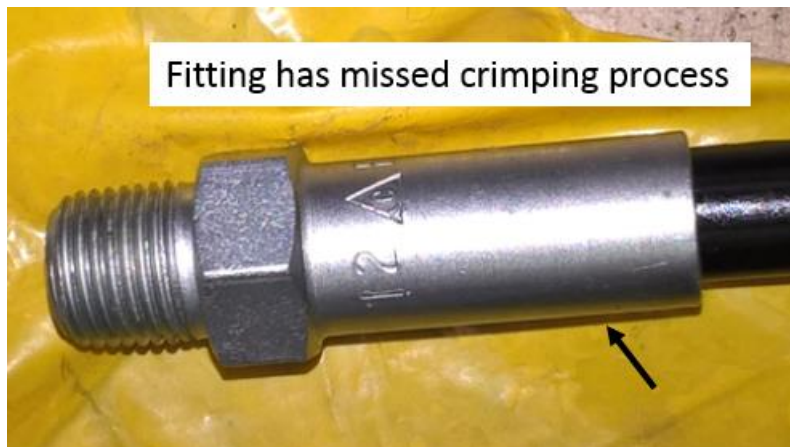
Illustration 3. Fitting has not been crimped – **Do not use.**
