Reference Number	Bulletin 01 2021
Affected Product	375-9988 Hydraulic Hose Assembly in 16M3/16/18M3 and 18 Series Motor Graders
Risks Identified	Potential risk of personal injury and/or property damage due to a rubbing induced wear failure of the hose.
Release Date	March 5, 2021

Problem Overview

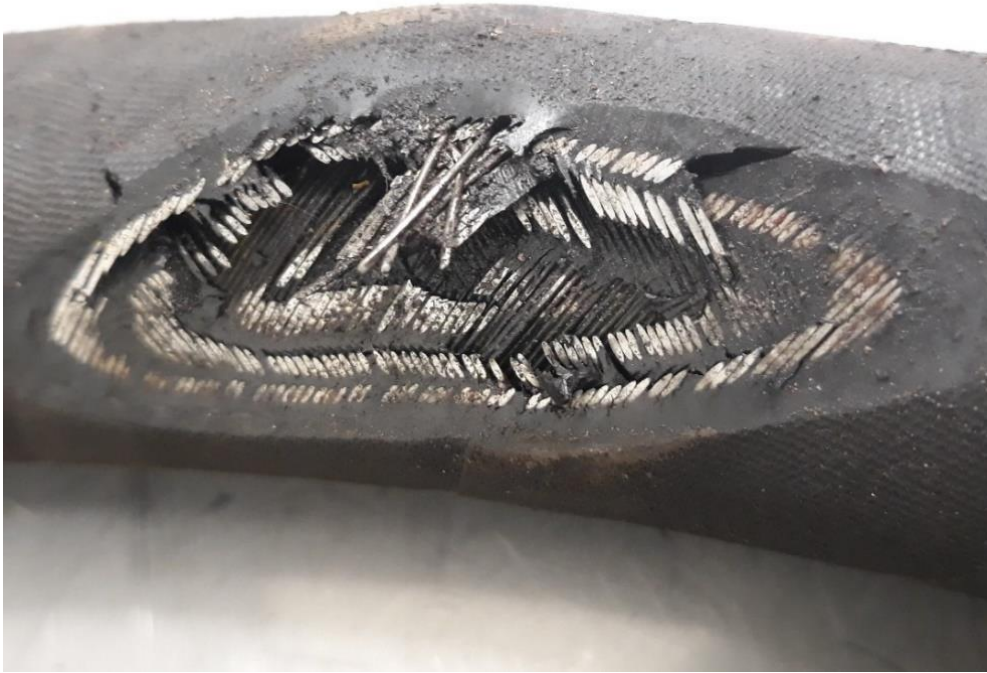
The 375-9988 Hydraulic Hose has been found to be making contact with other machine parts/hoses at different positions along the length of the hose resulting in the potential for rubbing induced wear failure. This is occurring with Factory installed hoses as well as Dealer/Customer installed hoses.

Operation of a machine with an excessively worn hose can lead to hose failure and result in personal injury and/or property damage.

Illustration 1. Hose has worn to the point of failure.

2. If the 375-9988 Hydraulic Hose has been contacting other components or hoses, inspect closely for chafing and damage to the 375-9988 Hydraulic Hose, and any other hoses in contact. If hose reinforcing wires are exposed, the hose cover is cracked, or a fluid weep is evident, the affected hose(s) must be replaced.

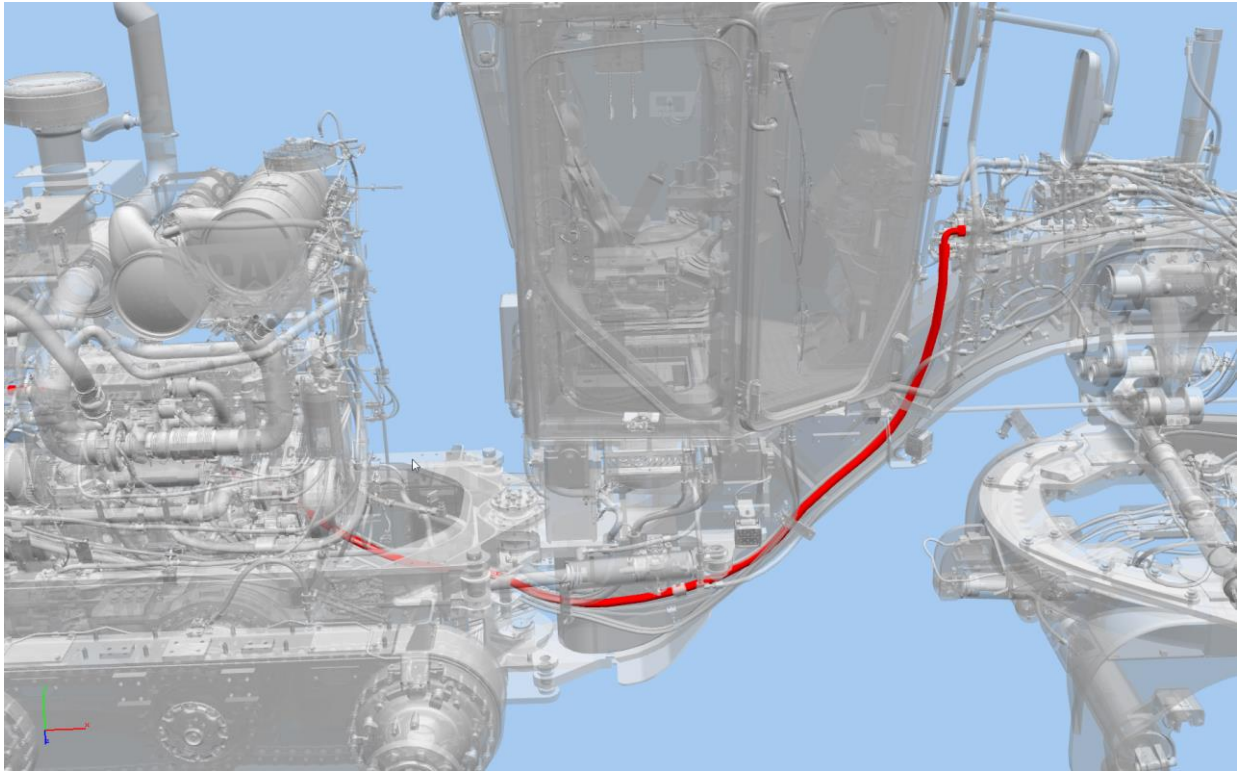
Illustration 2. Hose routing through the front frame of the machine.

1. Either before or at the next scheduled service, perform a visual inspection of the 375-9988 Hydraulic Hose. As this hose is routed through confined regions of the machine, use the attached 3D views to aid identification of the 375-9988 Hydraulic Hose route.

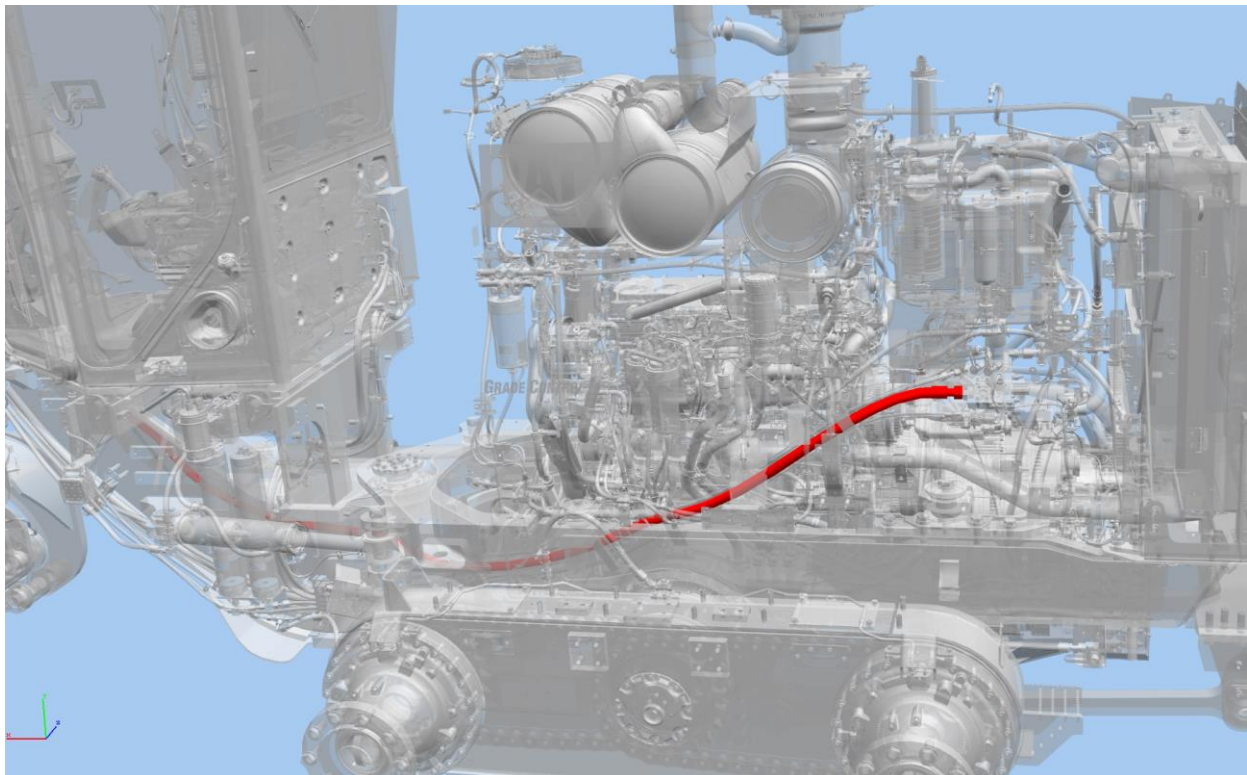
Illustration 3. Hose routing through the rear frame of the machine.

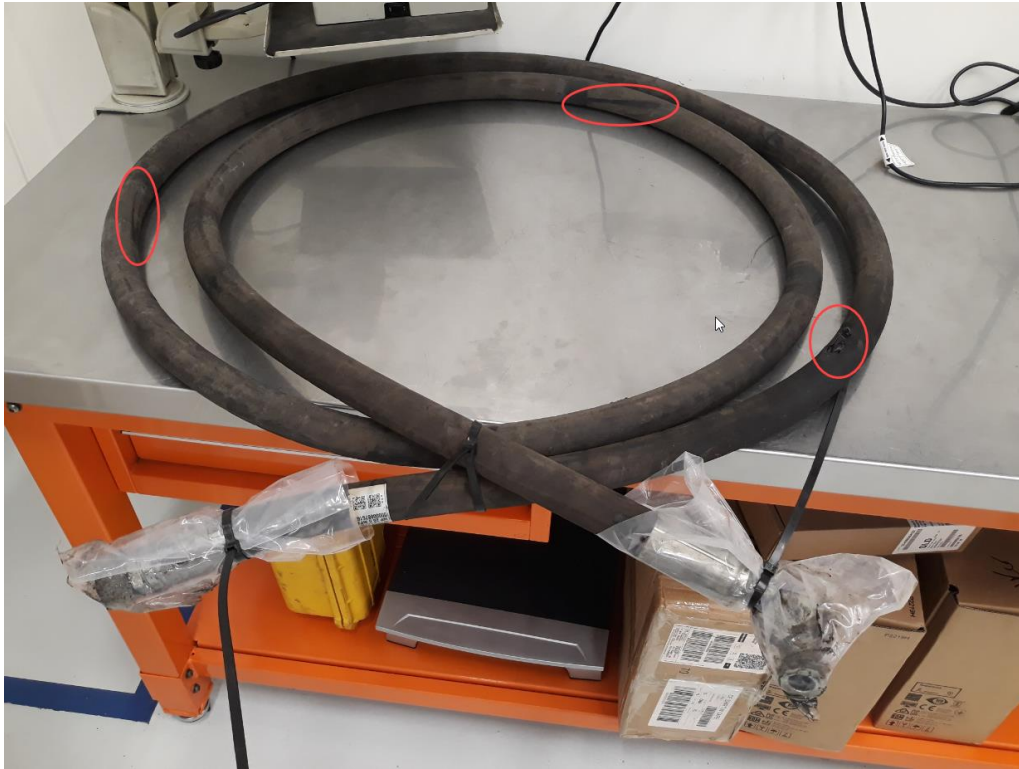
Hose wear that has resulted from rubbing contact can occur anywhere along the length of the hose depending on how that hose interacts with other parts/hoses on the machine.

Illustration 4 is an example of the possible wear locations/chafe points that can be evident on the 375-9988 Hose.

4. The Hydraulic Hose route between adjacent clamping points should prevent contact with any other part. If hose rub points cannot be corrected by adjusting the position of clamps or end fittings, contact your Cat dealer representative for advice.
