ErSed Reference: 21003-ERQR-03-240507

Re: SSD 9138102 - Westlink

Environmental Representative: Quarterly Report (ERQR #3)

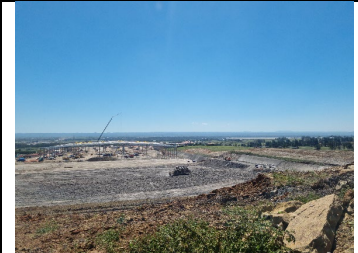
<p>2 FEB 24 Lot 1 – RCC Toll</p> <p>Works to extend the formation for lot 1 are progressing.</p> <p>Interface with the building works were discussed. It was indicated that there have been no further issues of water passing from the upper formation into the ongoing works or access areas.</p>	<p>NA</p>

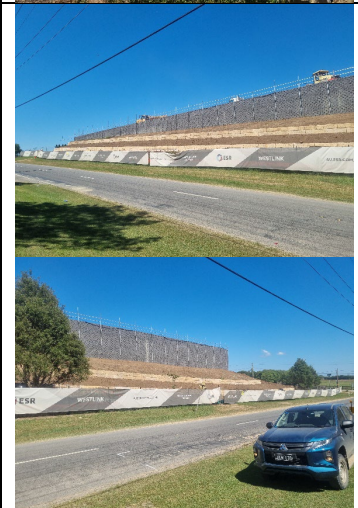
<p>2 FEB 24 - Road frontage to Aldington</p> <p>Work to construct the benched retaining wall around the western and southern boundary has been completed.</p> <p>The surface is to be left bare pending landscaping works.</p> <p>Sediment fence is in place at the boundary fence.</p> <p>It is a requirement of the DCP and referenced ESC guidance that all unstable areas in excess of 2500m² be made to report to a type A or B sediment control.</p> <p>This requirement forms part of condition B21</p> <p>Alternatively, the surface may be stabilised with application of a suitable polymer pending completion of landscape works.</p>	<p>JKW to confirm when site has been Polymered (confirmed as treated 20th FEB 24)</p>

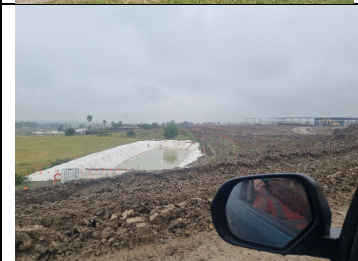
<p><u>15 FEB 24 – SE Boundary</u></p> <p>The location of the break /corner in the SE boundary of the site was discussed.</p> <p>It was indicated that this approximates the corner of the fence line and not the alignment of the sediment fence.</p> <p>This is need to be clarified with during the meeting with the DPE.</p>	<p>NA</p>

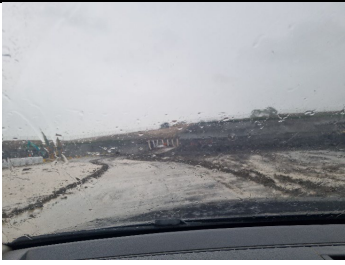
<p><u>20 FEB 24 - STAGE 1 – Catchments leading to access road / exit to Abbots</u></p> <p>Surface water from the upper catchments are generally managed to the main HES-A control.</p> <p>A portion of the access road drains on the northern side of the main access – and then passes towards the entrance and bypasses the main HES-A control.</p> <p>Works should be undertaken to maximise the flows to the HES-A.</p>	<p>JW confirm that bags are made available during rain shut down to direct catchments across access ways</p>

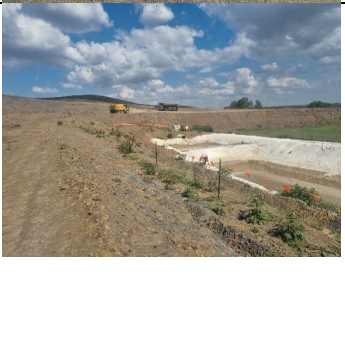
<p><u>08 MAR 24 HES Basin B</u></p> <p>Issues associated with interaction at boundary.</p> <p>It was confirmed that water flowing from catchments within the SSD must be managed by controls approved within the SSD.</p> <p>As such catchments to the south east corner must be managed to the high efficiency Basin and not allowed to pass to the southern boundary.</p> <p>Additional controls will be required to accommodate these catchments or otherwise a culvert provided to engage the high-efficiency Basin.</p> <p>This issue should be discussed with the CPESC and the erosion and sediment control plan updated</p>	<p>Updated ESCP pending</p>

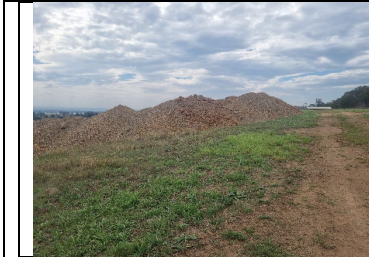
14 MAR 24 Stockpiling – eastern extent
 Excess material has been stockpiled at the top the lot 1 cut. It was questioned if this material is within the approved earthworks footprint for the development.

This could not be confirmed. It is requested that the location of this pile be confirmed with the surveyed limit of the approved works.

JKW confirm with arial image overlaid with site boundaries that stockpiles are in reserved land.

ESR requested to confirm if a noncompliance should be reported in respect to condition B27 and B25(h).

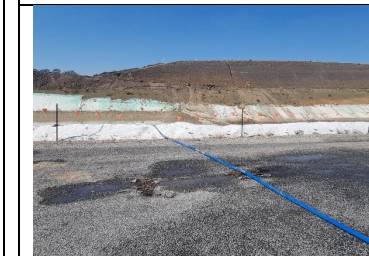
26 MAR 24 – HES A

The forebay of the high efficiency basin is being de-watered in preparation for clearing of sediment prior to the planned shutdown of the works.

The forebay is being a pumped across to the main bay -adjacent to the decant units. This pumping should be moved to immediately adjacent to the central to maximize the time for this water to settle prior to passing out through the decant outlet.

Pumped moved during inspection

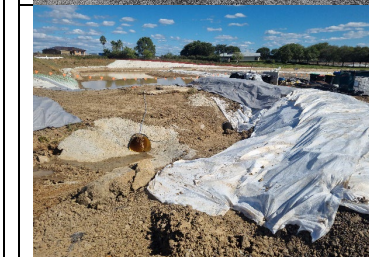
11 APRIL 24 – HES A

The recent heavy rain has caused the inlet area to the control to be overwhelmed. The diversion on the western side to be surpassed and had failed. Water from the side flowed partially to the HES Basin dosing but also through the site to the west and underneath the site compound area.

A full inspection and report from the project CPESC is requested detailing performance and areas of failure within the erosion and settlement controls.

April CPESC report expected to be discussed in June ERM
