Project 92352.03
29 January 2025
R.024.Rev1
RCB

Report on Groundwater Review

Westlink Industrial Estate – Stage 2

Abbotts Road, Kemps Creek

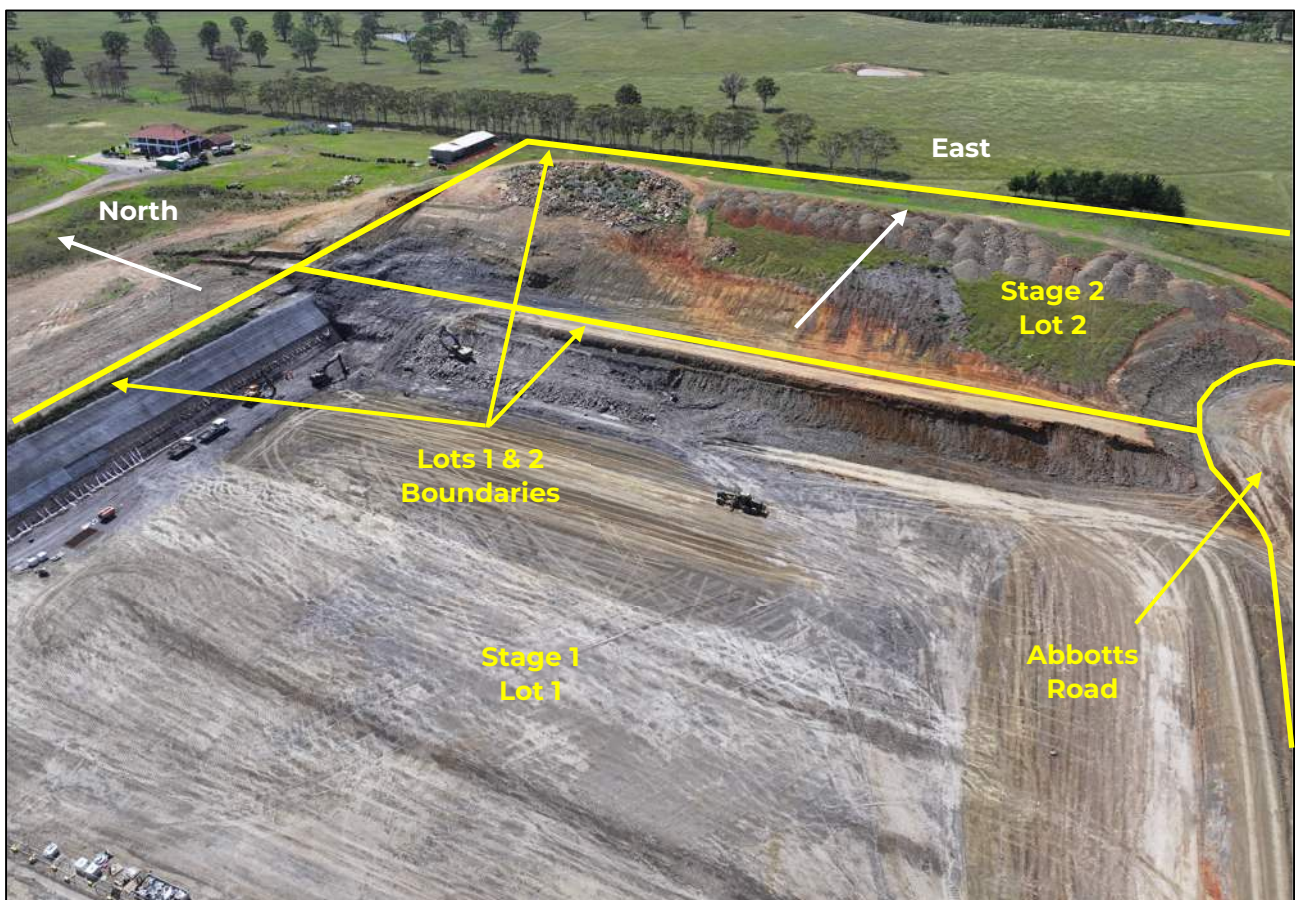
Figure 2: View of Deep Excavation Faces in Stage 1

In addition to the results of the geotechnical investigations, excavation of deep cuts within Stage 1 along the northern and eastern sides of Lot 1 has not encountered any significant groundwater during construction. Excavations were formed to 20+ m depth around Lot 1 and have since been supported by anchored and shotcreted retaining walls. DP personnel has been present on the site during construction of the retaining walls and Figure 2 shows a typical appearance of the excavation conditions encountered.

From Figure 2, it can be seen that the deep cut faces created in Stage 1, Lot 1 are dry and did not intersect any significant groundwater bearing or seepage zones. Excavation depths in Figure 1 are up to 20+ m deep. It is also evident from the figure that there is no significant up-gradient catchment from which groundwater can be derived. Accordingly, the groundwater conditions experienced within Stage 1 can be considered equivalent to those likely to be encountered during Stage 2 works.
