TECHNICAL REPORT

Edison amplifier horn restoration
John Bump

Introduction

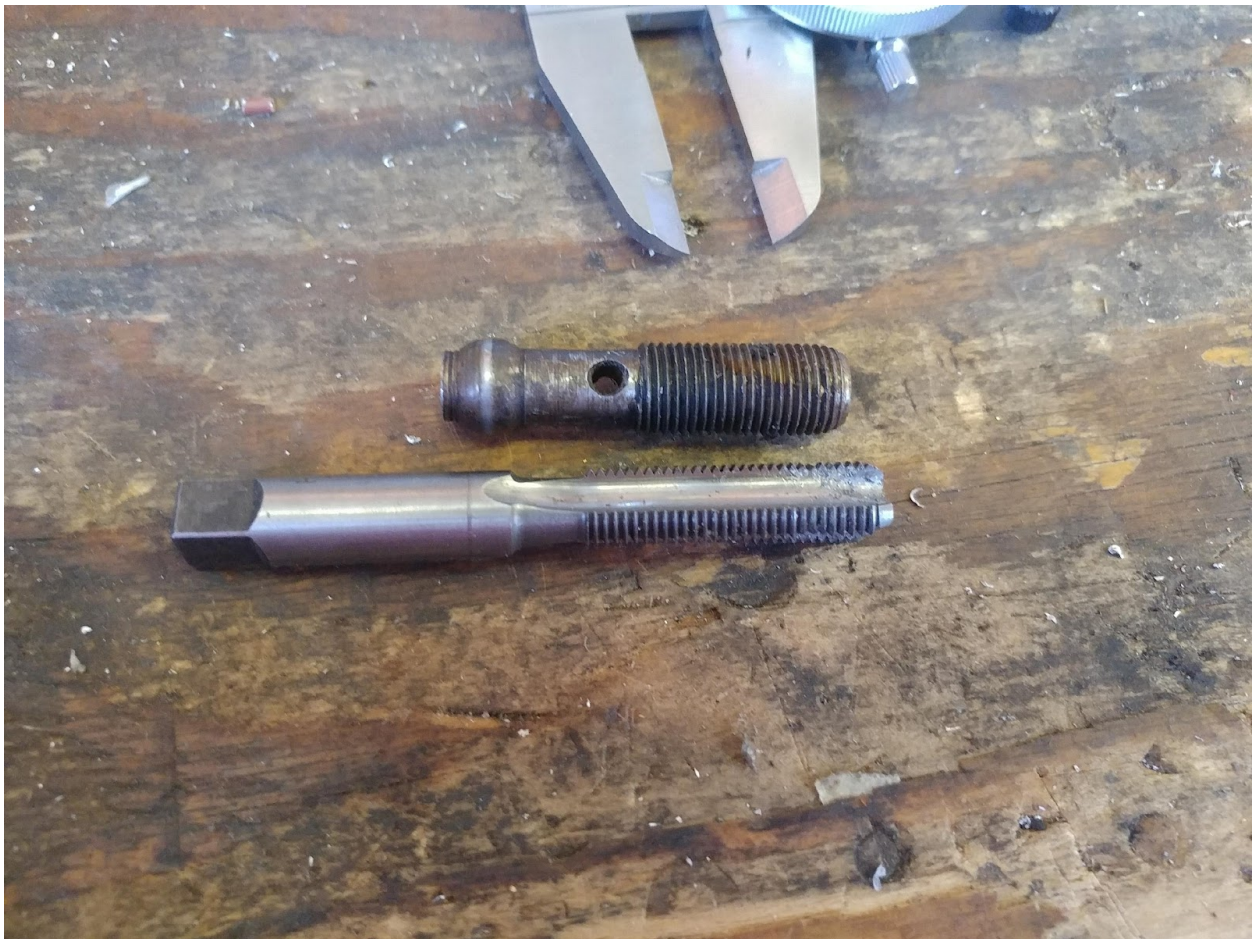
Fig. 1: well now what.

On the bottom, a 3/8-24 tap, which is an SAE UNF

standard. On the top, the Edison lower pivot. So what is it.

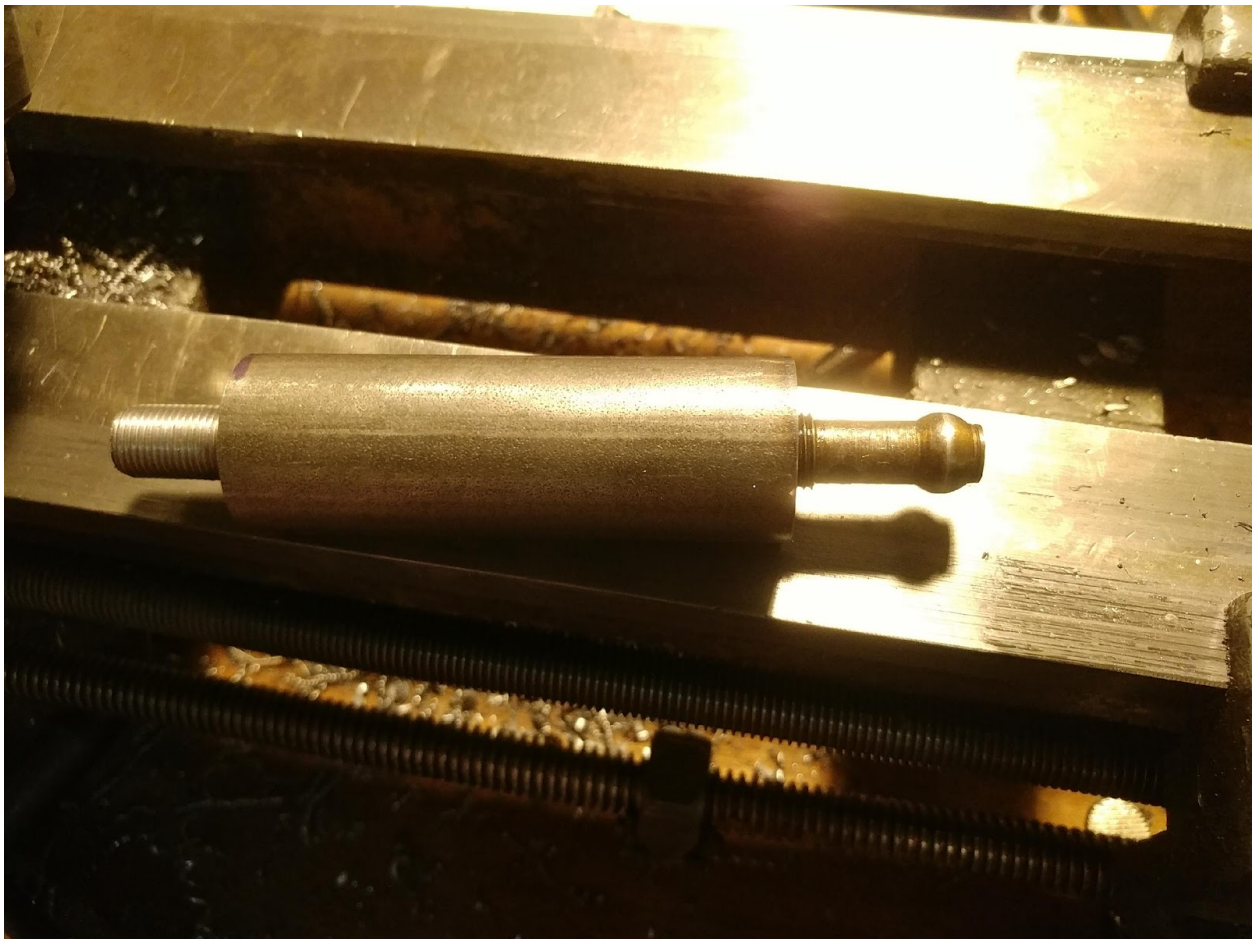
Fig. 3: extension with new threaded stub on one end, and original pivot on other, glamour sepia color.

This threads into the original lower bracket. The 10cm pivot extension is drilled through and internally threaded the same way. That way it can thread onto the stub, the original brass end pivot can thread into it, and it behaves like a single unit.

The threaded section has some loctite on it so it'll stay in place in the extension. The extension was drilled and tapped with a 10-24 thread, and two brass thumbscrews were fabricated, one for the extension and one for the original bracket. These thread in and bear perpendicular against the steel threads (upper) and brass threads (lower, original pivot) to prevent them moving and unscrewing as the arm pivots back and forth during use.

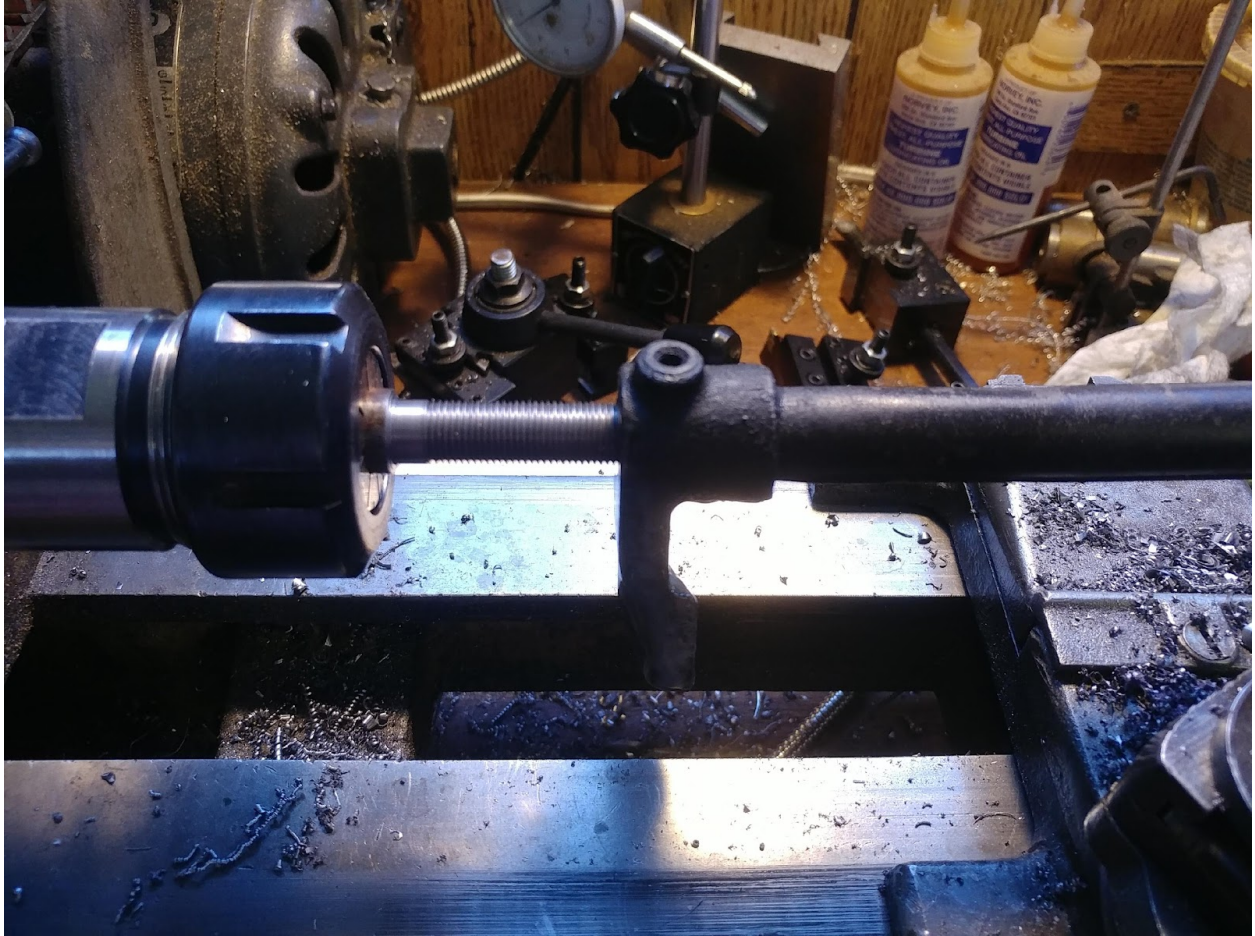
Fig. 6: lower bracket test fit.

In fig. 6 the original (missing) thumbscrew location is visible. This prevents the adjustment screw from shifting during use, so this is where the other thumbscrew is fitted.

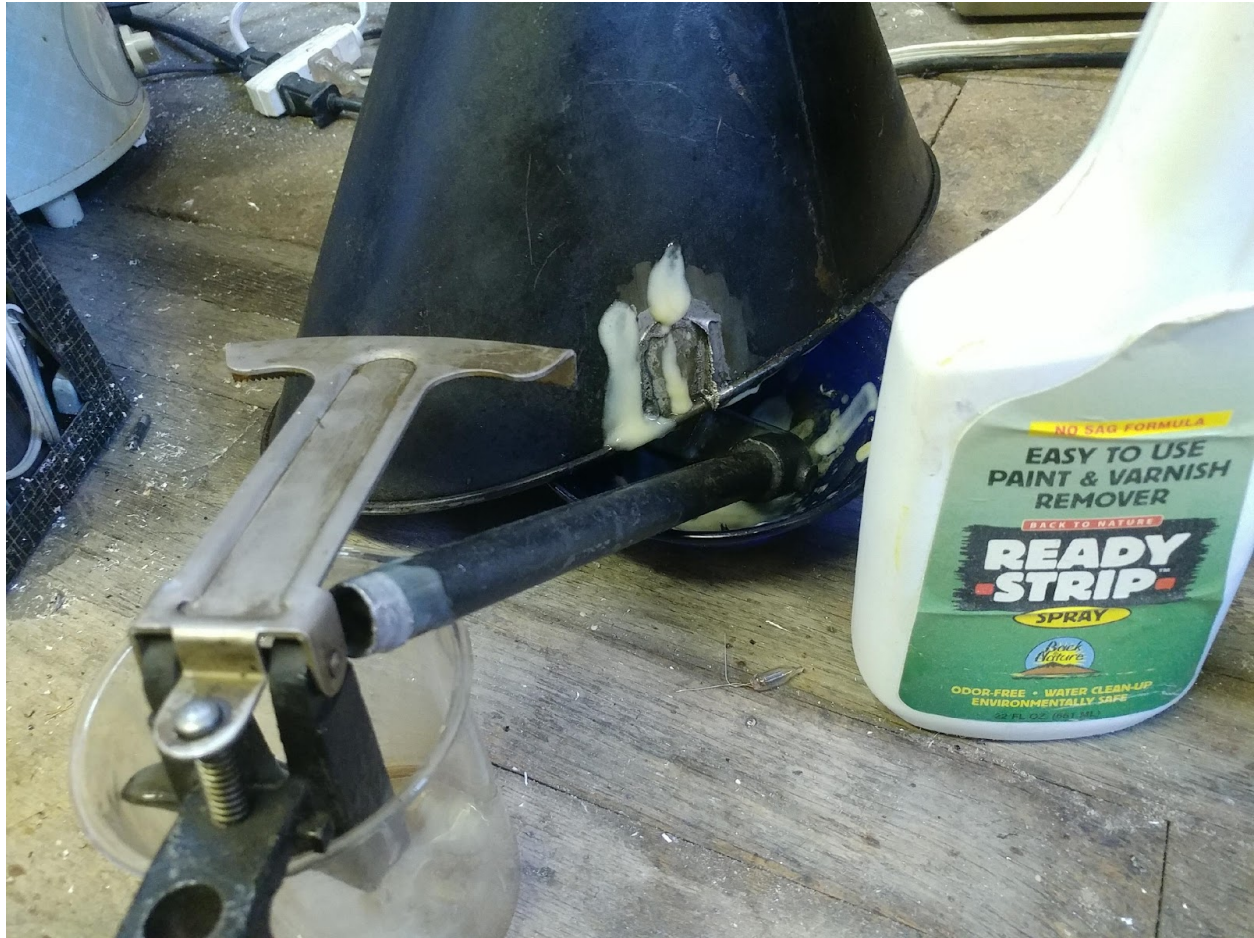
The black coating is some mystery stuff that comes off on your hands if you handle the material. Emily Velasco (@MLE_online@twitter.com) suggested it was japanning, which was the standard anti-rust coating for

Fig. 7: starting the process of stripping off the coating.

This stuff worked well. The horn needed to have the coating stripped on inside and outside of each solder joint (bottom and top) and the brackets similarly needed their contact points with the horn and with each other stripped prior to re-soldering.

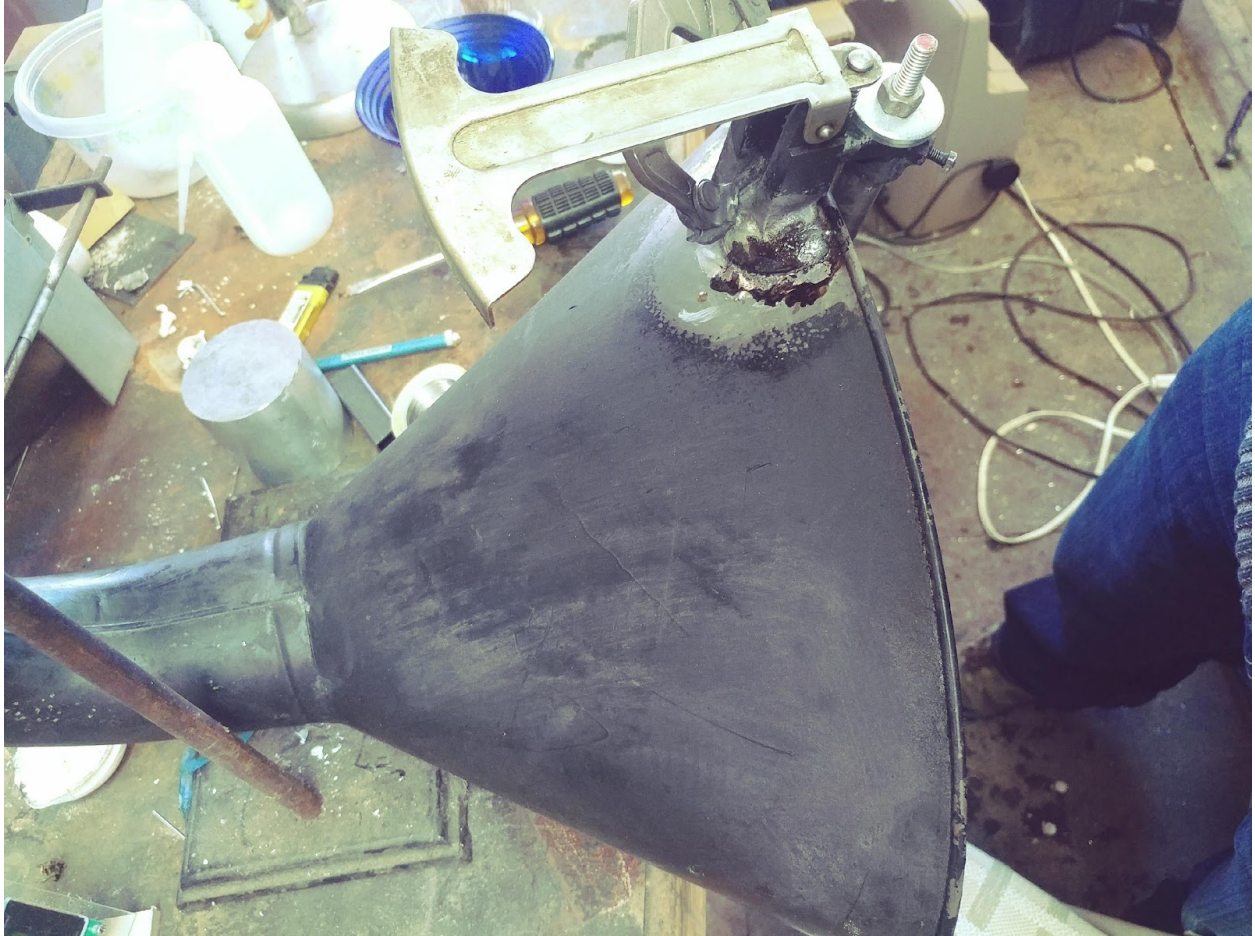
Fig. 9: bracket clamped to horn, first solder joint finished. Flux debris is visible across the joint.

I cleaned up all the joints with a wire brush and using the old broken lead joints as guides, clamped all three pieces together, then reflowed with an oxypropane torch. Because lead is such a poor conductor of heat, it's pretty easy to direct the torch on an area and melt it, add some lead, then move on to an adjacent area, letting the first bit freeze. It is not necessary to heat the whole joint to melting, so it's similar to TIG welding but much lower temperature. The original coating was stripped back to about 3cm away from the joint and did not get hot enough to get hurt during the process of reflowing the joints.

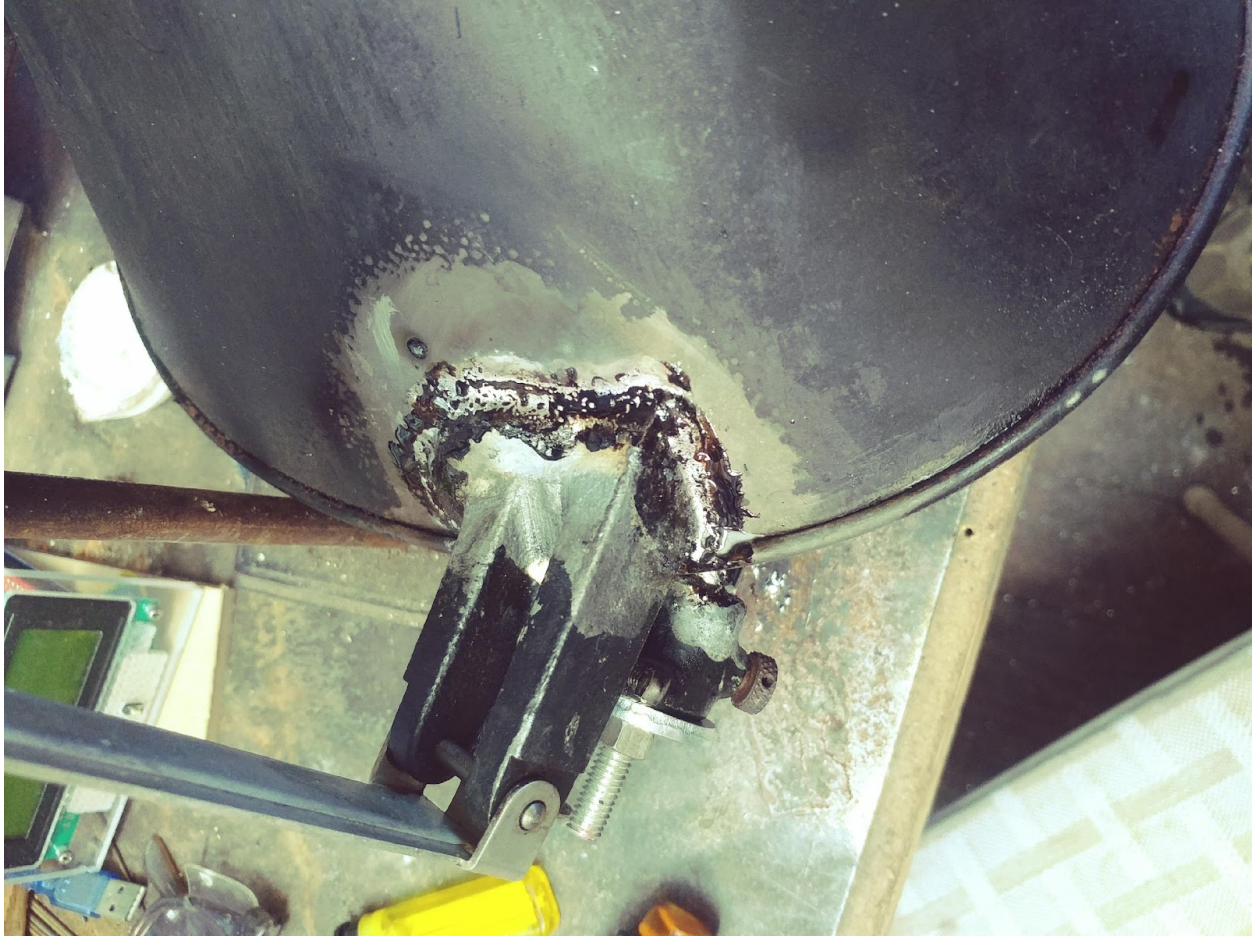
Fig. 10: closeup of top joint post-soldering.

I worked my way around the joint, adding flux with a brush and then reflowing the lead locally.

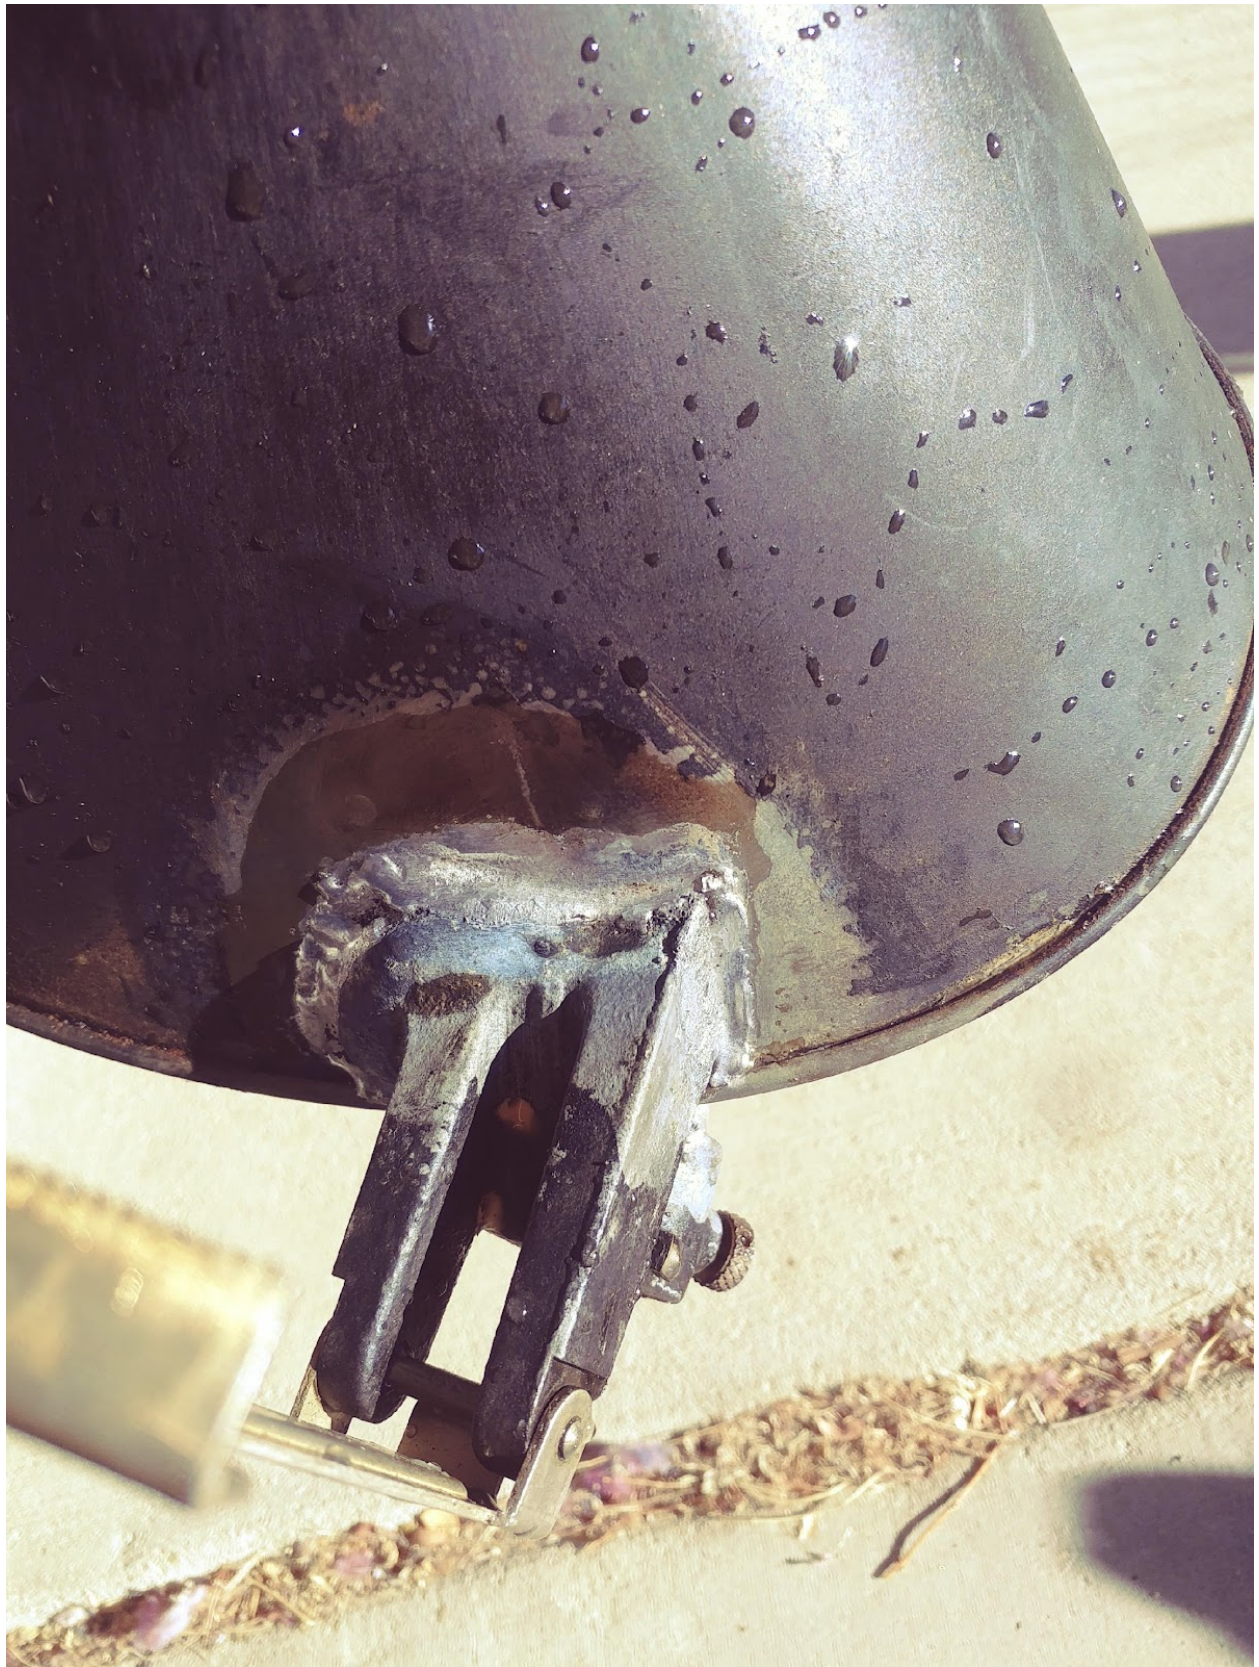
Fig. 11: soldered, washed, and wire brushed.

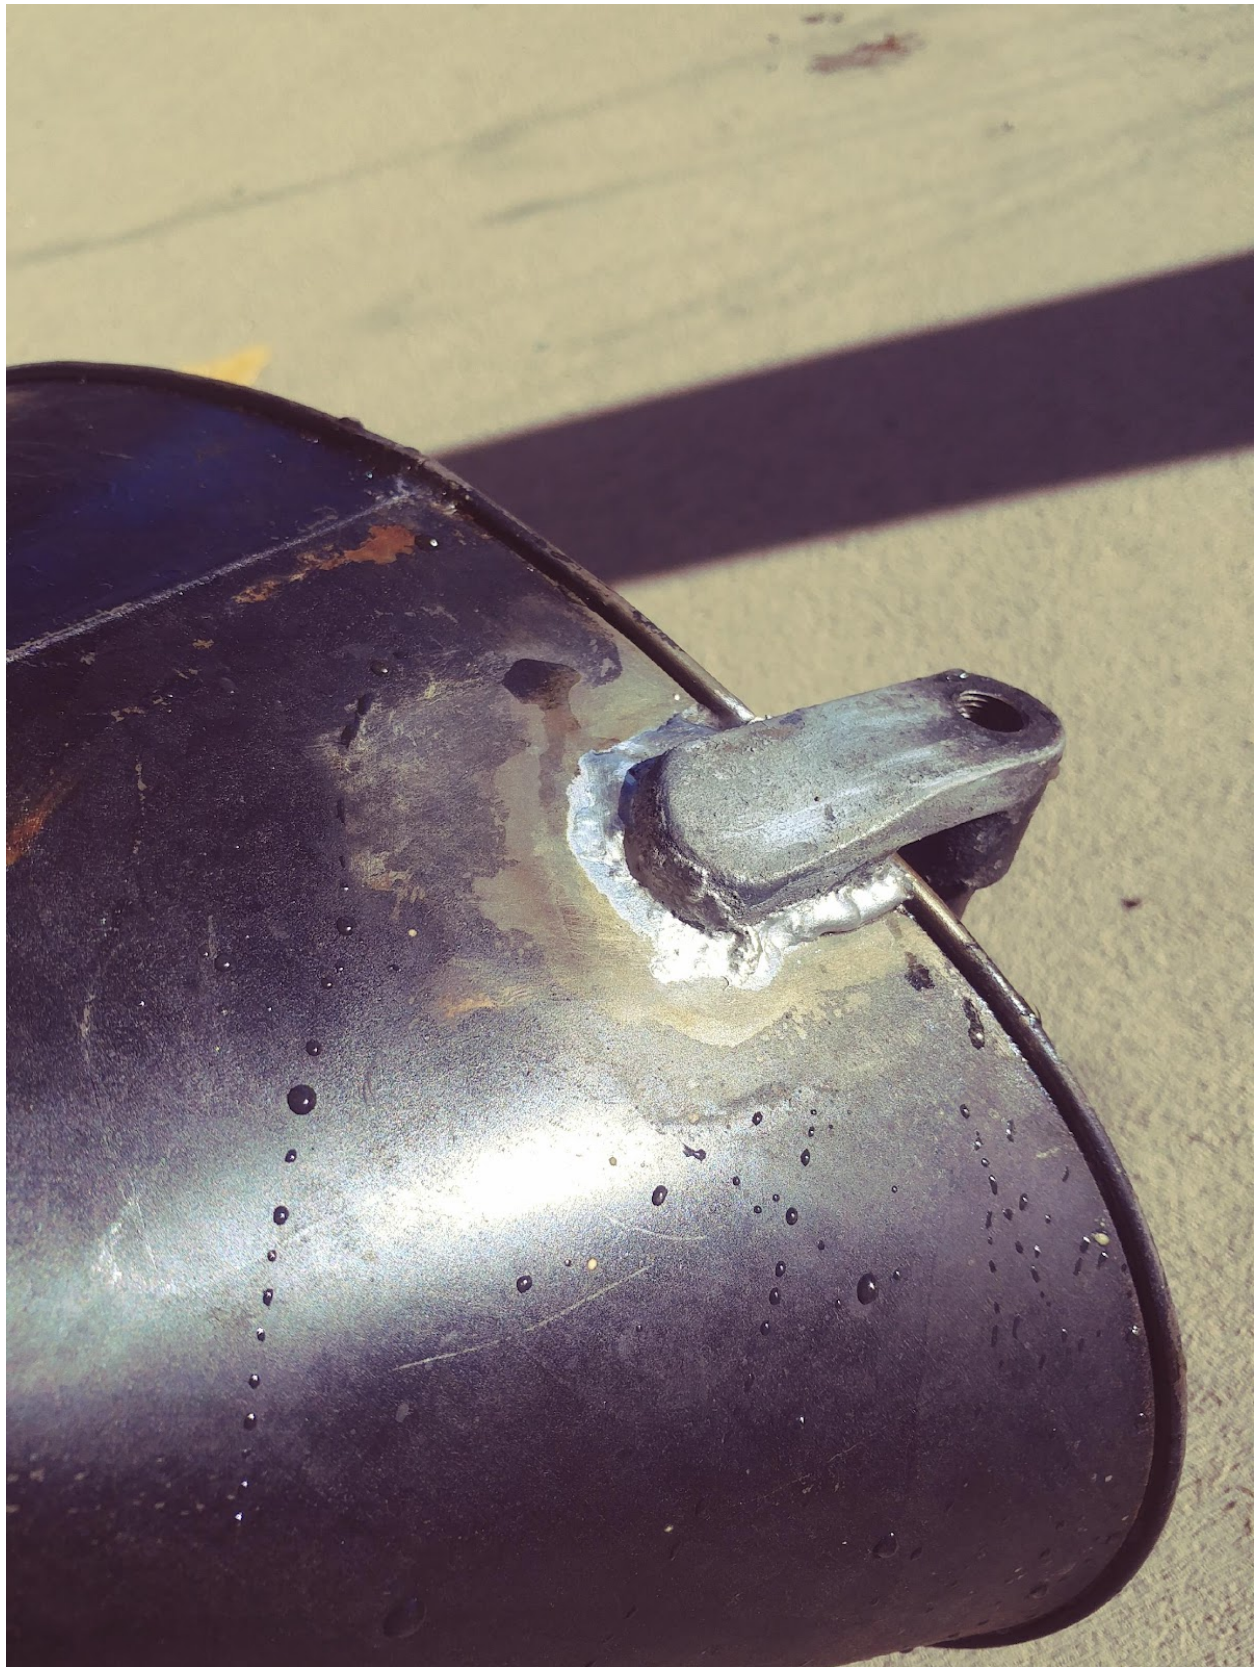
Fig. 12: lower bracket soldered, washed, cleaned up.

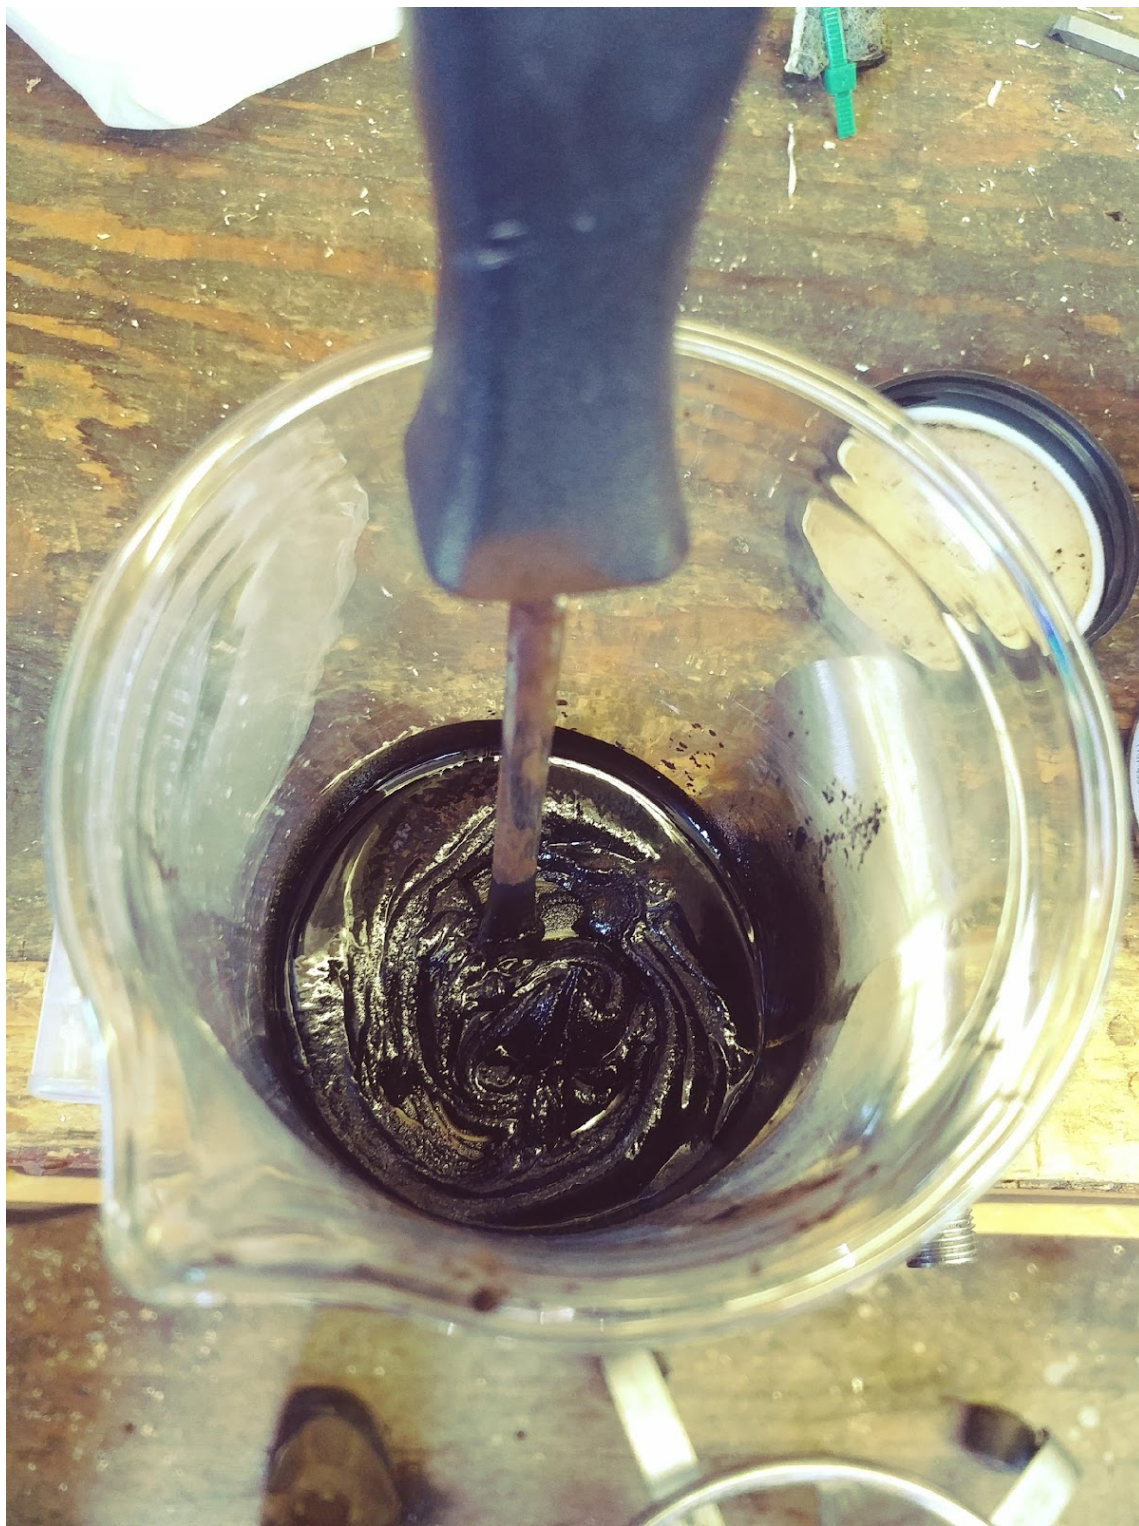
What I found is that the turpentine/linseed oil mix is quite thin, like water, and I added the recommended amount of asphaltum (about 1.5x by weight) and then I had a slightly sludgy colloidal mix of very thin material that would run off, and I kept adding asphaltum until it finally got to the consistency I wanted, which was more like molasses, and I went to apply it to some steel, and then it was like chewing gum.

Fig. 14: like chewing gum.

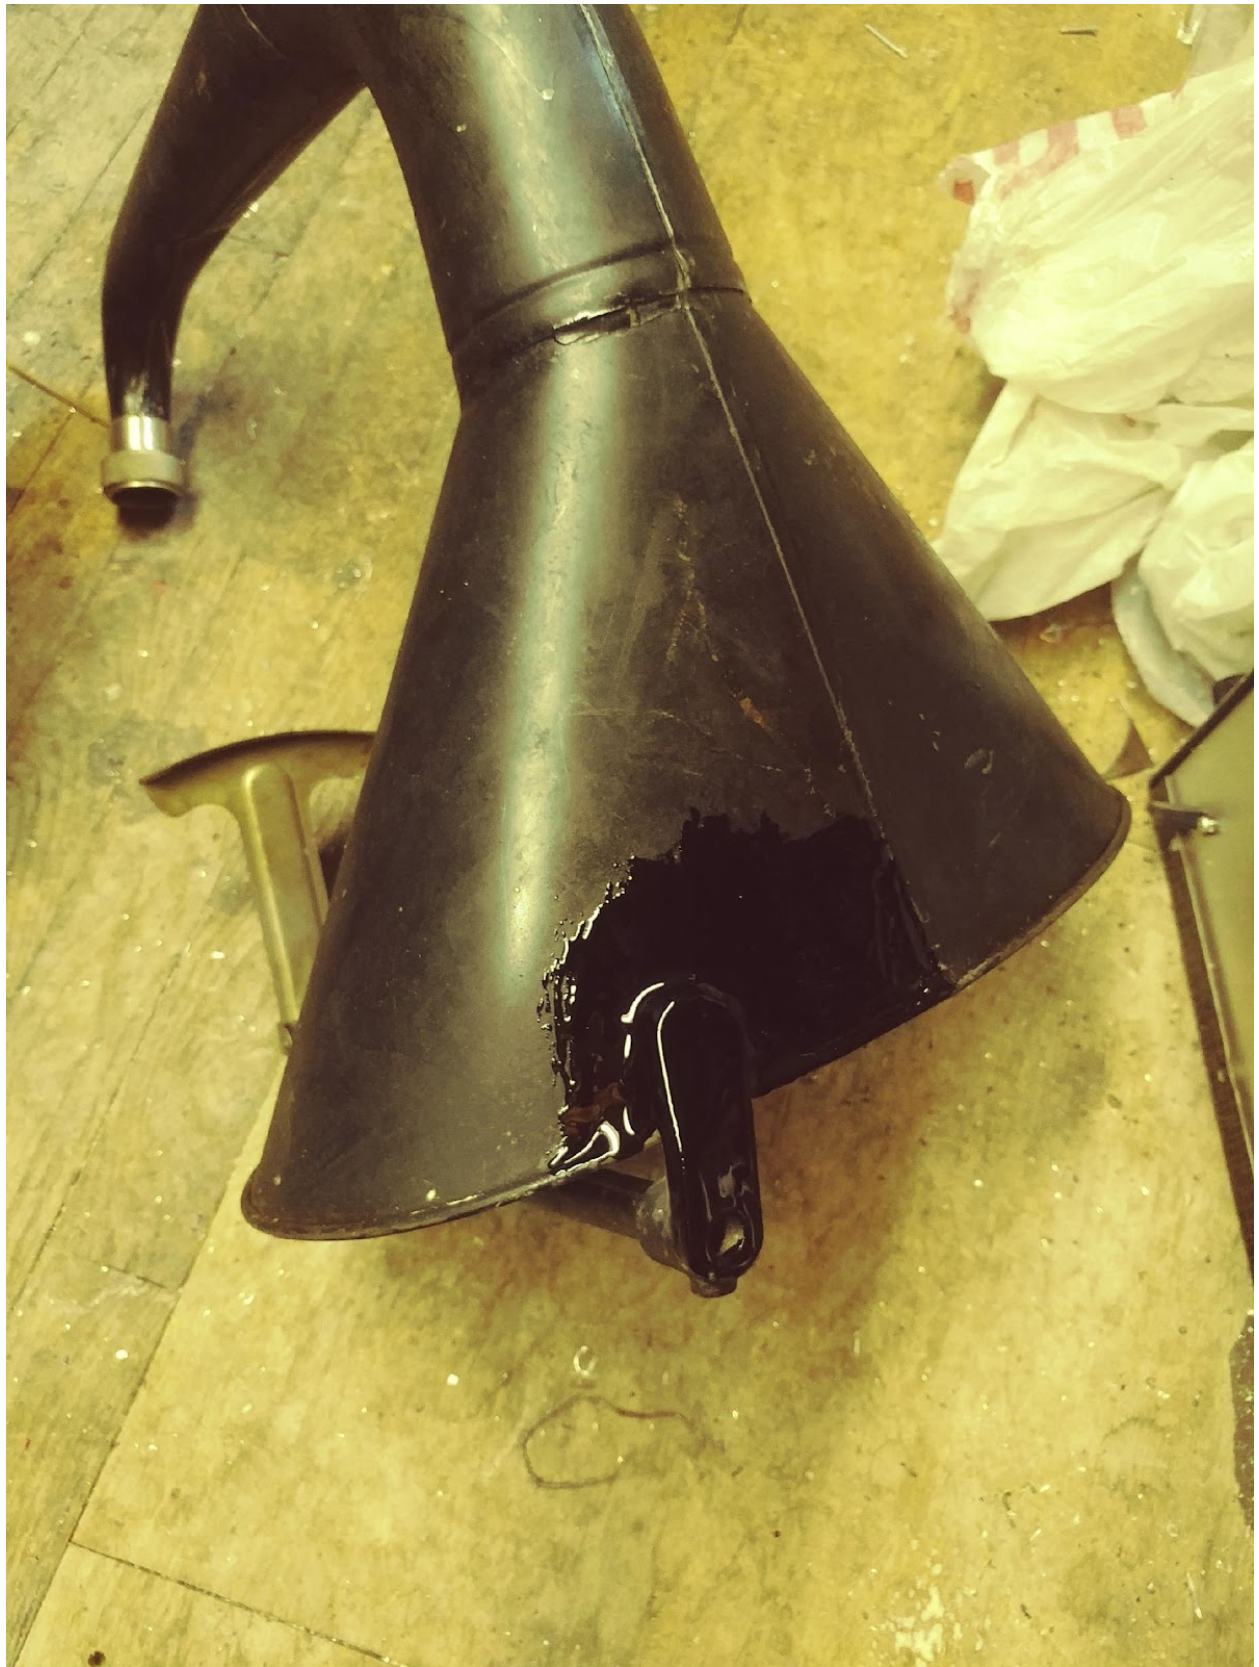
Fig 16: Japanning applied, thick viscous coat slowly drying.

I put a forced air heater beside it and a thermocouple on the back side of the material and heated it to 200F, let cool, heated to 300F, let cool, but could not manage 400F in an open room in the middle of winter in an unheated workshop.

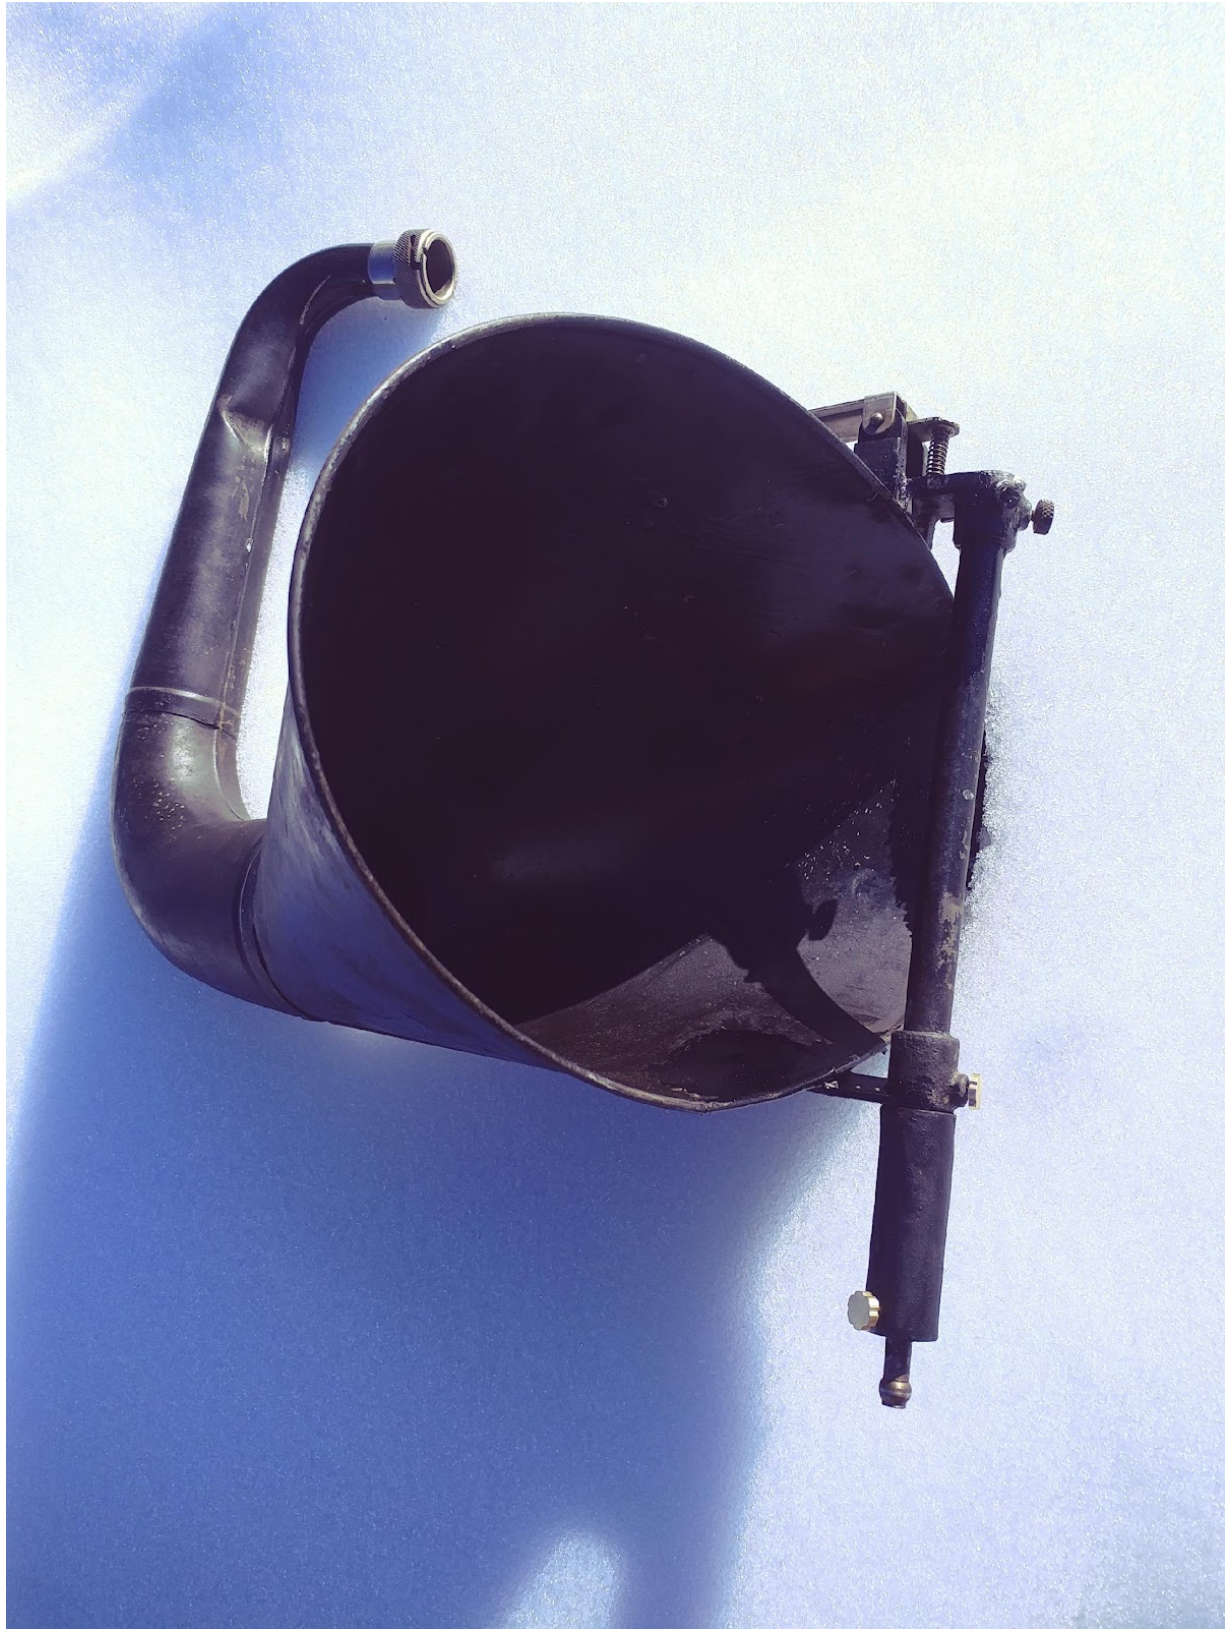
This has the completed extension, with the thumbscrews populated, the solder joints fixed, and the inside, outside, and brackets re-japanned.

Fig. 17: finished and assembled

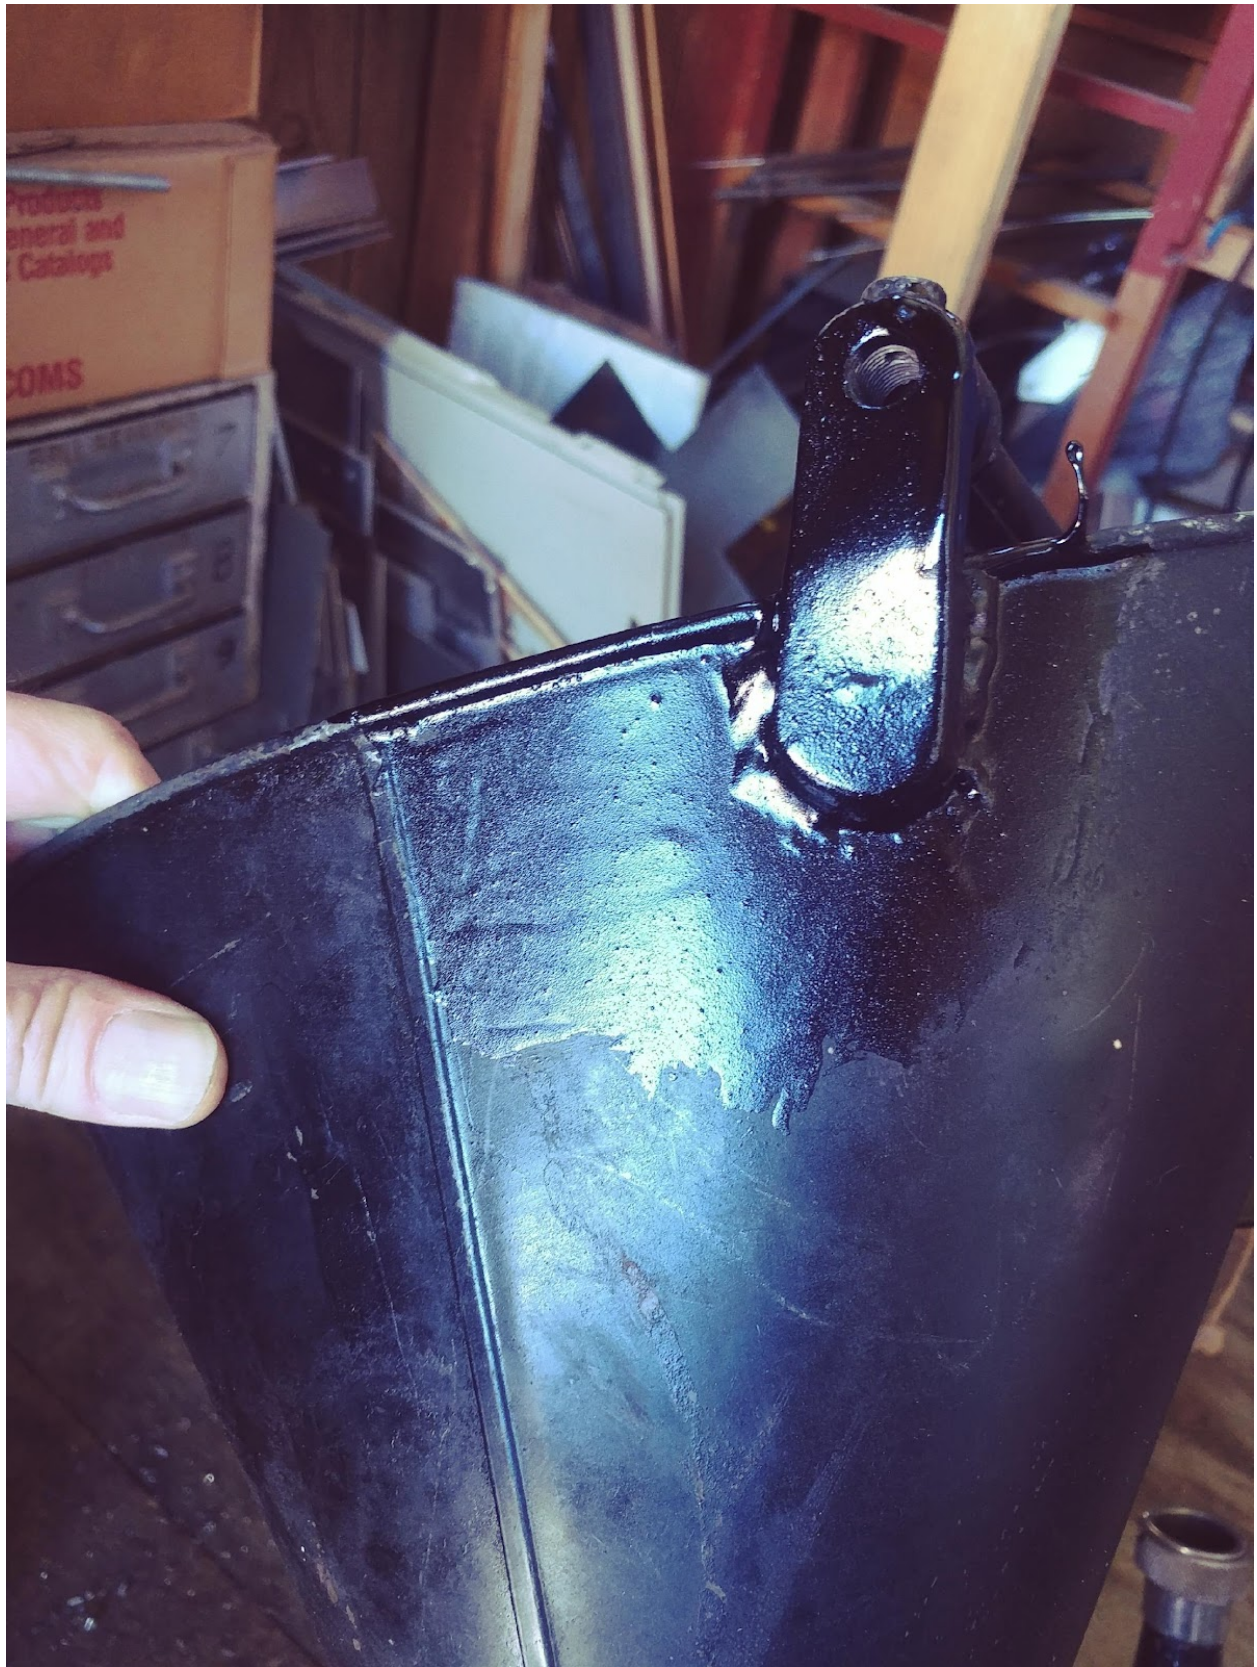
Fig. 18: Japanning cured

There was a side plot involving a dent (visible) in the horn near the needle end making it sit too low to adjust the needle to the right tension. I unbent that a little by sticking a wooden dowel the same diameter as the input to the horn in a vise and bending the whole assembly to get an extra 8mm of clearance between the two ends of the horn. Then it seemed to work okay.
