**Project name:**  
2024 Foreshore Monitoring and  
Sampling Program

**Project Ref:**  
60704318

**Subject:** July 2023 through March 2024 Foreshore Passive Treatment System Inspection Memo

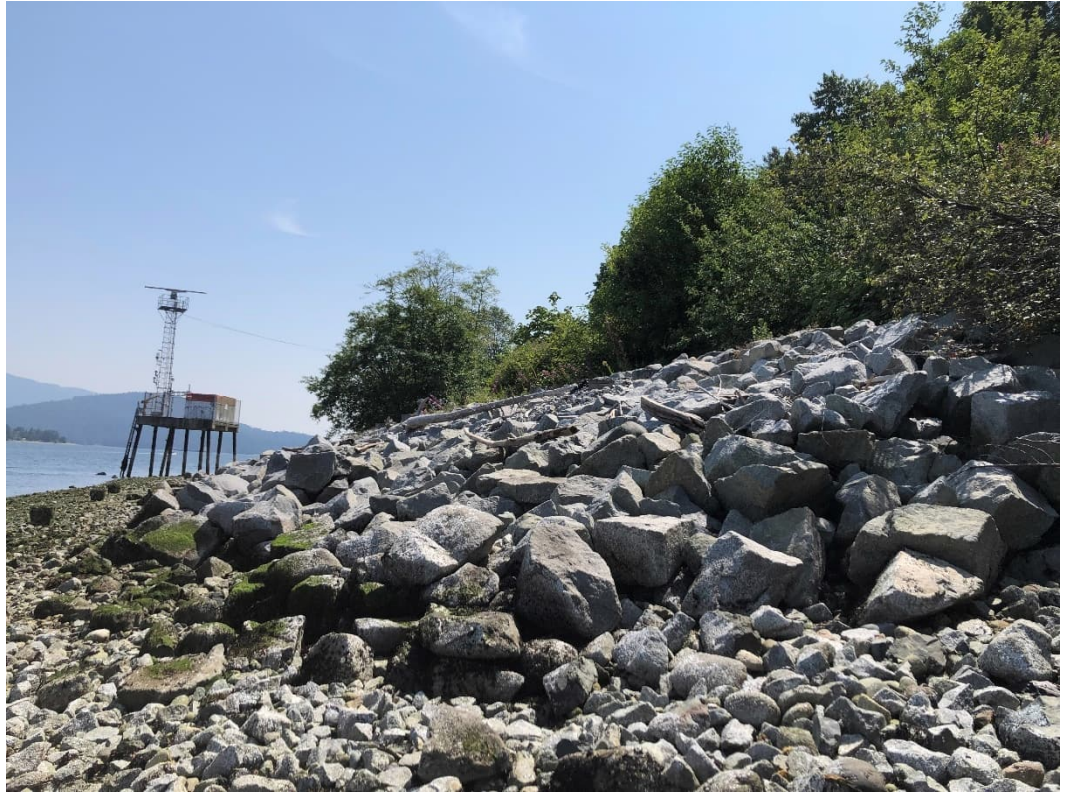
<b>Photo No.</b> 1	<b>Date:</b> July 05, 2023
<b>Direction Photo Taken:</b> Northeast

At both the Eastern and Western sections of the FPTS, weeds were observed growing on the south side of the barrier, and there was overhanging vegetation along the south side. No vegetation growth was observed on top of the treatment cells or OBB layer. Overhanging bushes were trimmed to prevent further encroachment over the treatment cells. The Eastern and Western FPTS are shown in photos 1 and 2 in **Appendix A**.

<b>Description:</b> Eastern FPTS.
--------------------------------------

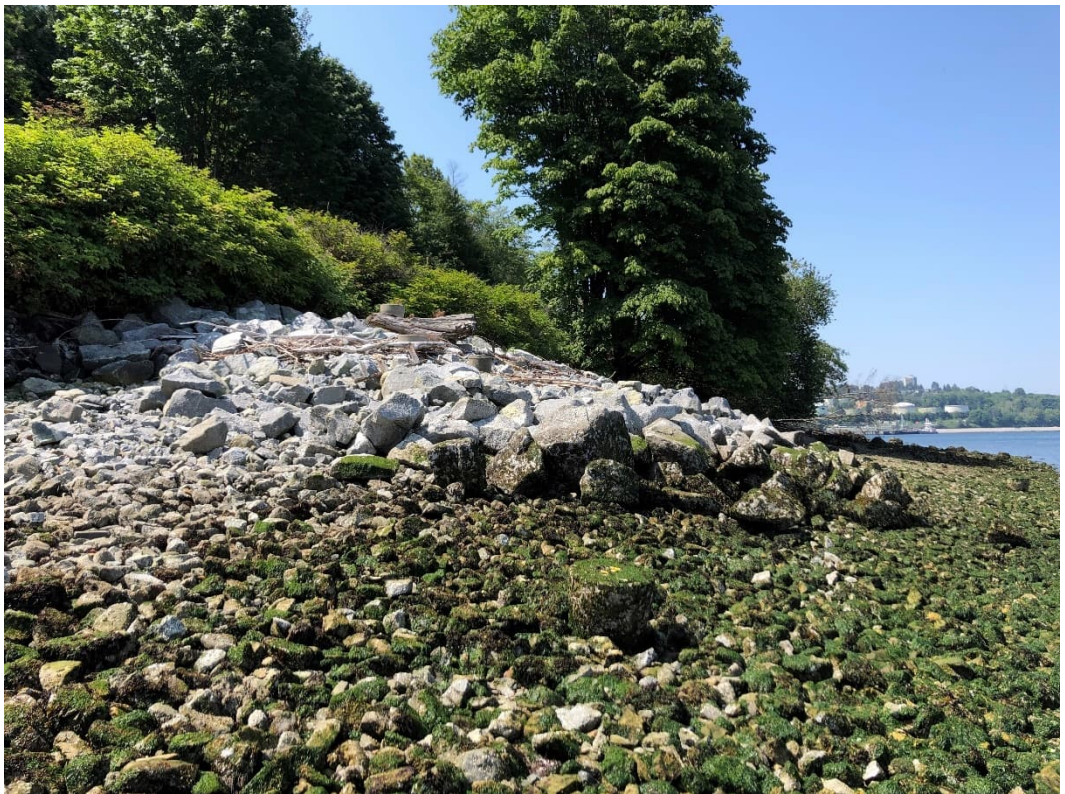
<b>Photo No.</b> 2	<b>Date:</b> July 05, 2023
<b>Direction Photo Taken:</b> Southwest

<b>Description:</b> Western FPTS.
--------------------------------------

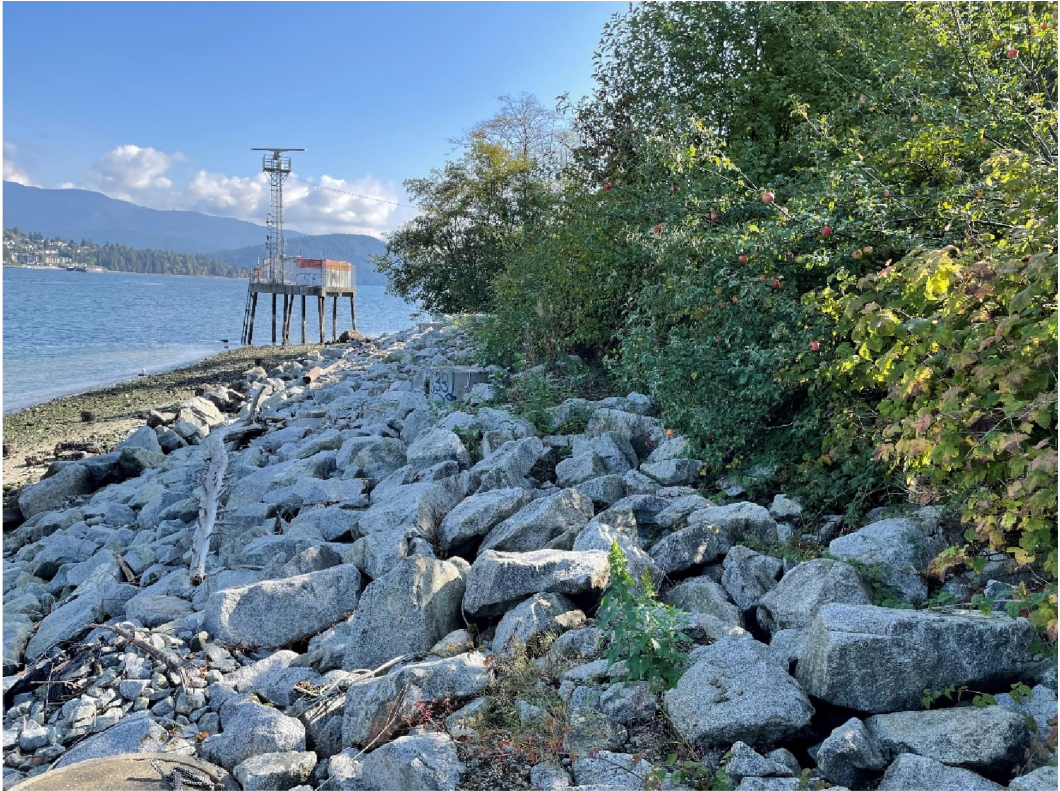
<b>Client Name:</b> Parkland Refining (B.C.) Ltd.		<b>Site Location:</b> Foreshore – Downgradient Area 2, Parkland Refinery, Burnaby, BC	<b>Project Number:</b> 60704318
<b>Photo No.</b> 3	<b>Date:</b> September 29, 2023

At the Eastern section of the FPTS, weeds were observed growing on the south side of the barrier, and there was overhanging vegetation along the south side (refer to photo 3 in **Appendix A**). No vegetation was observed on the barrier of the Western FPTS (refer to photo 4 in **Appendix A**). There was no vegetation growth on top of the treatment cells or OBB layer of either the Eastern or Western FPTS.

<b>Direction Photo Taken:</b>  Northeast			
<b>Description:</b>  Eastern FPTS showing overhanging vegetation.			
<b>Photo No.</b> 4	<b>Date:</b> September 29, 2023

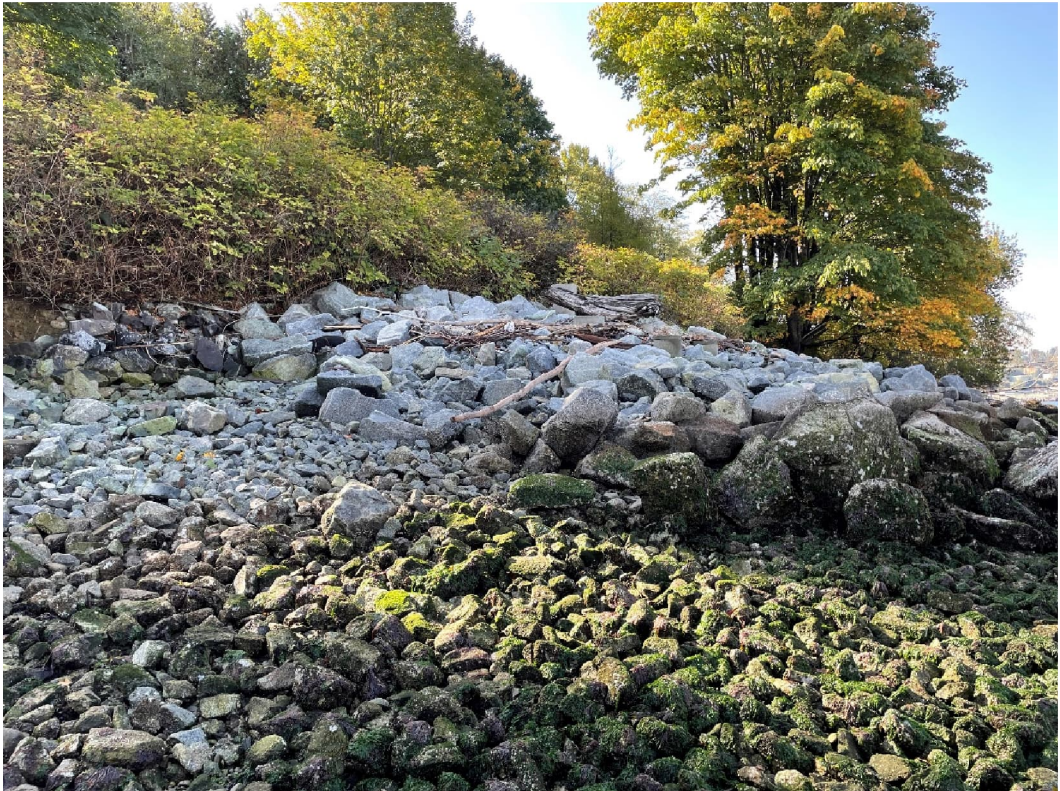
<b>Direction Photo Taken:</b>  Southwest			
<b>Description:</b>  Western FPTS.

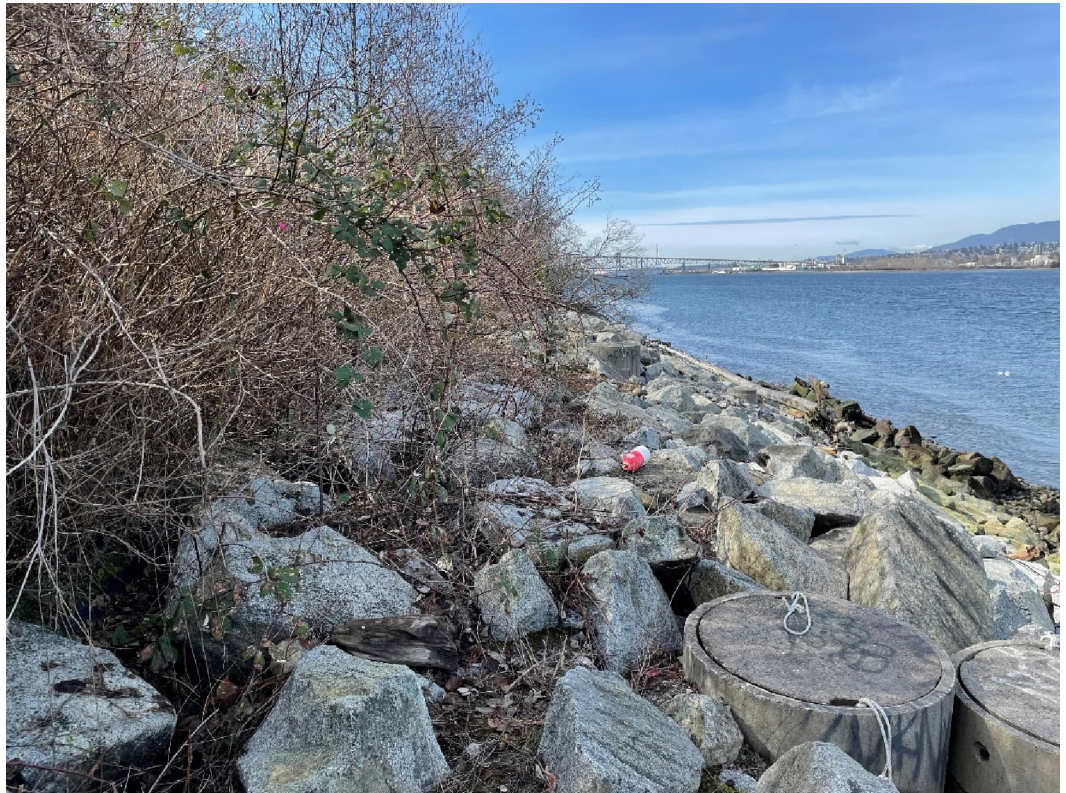
At the time inspection, there was no vegetation growth observed on top of the treatment cells or OBB layer of either the Eastern or Western FPTS. Some overgrowth was observed extending from the Canadian Pacific Railway (CPR) Right of Way onto the treatment cells at both sections of the FPTS (refer to photos 5 and 6 in **Appendix A**). Cutting of vegetation is suggested to reduce this overgrowth along the southern extents of the eastern and western FPTS in proximity to the Up Gradient wells.

**Description:**  
Eastern FPTS showing overhanging vegetation and concrete well protectors with graffiti.

- During inspections completed in July 2023, September 2023 and March 2024, none of the gauged monitoring wells contained a measurable thickness of NAPL.
- No significant concerns were noted during inspections of the FPTS completed between July 2023 and March 2024. Most Sentry and Compliance Wells are covered in barnacles and seaweed. No significant damage to monitoring wells was observed.
- Graffiti on the concrete protectors of six wells associated with the Eastern FPTS, first observed during the October 2022 inspection, was continually noted throughout the inspections from July 2023 to March 2024. No damage or disturbance to the wells were observed during these inspections; they did not appear to have been tampered with.
- Some overhanging vegetation from the Canadian Pacific Rail Right of Way was observed to be encroaching on the Eastern and Western FPTS and is suggested to be cut.

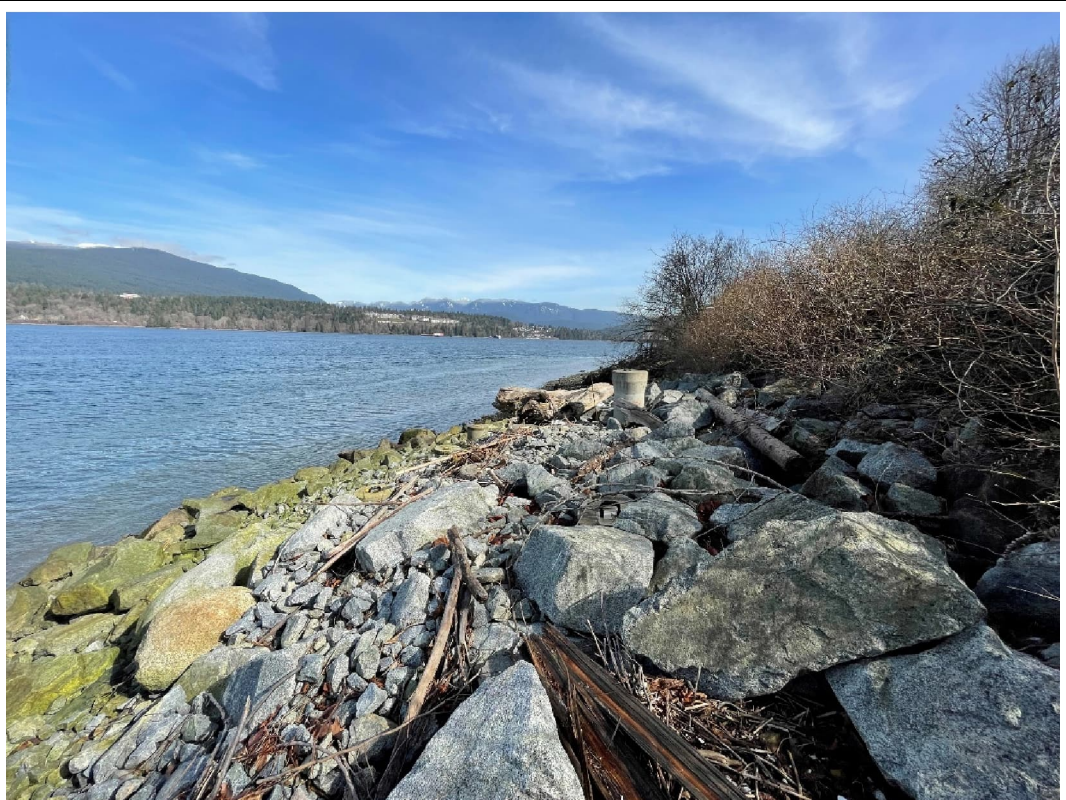
<b>Photo No.</b> 6	<b>Date:</b> March 14, 2024
-----------------------	--------------------------------

**Description:**  
Western FPTS.

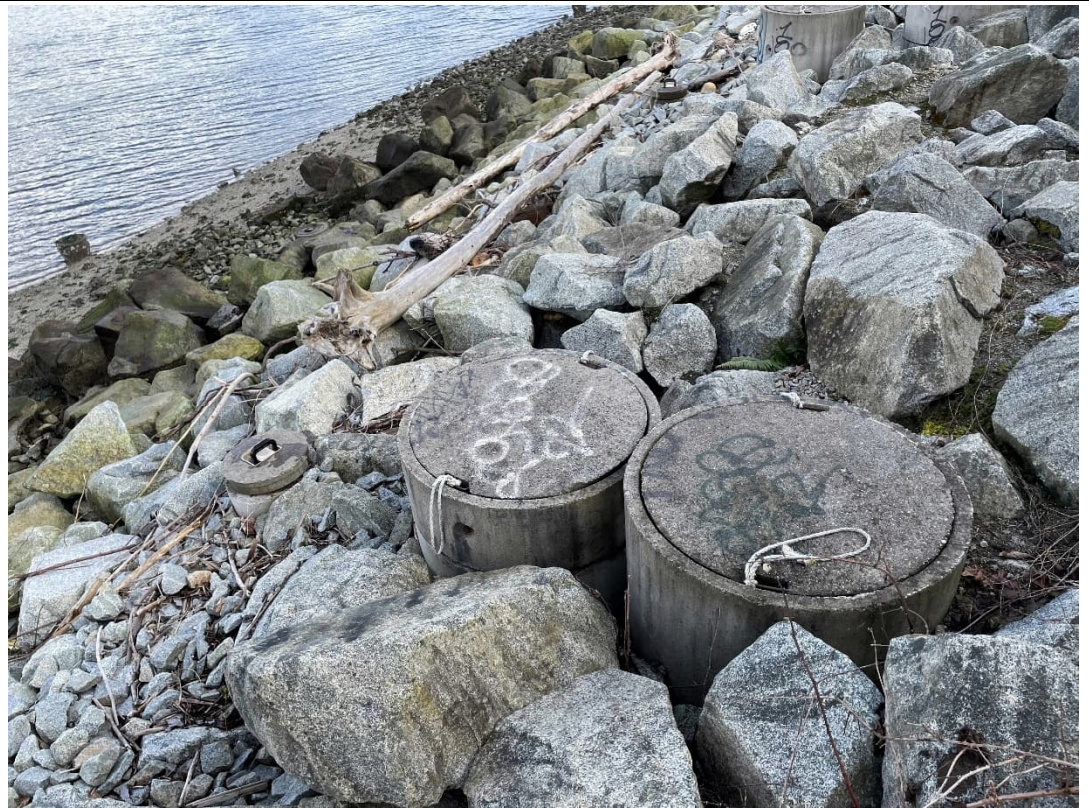
As observed during previous inspections, the concrete protectors of six wells (PW17-16, PW17-17, PW17-21, PW17-22, PW17-26, and PW17-27) had graffiti on them. Photo 7 in **Appendix A** shows an example of the graffiti. In addition, the

concrete lids and cases of some of these wells were chipped. No other damage or disturbance to the wells was observed at the time of inspection and they did not appear to have been tampered with.

<b>Description:</b>  Graffiti on some Eastern FPTS wells.
---

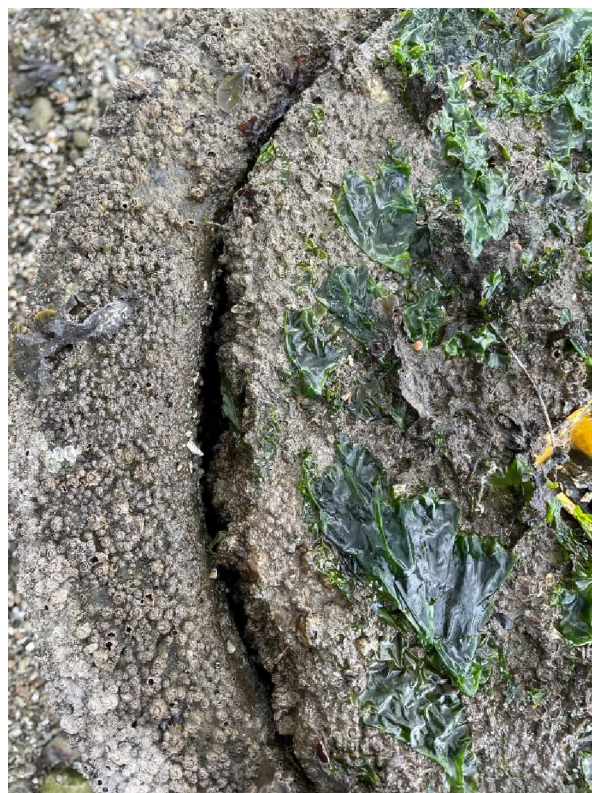
<b>Photo No.</b> 8	<b>Date:</b> March 13, 2024
-----------------------	--------------------------------

Most of the Sentry and Compliance Wells are covered in barnacles and seaweed and no significant damage to monitoring wells was observed, though minor chipping to the well casing and lids was noted.

<b>Description:</b>  Barnacle and seaweed growth on concrete well protector, as well as minor chipping on concrete well lid.
--
