# Accident Investigation Form - Worksafe NZ

Accident Investigation Report

Sunshine Ridge Residential Development

**Conducted on** 22.09.2025 11:20 PST

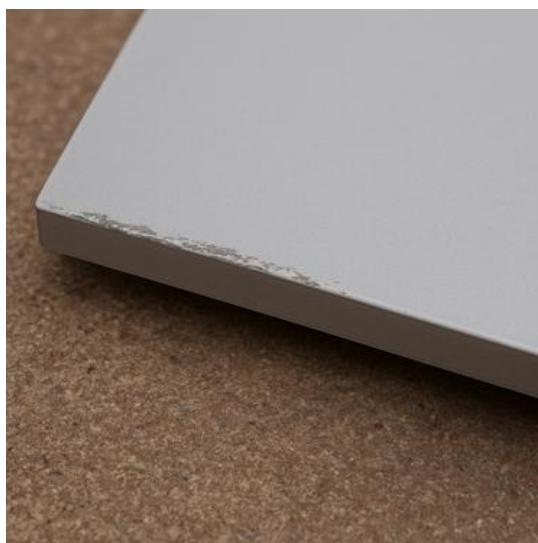
Photo 1

Damage to façade panel

minor scuffs on one edge

The panel fell

At about 10:15 am, Mr Wilson was positioning a 1.2 m × 2.4 m lightweight aluminium composite panel onto the façade framing at Level 3 (approx. 9 m above ground) using a temporary hoist and sling. As he guided the panel into place, the panel suddenly swung free from the sling because the crane hook latch had not been fully closed. The panel began to rotate, striking Mr Wilson on his left forearm and causing him to lose balance. He managed to grab the frame and prevent a fall but sustained a fracture and deep bruise to the forearm.

The panel suddenly swung free from the sling because the crane hook latch had not been fully closed.

Update and enforce a detailed pre-lift checklist including hook latch verification

Assign additional safety supervisor for façade operations
