Means of Egress Inspection Checklist

Score	44 / 47 (93.62%)	Flagged items	4	Actions	3
Conducted on					27.03.2026
Location					2500 Mc Hale Ct #100, Austin, TX 78758, USA (30.3842559, -97.72096359999999)
Prepared by					Trish Castle
Department/Team					Facilities and Engineering
Role/Position					Facility Manager

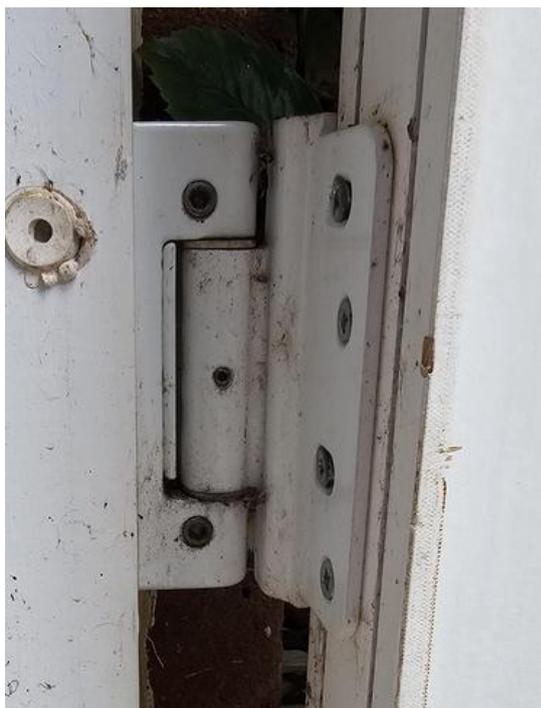
Photo 1

Rear exit door (Ground Floor, south side) exhibits stiff operation and audible squeaking upon opening; hinges show signs of rust and inadequate lubrication.

Repair Rear Exit Door @ GF South

- Remove rust from all hinge surfaces
- Apply heavy-duty lubricant

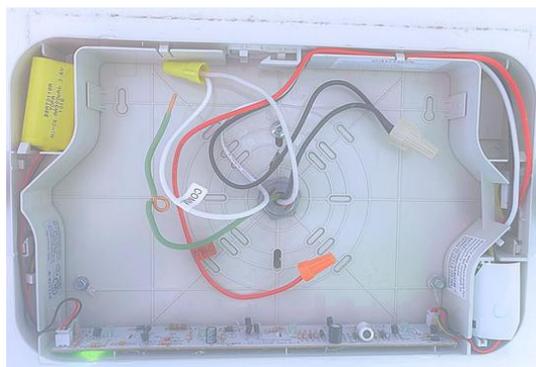
Photo 2

Stairwell B Landing's exit sign is only partially illuminated. Light is uneven and insufficient brightness

Repair Exit Sign @ Stairwell B

Install missing LED lights and reconnect all disconnected wiring. Test for both normal and battery backup operation upon completion
