# Structural Steel Inspection Report - Industry Vetted

| Project name | Lumière Residence Expansion – Stage 2 | | | | |
| Project number | SC-2478 | | | | |
| Conducted on | 30 Dec 2025 12:00 PST | | | | |

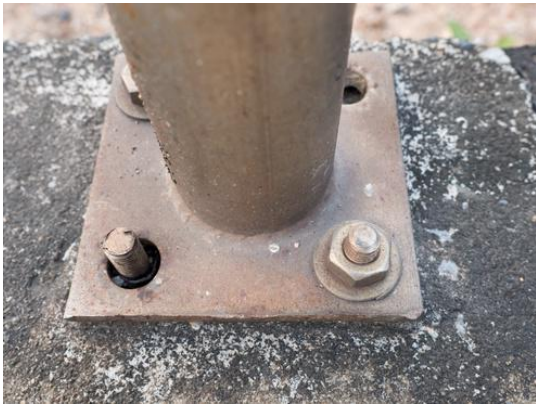
Photo 1

| <b>At least two bolts are installed in each solid web beam during temporary positioning</b> | | Fail |
| not bolted properly. pls re-check everything again | | |
