## Fix and Waterproofing Inspection Checklist

30 May 2023 / Philip Dunphy / Fixing Stage / Matthew Davis

| Score | 3 / 6 (50%) | Flagged items | 3 | Actions | 3 |
|---|---|---|---|---|---|
| Subject Property | | 14 Pine St, Marrickville NSW 2204, Australia<br>(-33.9086828, 151.1456221) | | | |

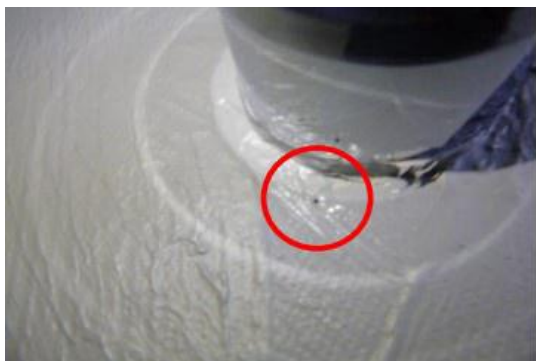
Photo 1

These are numerous holes in the waterproofing membranes applied to the wet areas of this home, which will likely lead to water leaks and damage in the future.

Rectify waterproofing holes in wet areas

This waterproofing has been poorly applied with no care taken whatsoever, all of these areas will need to be rectified and properly waterproofed so the wet areas are actually waterproof

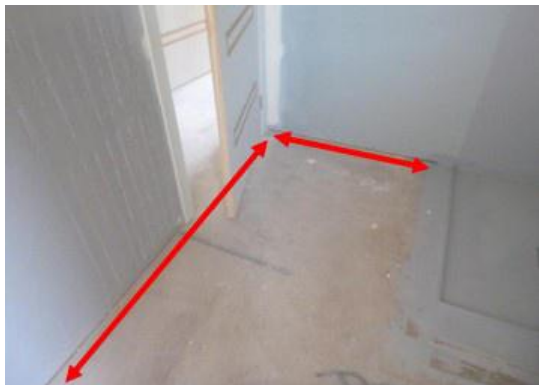
Photo 5

None of the wall/floor junctions or door openings throughout the wet area rooms of this home have been properly waterproofed as required by the BCA and the relevant Australian Standard - AS 3740, which will allow water to leak into the frame and cause possible future damage.

Notify the builder in charge to install waterproof wall/floor junctions to all of the wet areas of this home as required by the NCC/BCA and the relevant Australian Standard - AS 3740

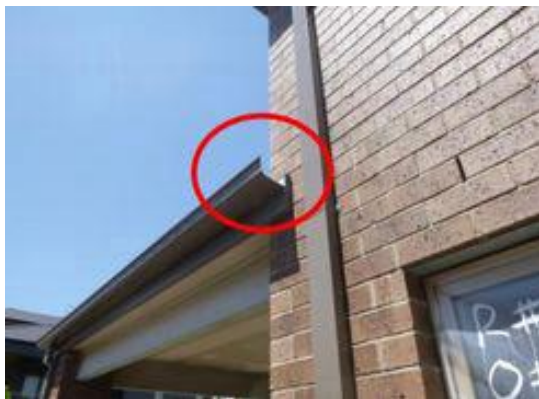
Photo 7

The downpipes have not been connected (temporary or otherwise) to the stormwater system throughout most of this build, which has directed water onto the ground adjacent to the footings and may be contributing to future slab heave issues. There have not been temporary downpipes fitted to the gutters of this house, which is directing water collected from the roof onto the ground immediately adjacent to the footings.

Notify builder to immediately place temporary downpipes fitted to the gutters, and the site drainage rectified to prevent further ponding of water against the footings
