## ISO Container Inspection Checklist

1 Feb 2023 / EECU322406 / Expert Exporters Co.

| Score | 64 / 73 (87.67%) | Flagged items | 9 | Actions | 3 |
|---|---|---|---|---|---|
| Container Number | EECU322406 | | | | |

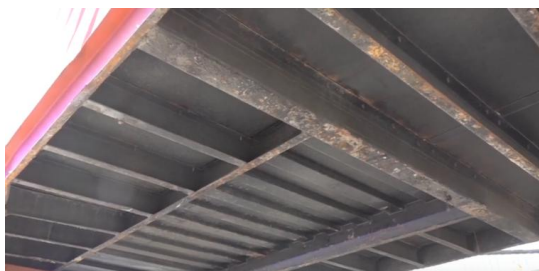
Photo 1

#### Bottom end rails

Pass

Still in good condition.

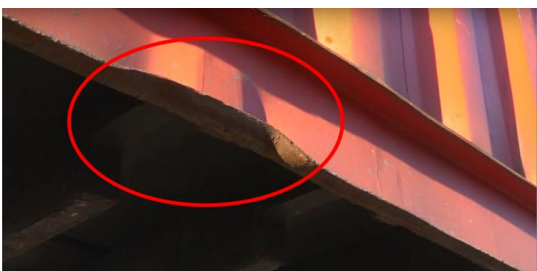
Photo 2

#### Bottom side rails

Fail

Monitor minor damage

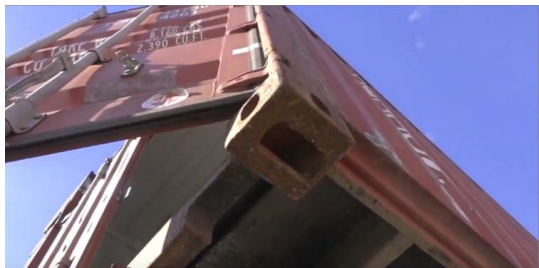
Photo 3

#### Door sill

Pass

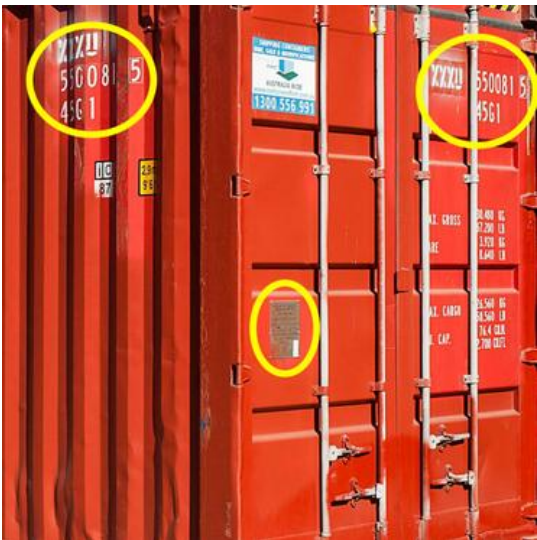
Photo 4

Clearly visible ISO marks and CSC plate

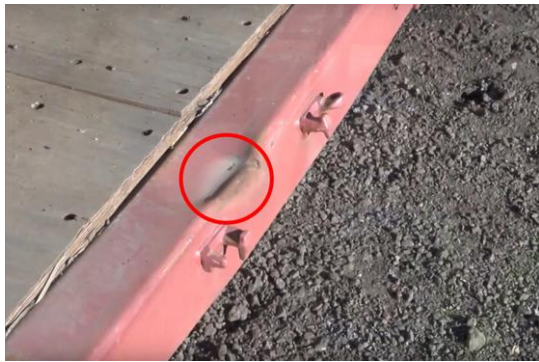
Photo 5

#### Door fittings

Fail

Monitor minor damage

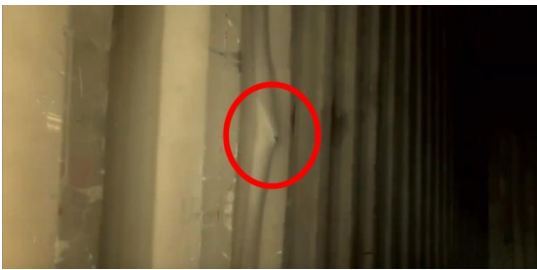
Photo 6

#### Vertical plate

Fail

Repair left side interior panel

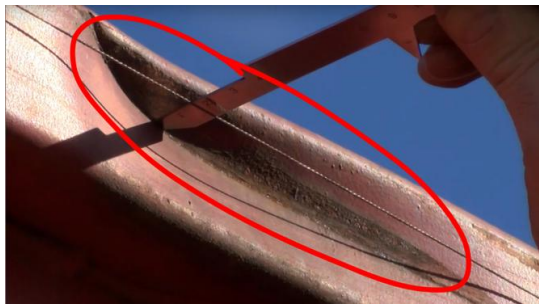
Photo 7

#### Top side rail

Fail

Monitor minor damage

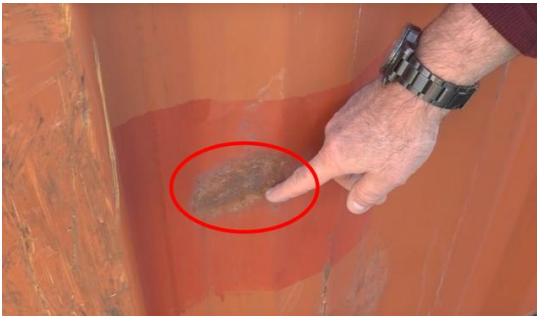
Photo 8

#### Panel

Fail

Contain small area of corrosion before it spreads

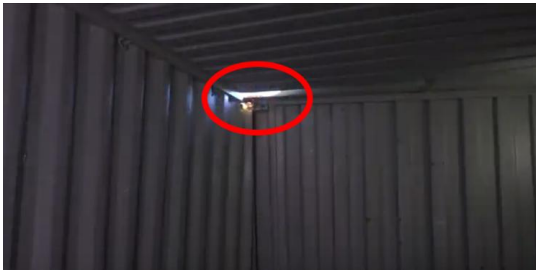
Photo 9

### Light leak

Fail

Cover roof hole near front wall

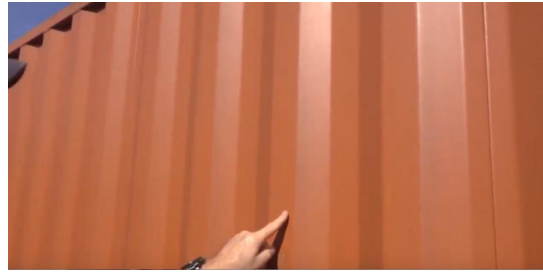
Photo 10

| Panel | Pass |

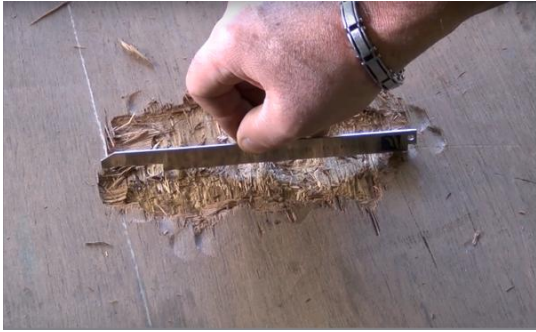
Photo 11

### Flooring

Fail

Patch this up, make sure no nails are protruding

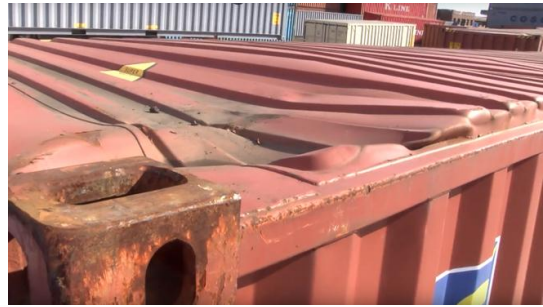
Photo 12

### Roof panel

Fail

This is the root cause for roof hole near the front wall. Repair this as well.
