## Vehicle Inspection Checklist

Robbie White / Jason Reyes / 21 Jun 2023

| Enter identification type | | Ford Everest 2015 Dark Blue |

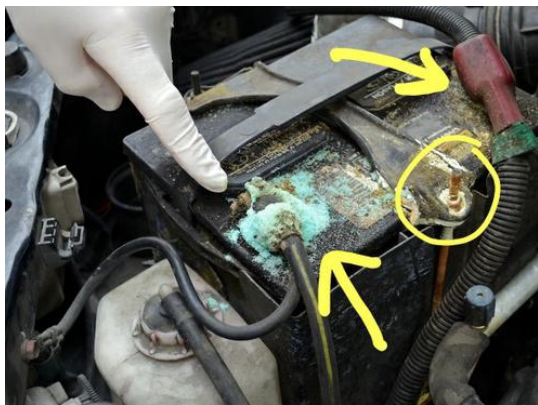
Photo 3

| <b>Battery</b> | Needs Repair |

Car battery became more pronounced. Colder temperatures made the engine oil much thicker.

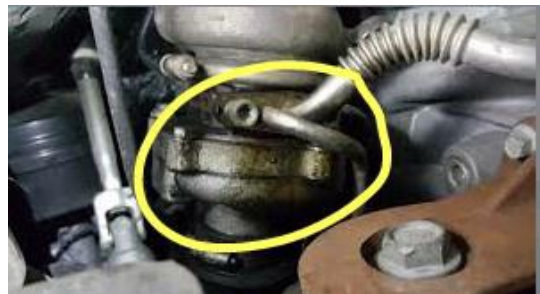
Photo 4

| <b>Visible leak</b> | Needs Repair |

Leaks found on fuel engine system.

1. Regularly check the vehicle components.
2. Check for leaks.
3. Inspect tire pressures.
4. Be mindful of the steering system.
5. Clean the brake dust off of the wheels.
6. Check oil levels.

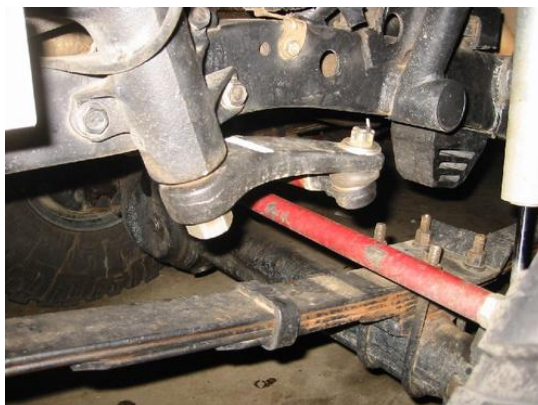
Photo 5

| <b>Pitman arm</b> | Needs Repair |
| Noticed some steering problems due to poor condition of pitman arm. | |

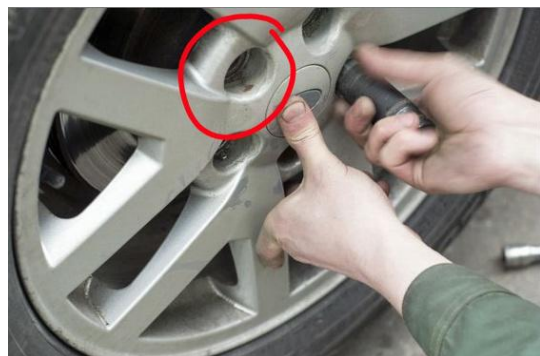
Photo 6

| <b>Lock or side rings</b> | Needs Repair |
| Side rings are dirty. | |
