## Racking Inspection Checklist

5 May 2023 / Blanche Monforte / SVC Warehouse

| Score | 3 / 8 (37.5%) | Flagged items | 5 | Actions | 5 |
|---|---|---|---|---|---|
| 3485 Broadway Avenue,<br>Chattanooga, Tennessee 37415 | | | | | |

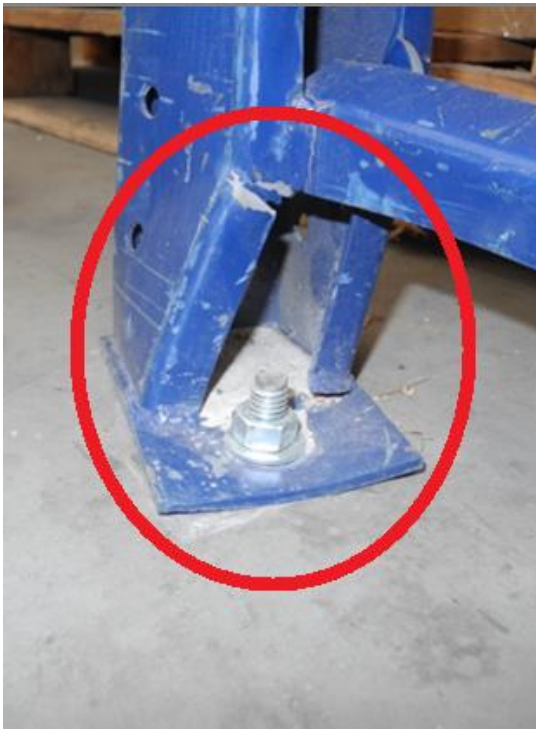
Photo 1

13mm twisted base plate, no shims installed

Rear base plate

Amber risk (significant damage)

Off-load, repair and install

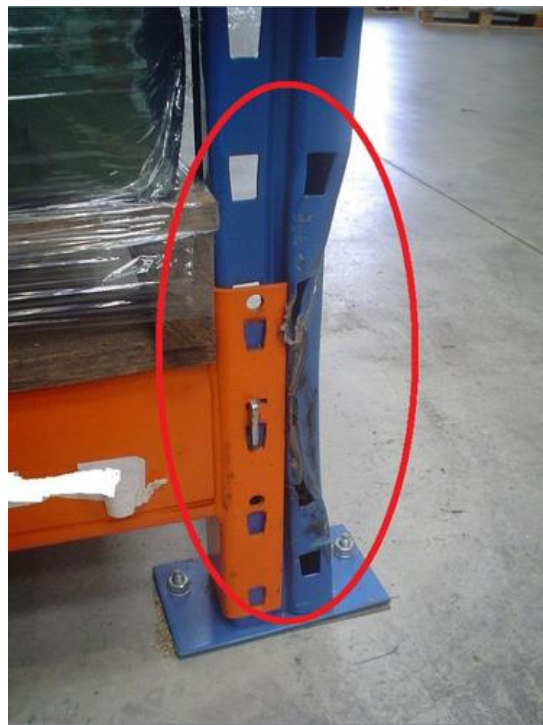
Photo 2

Side impact is over 10mm, no front upright guard installed

Which part/s of the frame is/are damaged? Front uprights

Take photos of the damage and identify risk level Red risk (critical damage)

Off-load NOW, replace and install

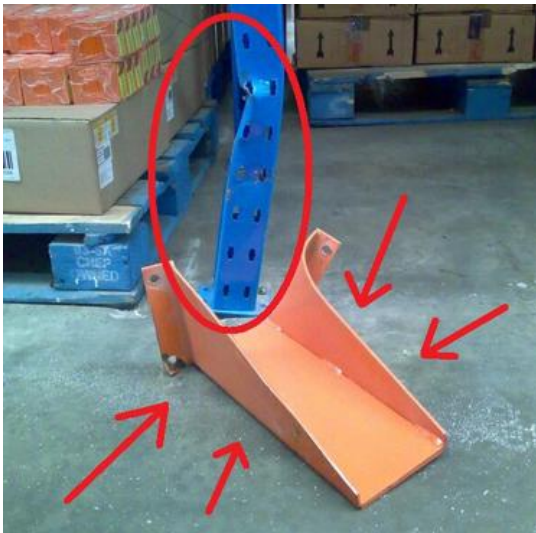
Photo 3

The detached rear upright guard and missing anchor bolts are also a slip, trip, and fall hazards!

Front uprights

Front shims

Red risk (critical damage)

Upright Guards

Off-load, remove and locate NOW

Isolate, replace and install

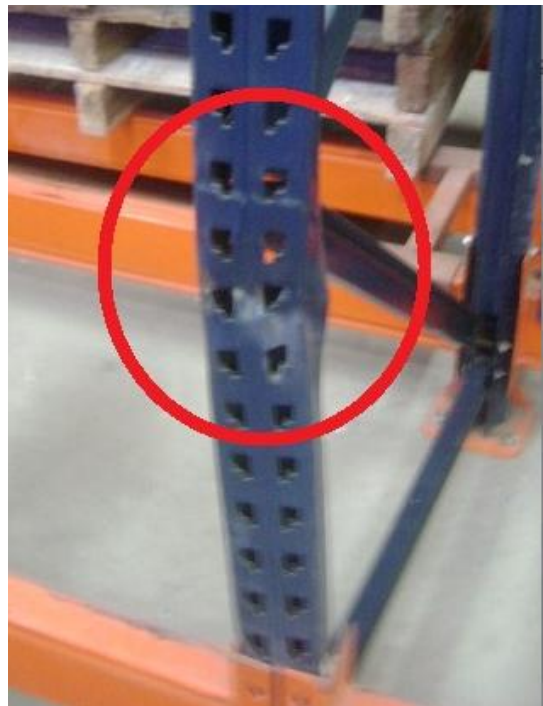
Photo 4

8mm side impact to rear upright

| | Front clips | Rear clips |
|---|---|---|
| <b>Which part/s of the frame is/are damaged?</b> | Rear uprights | |
| <b>Take photos of the damage and identify risk level</b> | Amber risk (significant damage) | |
| 8mm side impact to rear upright | | |

Off-load and repair

| | Front clips | Rear clips |
|---|---|---|
| Off-load and repair | | |
