# Leveraging Destructive Testing for Complex Cracking in LF-ERW; Case Study Phase II

## Abstract

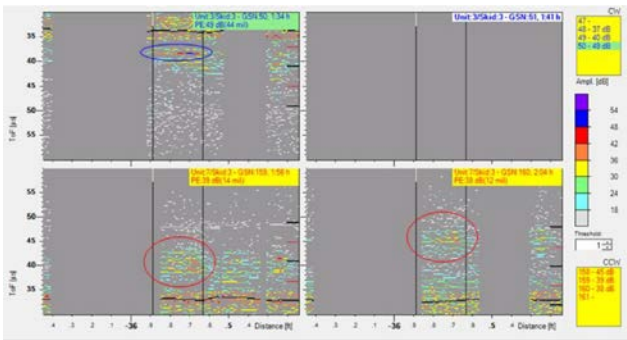
However, these indications followed a pattern of three linear reflections showing the highest recorded amplitudes alternating between the expected external and internal Time of Flight (TOF) windows (Figure 5), indicating some level of complexity or multiple reflectors. Figure 4 and Figure 5 show B-Scans where each sensor recording is color coded by amplitude, the darker the color the higher the amplitude. This recorded amplitude is depicted in front of their time of flight from the sensor and back (y axis), and relative distance to the referenced girth weld (x axis).

Figure 4 – B-Scan data for a verified hook crack following the first signal pattern identified. Upper scans correspond to CW sensors and bottom scans to CCW sensors.

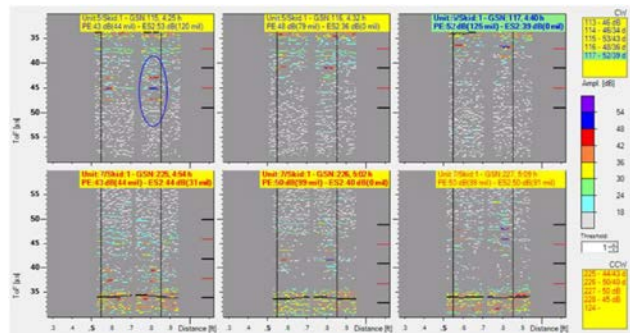
Figure 5 – B-Scan data for a verified hook crack following the second signal pattern identified. Upper scans correspond to CW sensors and bottom scans to CCW sensors

Nevertheless, all anomalies listed as potential 'hook cracks' that were matching the second pattern identified in Phase 1 based on the NDE results from

Vendor 1, were proved to be lack of fusion anomalies not related to 'hook cracks' by the destructive testing laboratory results. Therefore, the second pattern was removed from the list of characteristics for potential 'hook crack' and 'surface lap' identification.

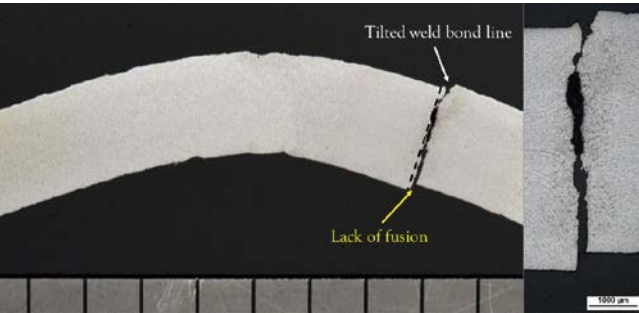
The summary of the laboratory destructive results is that of the 9 indications examined, 6 were found to be weld bond line LOF anomalies. An example is shown in Figure 7, while the 3 remaining indications were found to be surface laps. An example is shown in Figure 8. The surface laps likely resulted from improper weld formation. One of the three also shows evidence of hot tearing in the weld fusion zone. No evidence of in-service crack extension was observed during the metallurgical examination. (Stress Engineering Services Inc. 2023-2029-RP-02\_Rev4)

Figure 7 – Full-thickness macro and micro photograph of the transverse metallographic for one of the destructive tested anomalies identified as LOF. Scale divisions are 1/10 inch

The 6 planar anomalies that were found to be LOF, were situated on the bond line of the longitudinal seam weld and they had resulted from a localized lack of fusion, probably because of insufficient preparation of the strip edge prior to welding or because the strip edge was not heated sufficiently to cause melting. In addition, some of the samples show a tilted weld bond line probably caused by uneven forming pressure or misalignment of the strip edges during the manufacturing welding process.

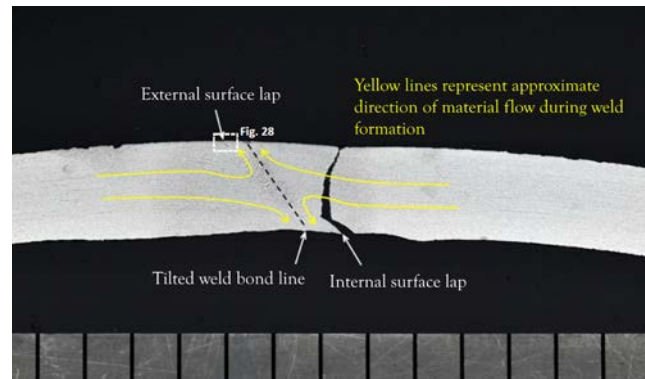
Figure 8 – Macro photograph of the transverse metallographic for an anomaly identified as surface lap. Scale divisions are 1/10 inch

However, for the 3 remaining anomalies it was discovered that they were not located at the weld bond line like the LOF defects. As can be seen in Figure 8 and Figure 9 examples, the anomalies took the form of a sharp curved lap extending from the pipe surfaces and are located to the side of the bond line. The bond lines of these anomalies were tilted almost 45 degrees from the ideal radial plane, indicating that the external surface layer of one strip had been forced over the other during weld formation. Microstructural banding indicated that the material on the opposing side of the bond line was forced to fold back on itself by the advancing strip edge producing a sharp unfused lap in the pipe surface. (Stress Engineering Services Inc. 2023-2029-RP-02\_Rev4).

It is important to note that considering the metallurgical report these lap anomalies differ from 'hook crack' anomalies in that they are formed by the folding of the external and internal surfaces of the pipe (Figure 10), as opposed to cracks caused by separations resulting from imperfections in the edge of the skelp, parallel to the surface, which turn toward the internal or external surface during weld upset.

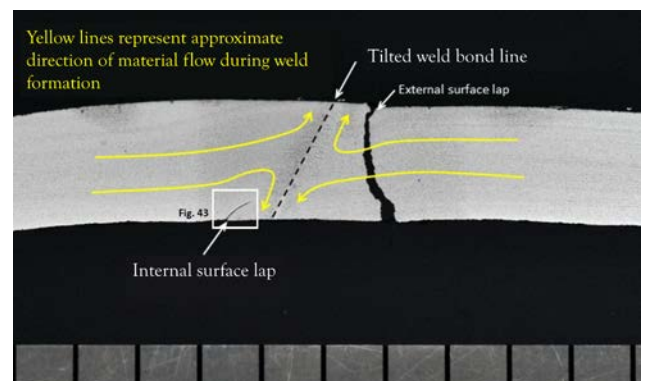
Figure 9 – Macro photograph of the transverse metallographic for an anomaly identified as surface lap. Scale divisions are 1/10 inch.

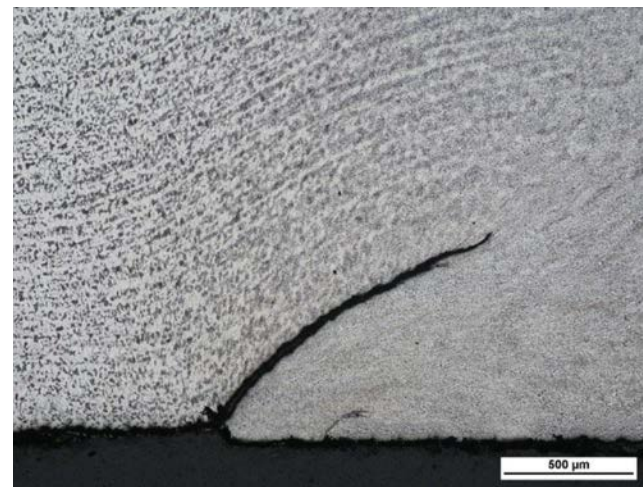
Figure 10 – Detail of an internal surface lap

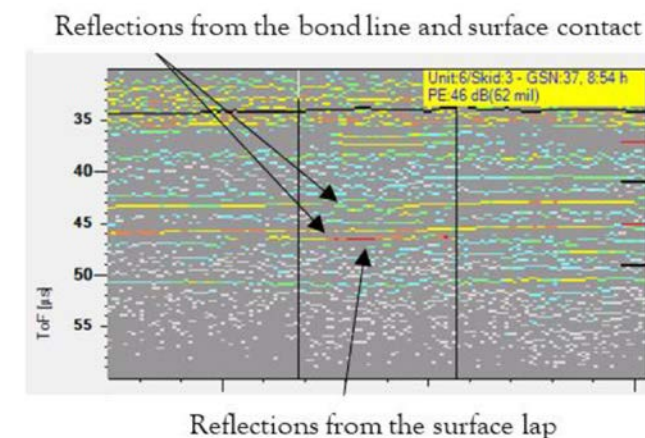
In addition, as can be seen in Figure 8, surface lap anomalies are not located in the bond line but to the side of it. Due to their relative position to the weld centre, the signals of the internal or external bond line-surface contact are blocked by the lap geometry. Therefore, a reduced amplitude sound wave is reflected from the contact between the weld and the surface in the multiple sensor shots along the anomaly (Figure 12).

Figure 12 – B-Scan ILI data for a CW sensor for a verified internal surface lap
