Complex Crack Detection

In an Above-Ground Pipeline

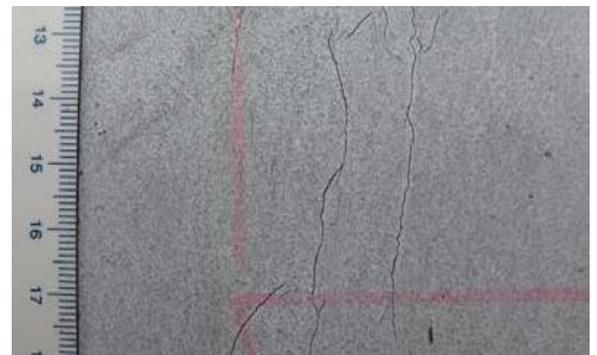
Example of the complex cracking

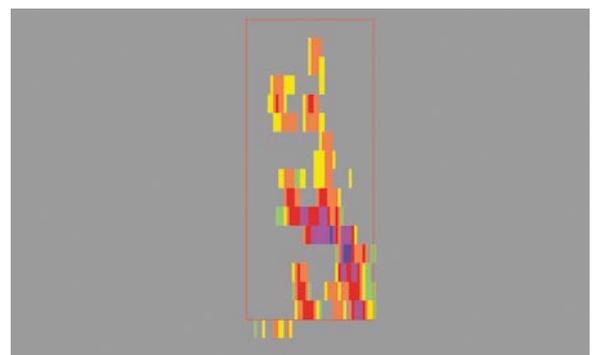
Complex crack field, max. depth 7.5 mm (C-scan)
