Verify Emerging Pipeline Cracking

Using Ultrasonic Technology

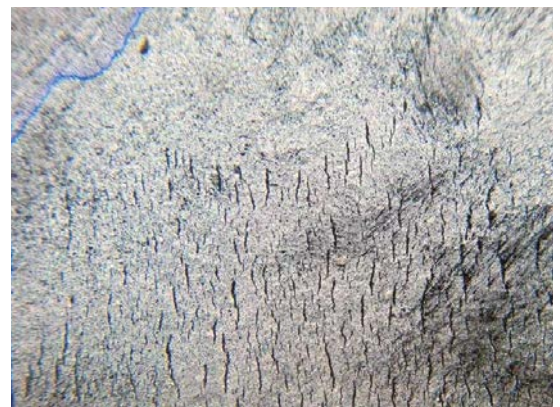
Circumferential crack field detected with ILI results using UCc
