# Cabbage Tree Bay Rising Main.

Improving the resilience of the sewer rising main that runs along Marine Parade, Manly is progressing. The next step is to install a sewer liner into the rising main.

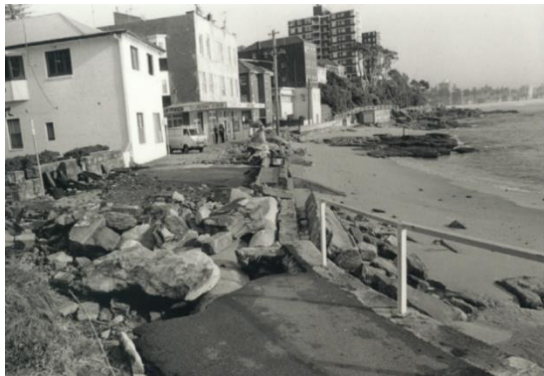
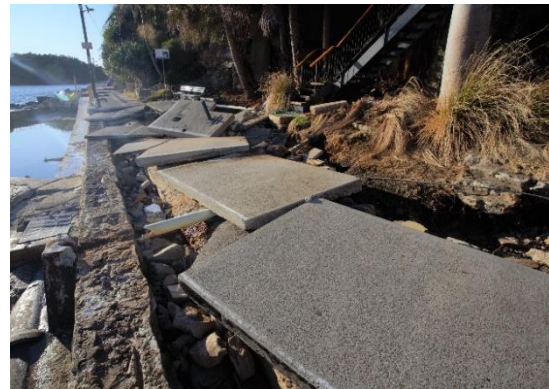
East coast lows bring strong winds and large waves to Cabbage Tree Bay. The storm surge can over top the seawall leading to flooding of the pathway and properties. The surge can damage property. Significant damage occurred in May 1974 and June 2016.

The trunk sewer main from Manly to Shelly Beach and the rising main back to Manly are protected from the sea by the seawall. In the vicinity of Bower Lane the rising main runs outside the seawall. This section of the rising main is concrete encased and when constructed was founded in sand. The storms have removed sand undermining the concrete encasement.

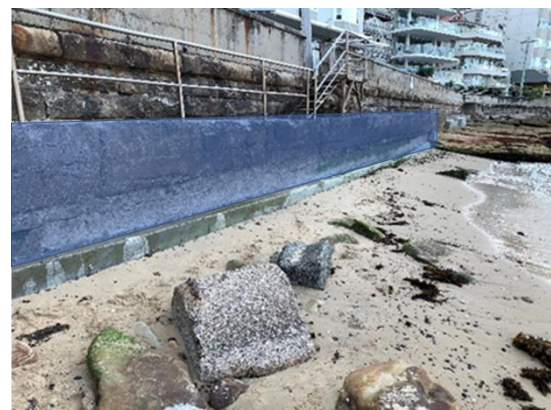
The rising main at Bower Lane shows signs of encasement deterioration with longitudinal cracking that is thought to be due to undermining. To prevent further deterioration this section was propped down to rock.

In 2019, the props were removed and the encasement underpinned with concrete down to rock. The location of the rising main (highlighted in blue) and new concrete underpinning can be seen in the photo.

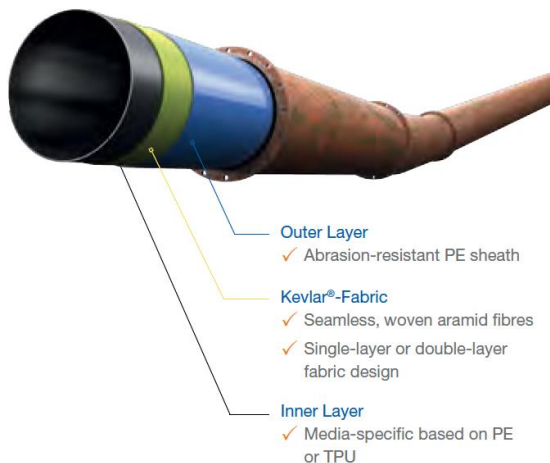
To further increase the resilience of the rising main, we hope to install a liner within the pipeline. A sewer liner will reduce the potential for pipe leakage and failure.

Right now, we're preparing to inspect the rising main with CCTV to ensure the pipeline is suitable for lining. We also need to determine its exact locations and we will use a sonde to do this. We need to know where to dig to expose and cut into the rising main to start and terminate the liner. We are having a bit of an issue with the scour valves that we will use to drain the wastewater from the rising main so that we can put the CCTV in. We expect to fix this issue shortly.

Liners are wide ranging in structural strength and purpose. They are generally used as a no dig solution for pipeline renewal. Installation of a liner into the rising main at Cabbage Tree Bay will decrease the risk of wastewater discharge to the Bay.
