Chromium Connect: Instructions for Bypassing Consumable Scanning

Document Number	CG000610
Title	Chromium Connect: Instructions for Bypassing Consumable Scanning
Revision	Rev A
Revision Date	September 2022

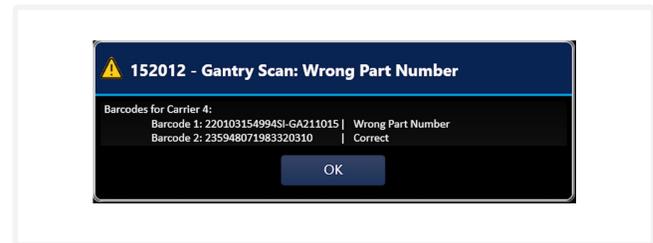
An incorrectly registered barcode may provide a “Wrong Part Number” message (Figure 3). The user will need to conceal the barcode and repeat the scan as per the guidelines below:

Figure 3. A damaged or incorrectly registered barcode may result in “Wrong Part Number” without the option to “CONTINUE.”

- a. Record and photograph the consumable barcode that provides a bad read and share the information with support@10xgenomics.com later.
- b. Verify that the correct consumables are being loaded during the run setup.

- c. To conceal the damaged barcode label (Figure 4), apply an opaque tape over the damaged label of a Sample Index plate, Gel Bead holder barcode, and/or a module strip 2d barcode. To conceal the label on a tube, change the tube orientation in the carrier.

- f. With the barcode obscured, and the deck correctly loaded for the run, repeat the carrier scan. Select “OK” or “RETRY,” then “SCAN.”
- g. Scanning with the concealed barcode should result in “BAD READ | Not Read” (Figure 5), allowing the user to proceed with the run by selecting “CONTINUE” and “CONFIRM.”

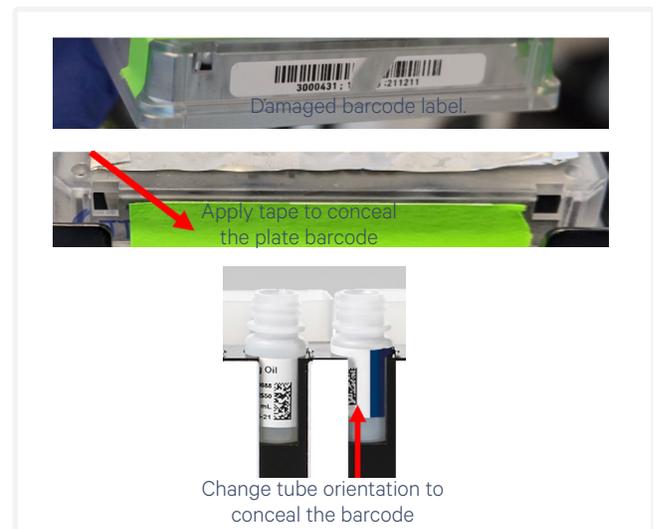
Figure 4. A damaged or incorrectly registered barcode concealed by applying a piece of opaque lab tape or by changing the tube orientation.

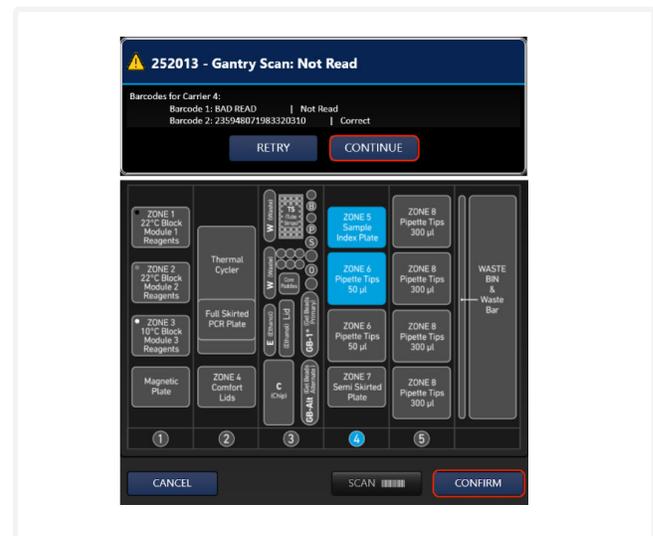
Figure 5. Re-scanning with a concealed label should result in “BAD READ | Not Read,” allowing the user to proceed/bypass further scanning by selecting “CONTINUE” and “CONFIRM.”
