Title: Product wind resistance, dynamic watertightness and impact resistance testing of a Mechsliip Façade for Ash & Lacy

Report No: N950-22-18370 rev1

Customer: Ash & Lacy, Bromford Lane, West Bromwich
West Midlands, B70 7JJ

Issue date: 23 November 2022

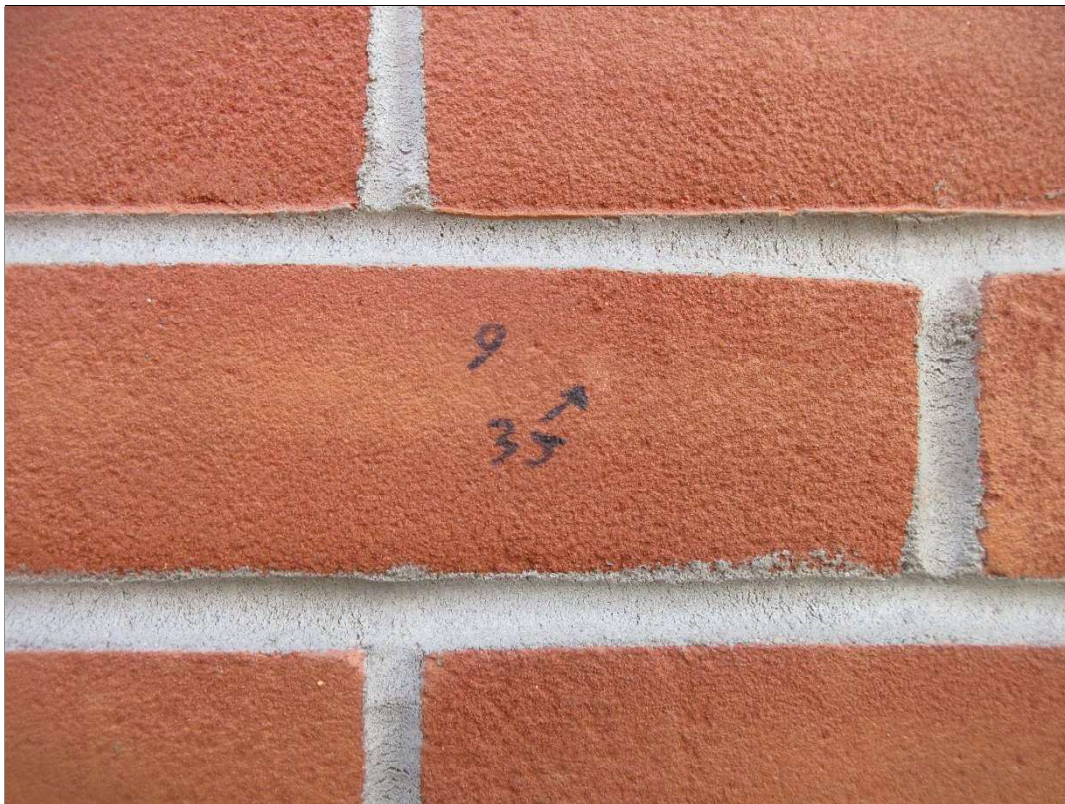
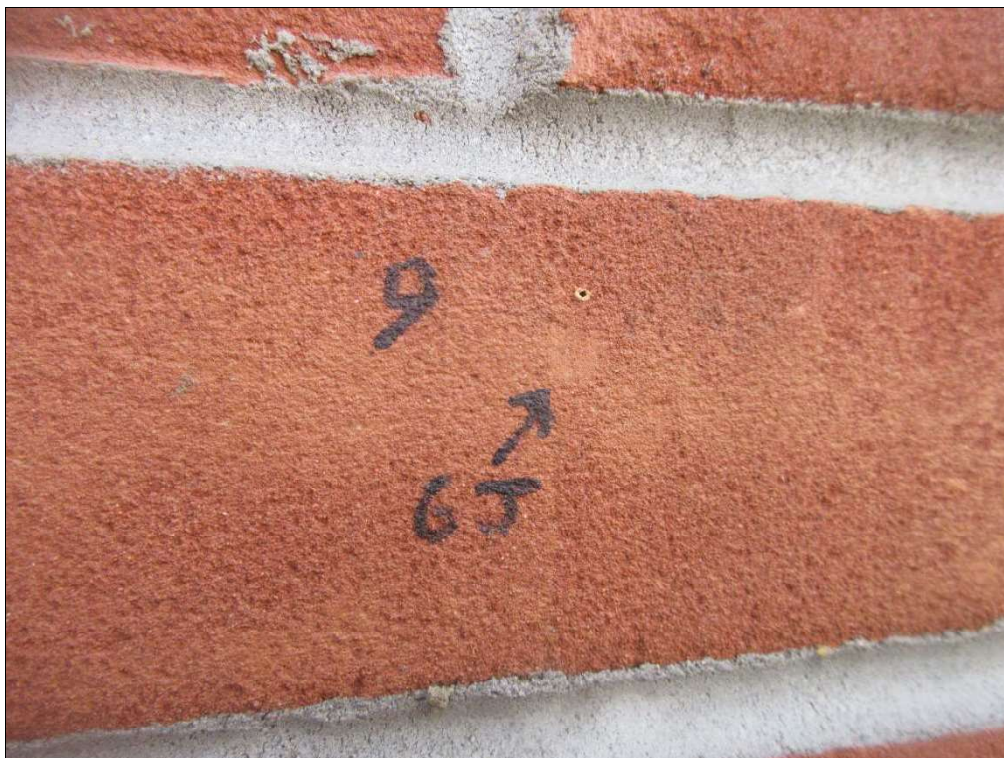
| Impact location | Impact energy (J) | Observations | Classification |
|---|---|---|---|
| 9 | 3 | Slight mark | Class 1 / Negligible risk |
| | 6 | Slight mark | Class 1 |
| | 10 | Minor indent | Class 1 / Negligible risk |

HARD BODY IMPACT AT LOCATION 9

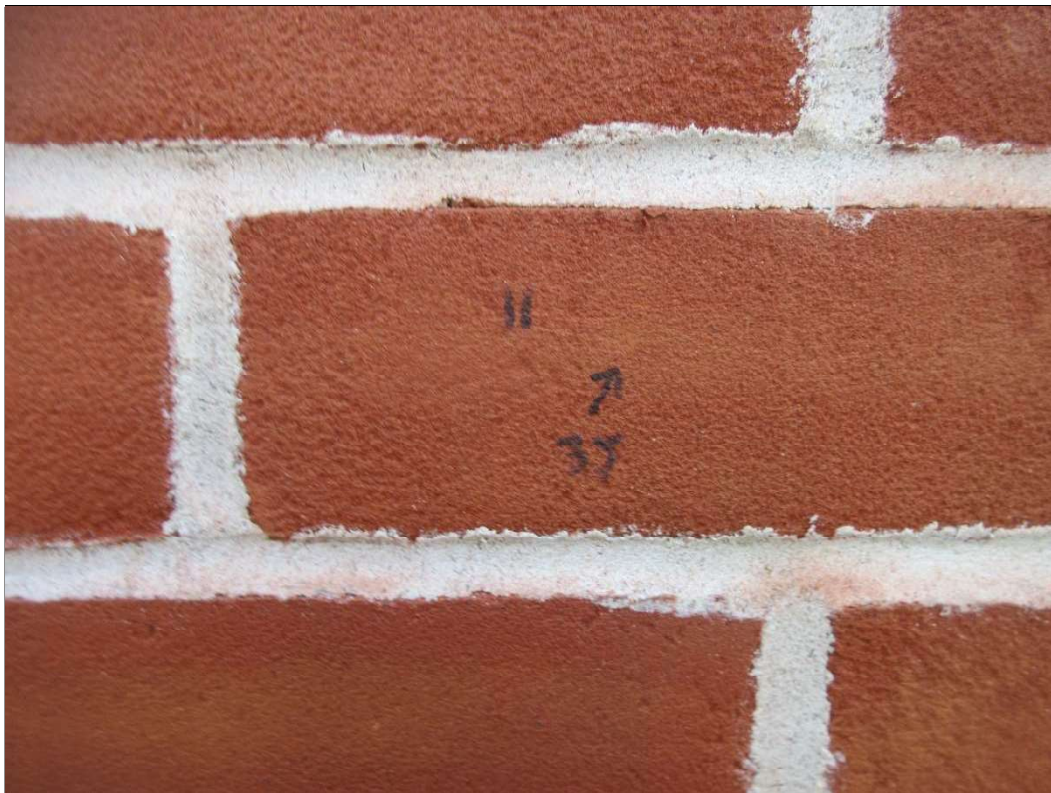
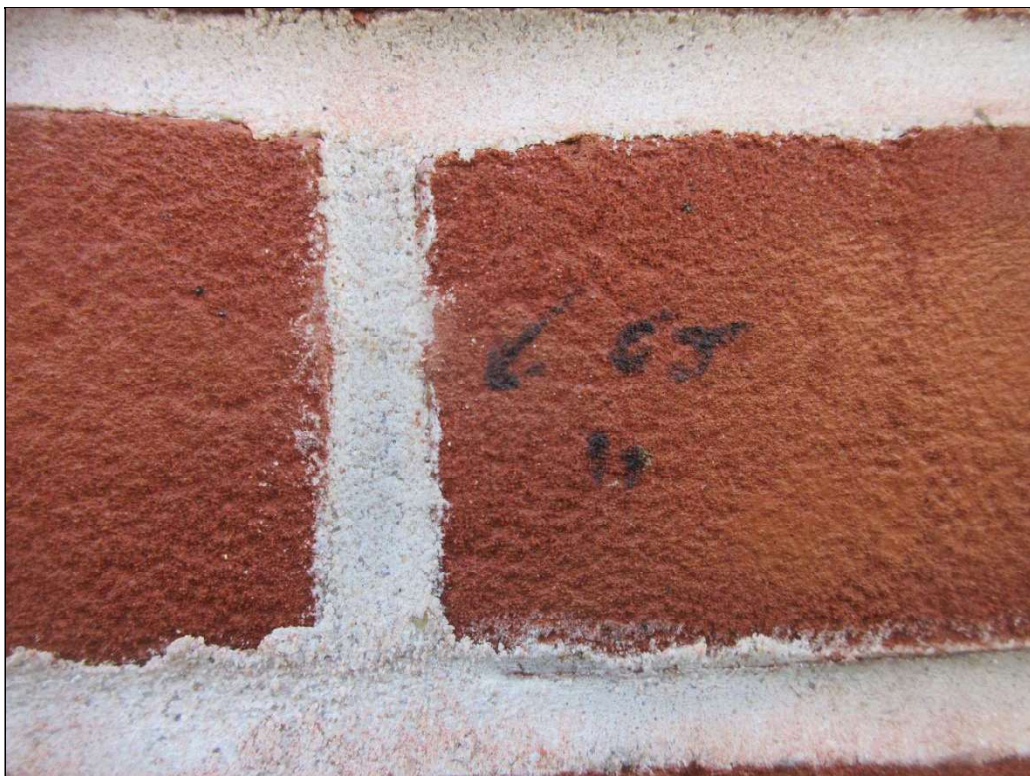
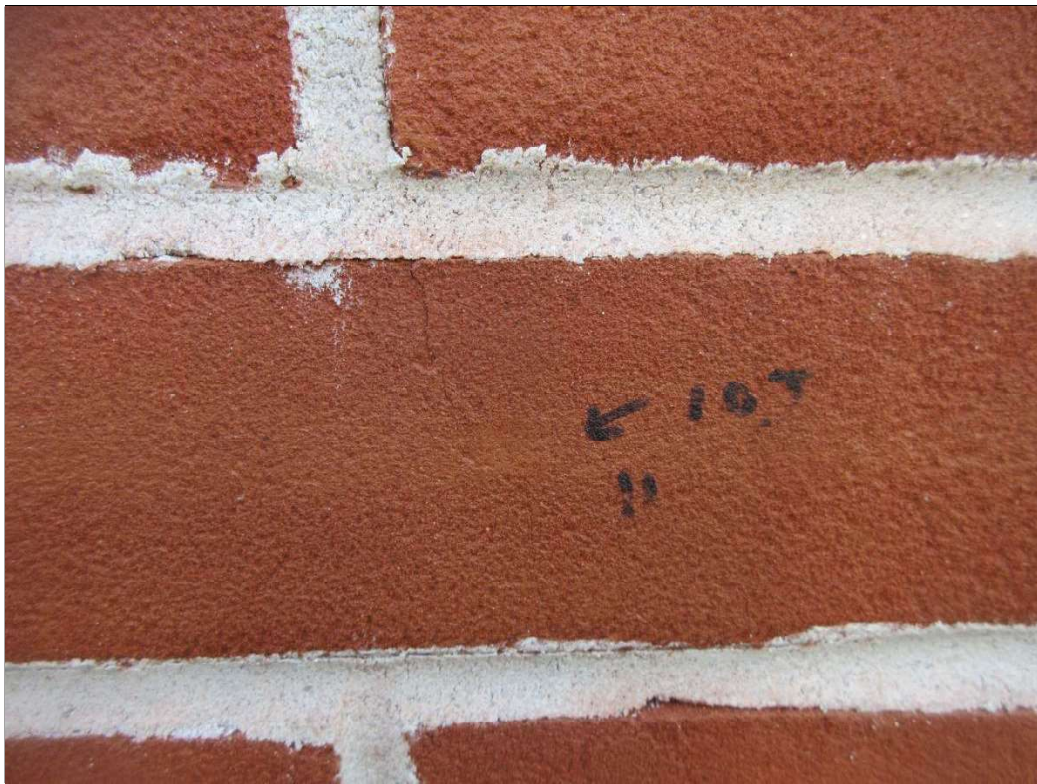
| Impact location | Impact energy (J) | Observations | Classification |
|---|---|---|---|
| 11 | 3 | Slight mark | Class 1 / Negligible risk |
| | 6 | Slight mark | Class 1 |
| | 10 | Minor crack | Class 2 / Negligible risk |

HARD BODY IMPACT AT LOCATION 11

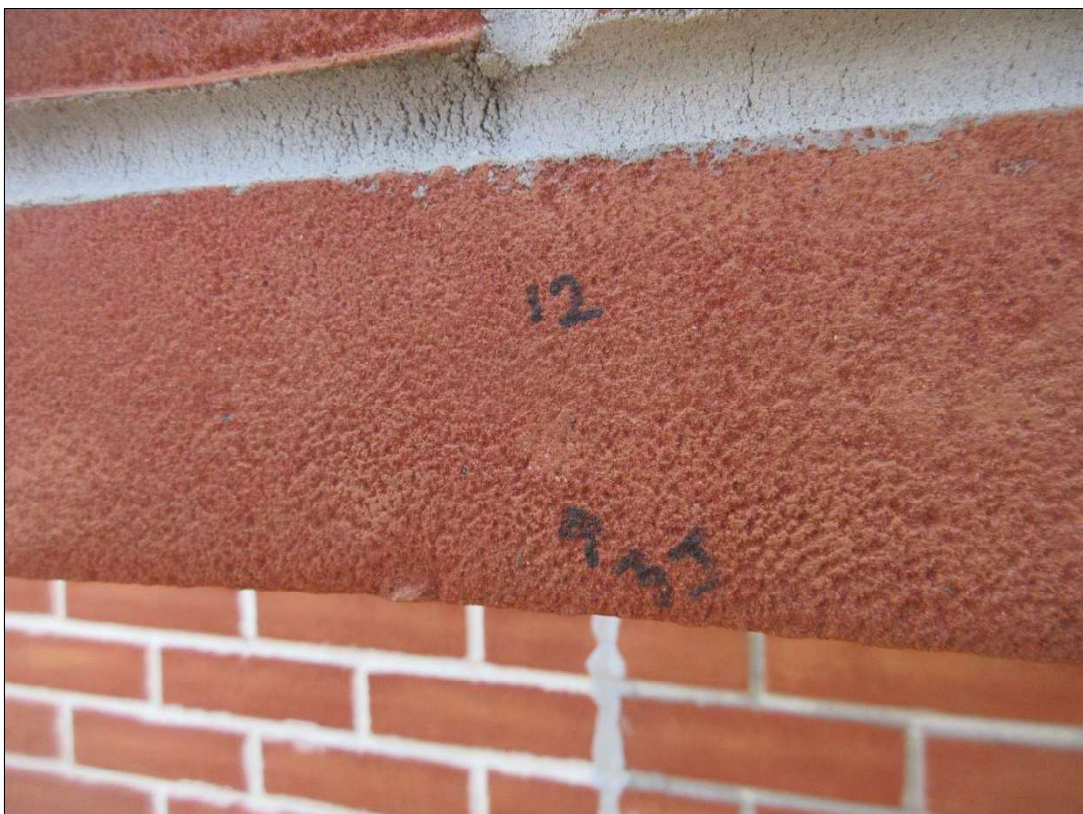
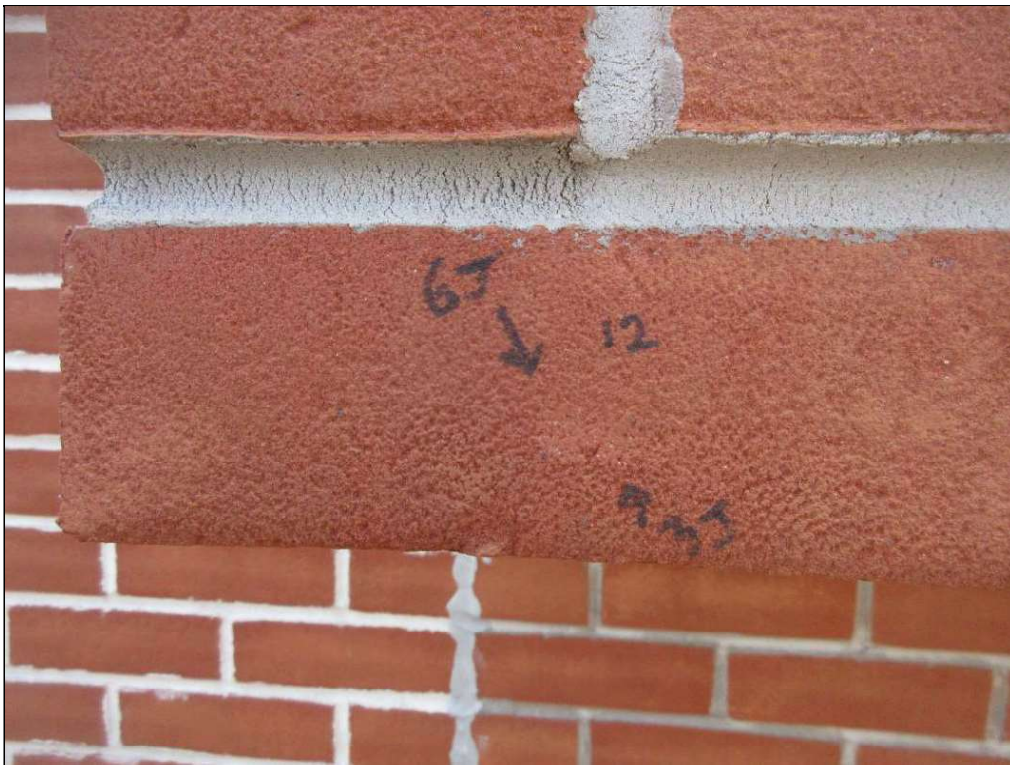
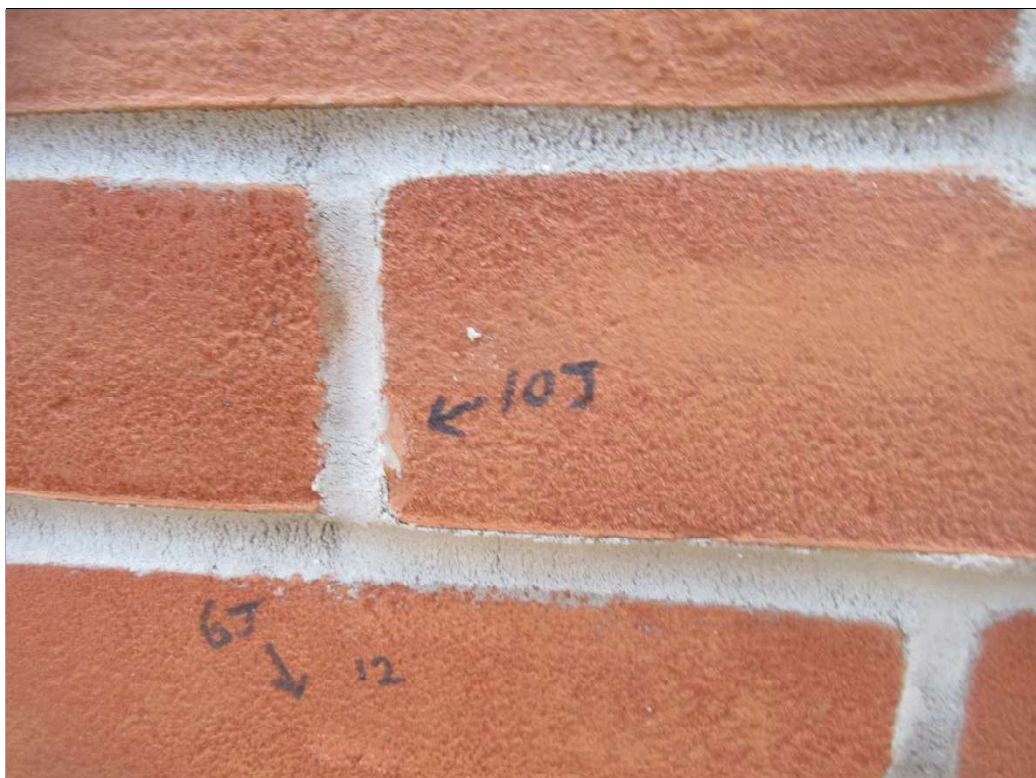
| Impact location | Impact energy (J) | Observations | Classification |
|---|---|---|---|
| 12 | 3 | Slight mark | Class 1 / Negligible risk |
| | 6 | Minor indent | Class 1 |
| | 10 | Minor fragment | Class 2 / Negligible risk |

HARD BODY IMPACT AT LOCATION 12

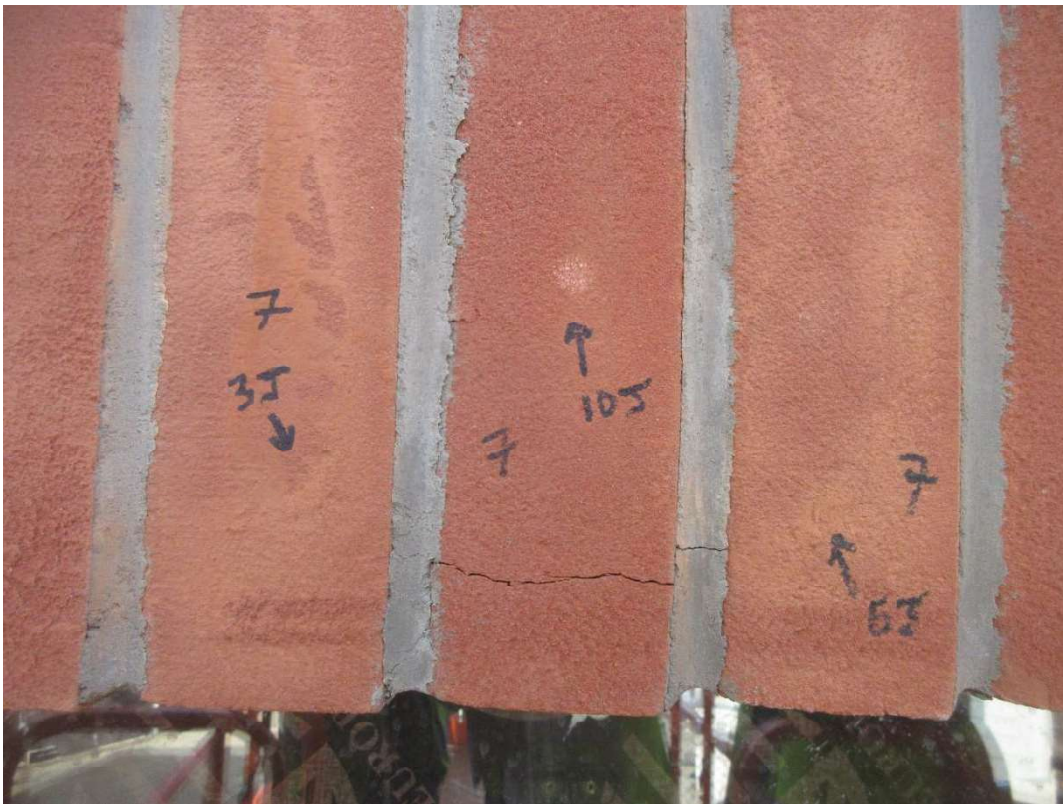
HARD BODY IMPACT AT LOCATION 7

| Impact location | Impact energy (J) | Observations | Classification |
|---|---|---|---|
| 7 | 3 | Slight mark | Class 1 / Negligible risk |
| | 6 | Slight mark | Class 1 |
| | 10 | Horizontal crack in brick | Class 2 / Negligible risk |

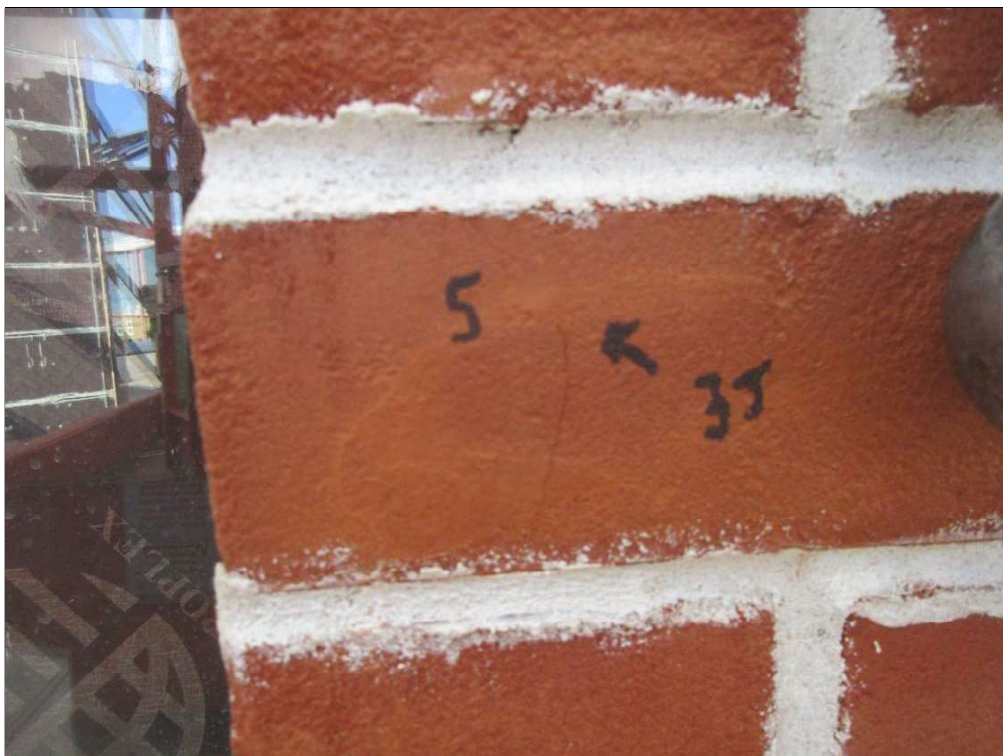
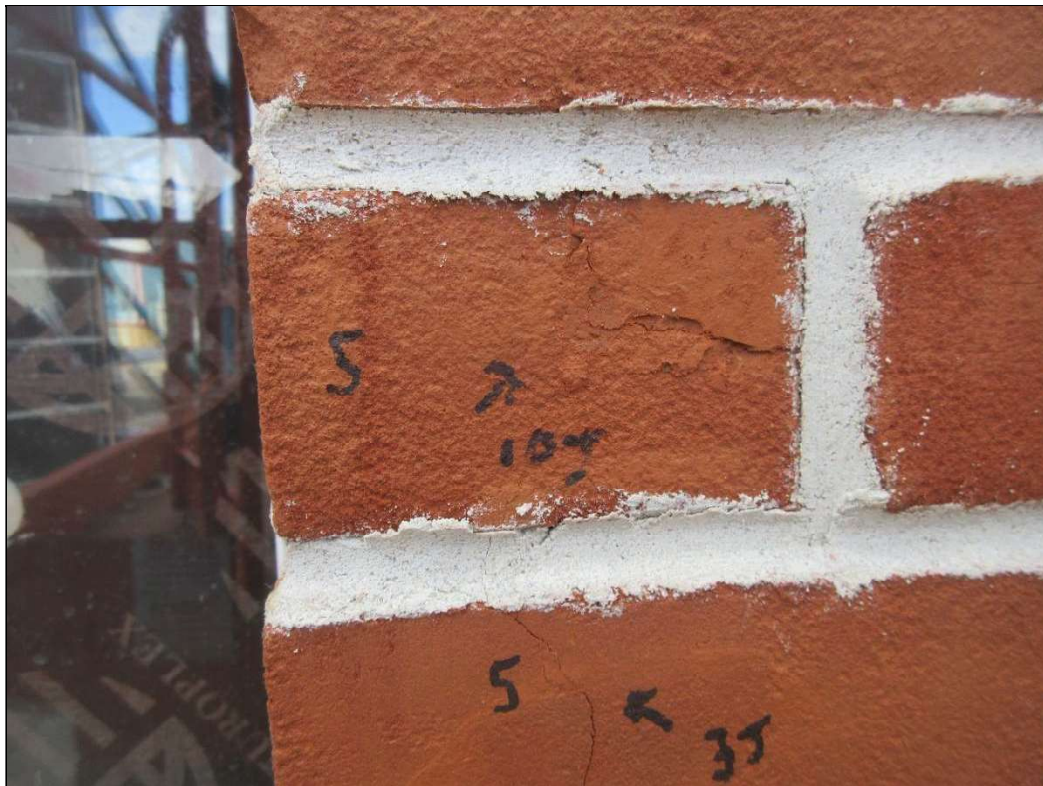
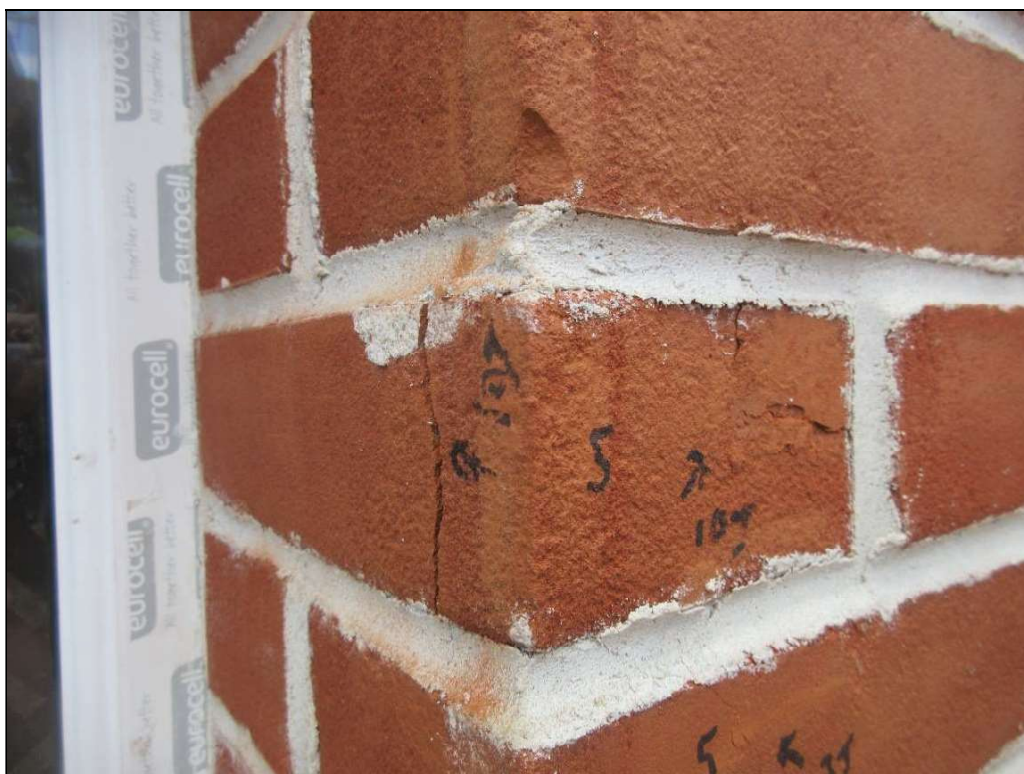
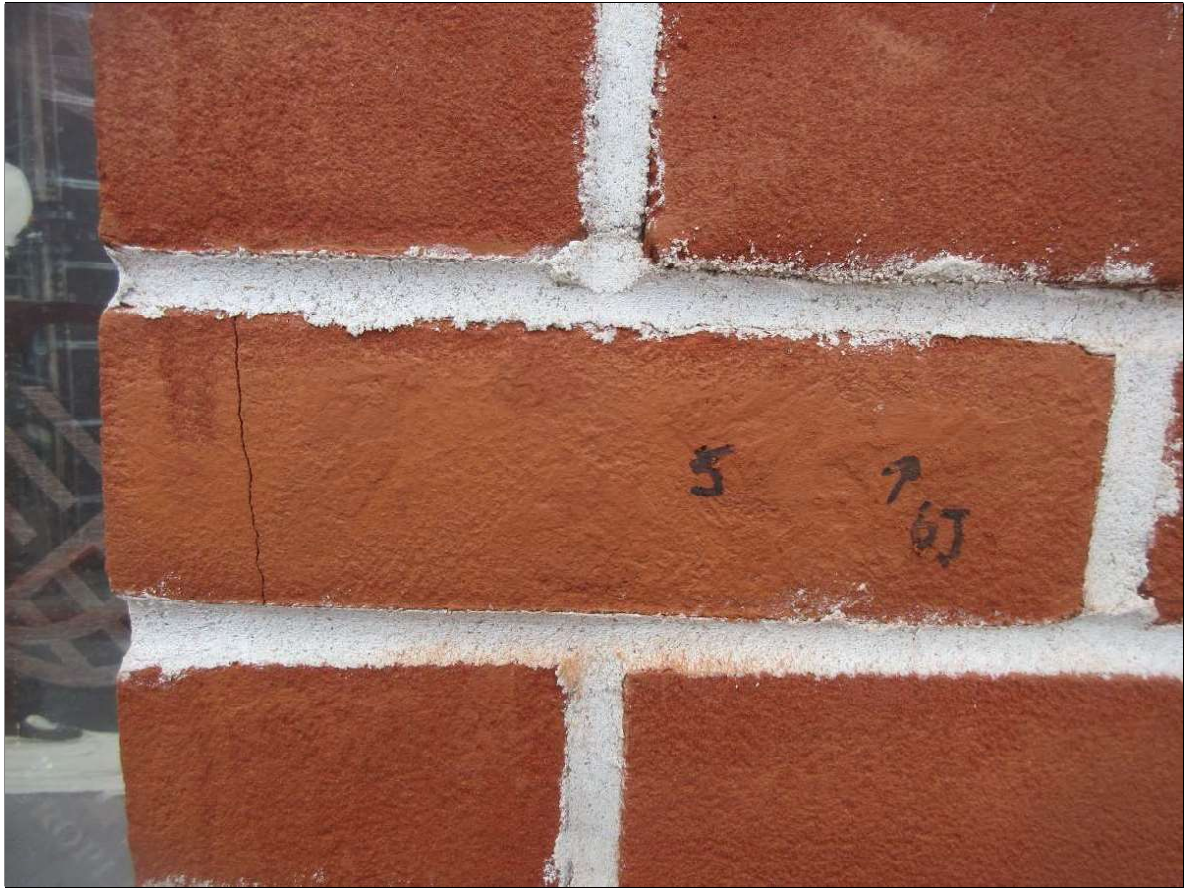
| Impact location | Impact energy (J) | Observations | Classification |
|---|---|---|---|
| 5 | 3 | Hairline crack, small flakes | Class 1 / Negligible risk |
| | 6 | Minor vertical crack in brick | Class 2 |
| | 10 | Diagonal & vertical crack | Class 2 / Negligible risk |

HARD BODY IMPACT AT LOCATION 5
