TECHNICAL ADVICE

APPLICATION Surfactant leaching

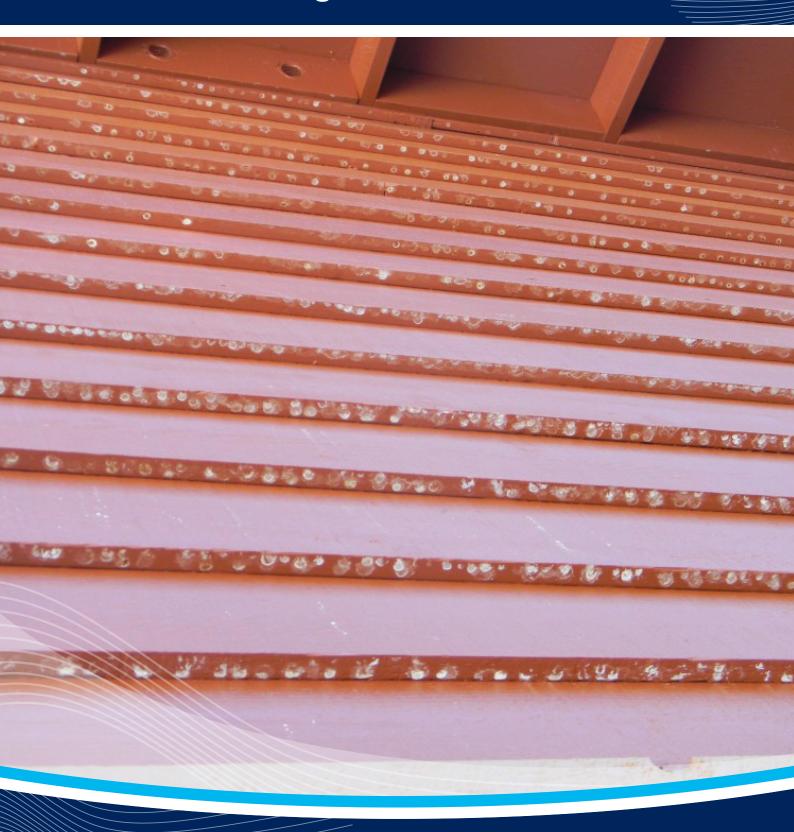
"Surfactant leaching" is best described as soapy, sticky or oily spots or perhaps glossy streaks that appear on newly painted surfaces, usually within the first few weeks after application.

The leached material can vary in colour or appearance from almost clear (being detected as glossy patches on the paint surface) to whitish (translucent), to shades of tan, brown or orange.

Surfactant leaching occurs when poor drying conditions cause the paint to dry too slowly, allowing the surfactants to rise to the surface of the paint film in concentrated amounts and thereby leaving oily or sticky deposits or residues on the painted surface.

On exterior surfaces, surfactant leaching will usually weather off over a short period (approximately a month) without the need for intervention. Rinsing with fresh water can help to wash it away.

On interior surfaces, the leached material can be easily removed within a week (allow the paint film to fully cure and harden) by washing with a mild soapy solution and a soft cloth or sponge, followed by a thorough rinse with clean water. Care must be exercised when washing to prevent damage to the soft or uncured paint film.
