General Equipment Safety Bulletin

Bulletin 006/2012

Subject: Caterpillar AD55B Fuel Transfer Pump De-isolation after Service Work has been performed on Fuel System.

Affected Product: AD55B Underground Articulated Truck Serial Prefix: JNW

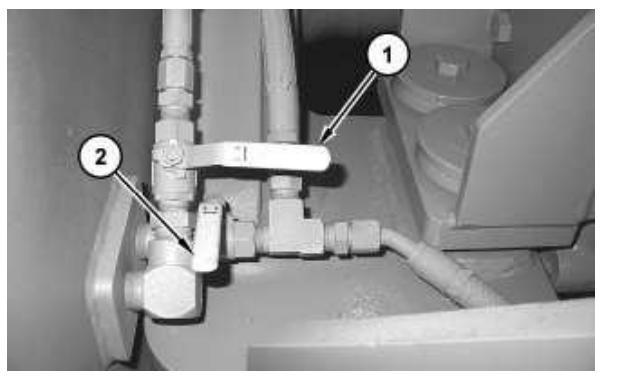
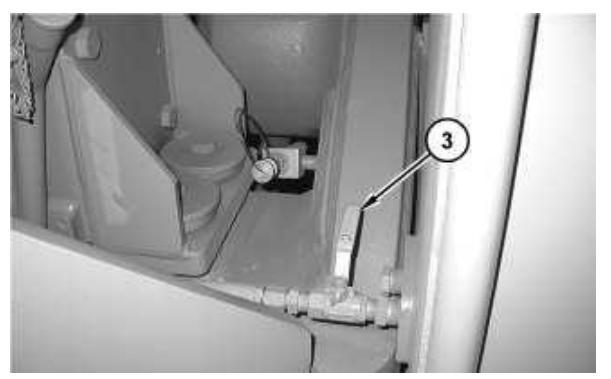
Left side of machine Right side of machine 1. Return valve - LHS 2. Supply valve - LHS 3. Supply valve-RHS NB. All valves shown in closed position

Ensure all valves on the fuel system that are required to be open for engine operation are open after a service task is completed. Refer illustrations below.
