WARRANTY BULLETIN

Subject: Warranty Claim Requirements – Boilers

Date: 7/16/2019

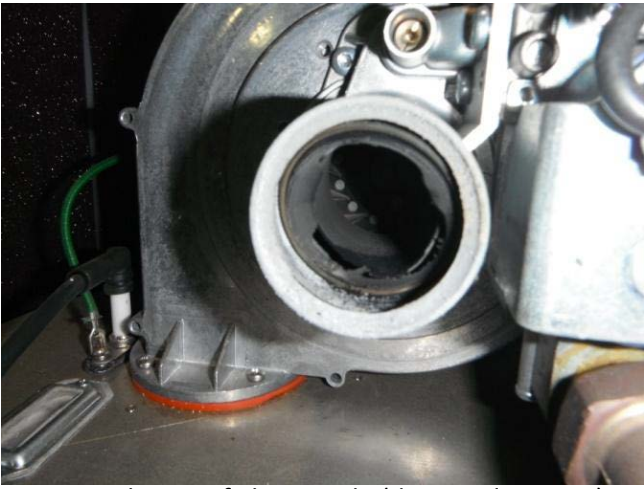
Picture showing failure mode (damaged Venturi)

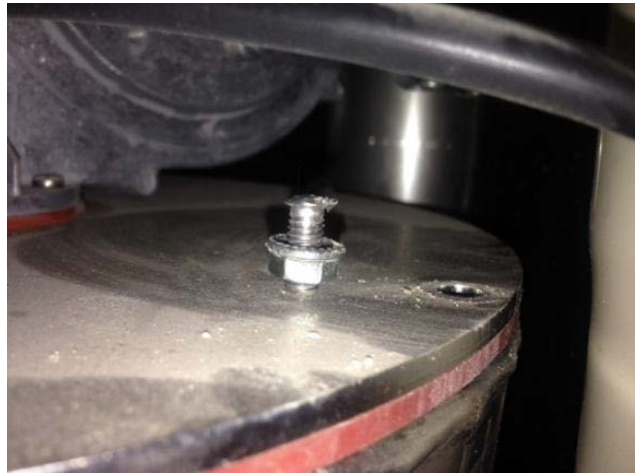
Picture showing failure mode (broken stud)

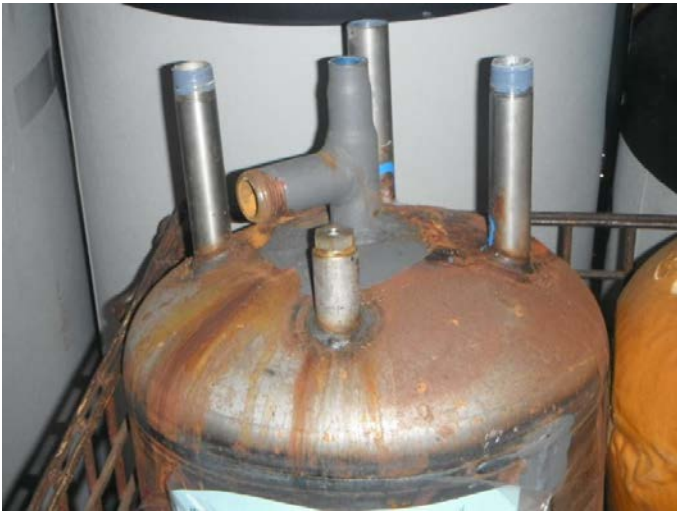
Picture showing failure mode (pin hole leak in the Excellence tank nipple connection)

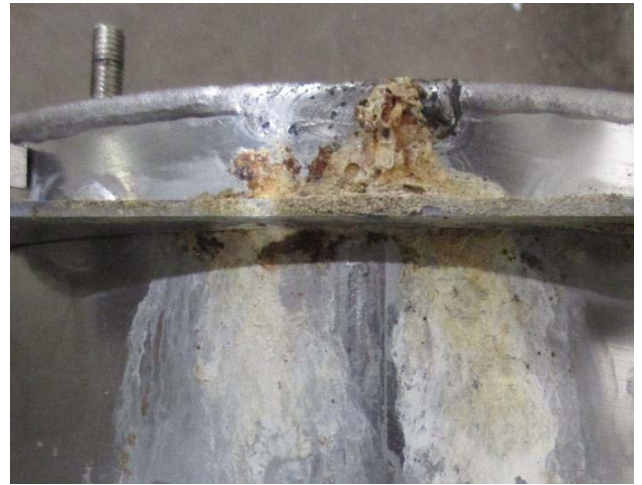
Picture showing failure mode (circular weld leak)

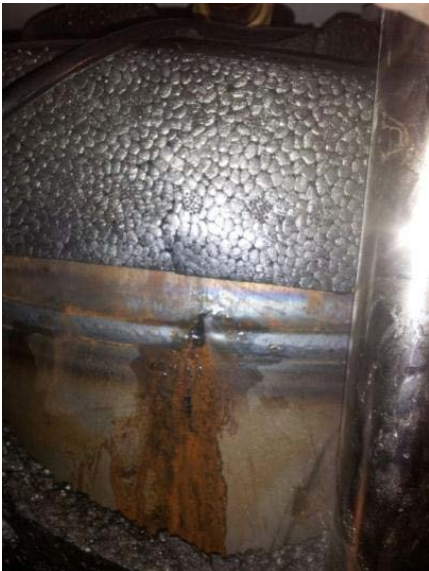
Picture showing failure mode (leak at weld)

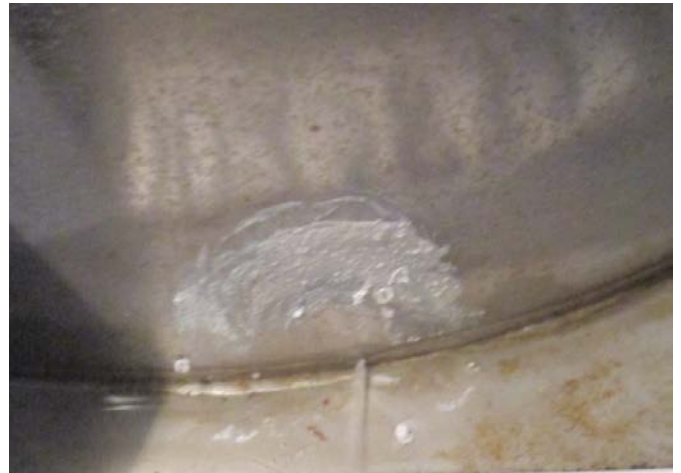
Picture showing failure mode (pin hole leak in the weld)
