# Greater Manchester's Clean Air Plan to tackle Nitrogen Dioxide Exceedances at the Roadside

# Note 20: Greater Manchester Specialised Goods Surveys: Results Summary

Version Status:	APPROVED	Prepared by:	Transport for Greater Manchester on behalf of the 10 Local Authorities of Greater Manchester
Authorised by:	Ian Palmer		
Date:	5 <sup>th</sup> August 2019

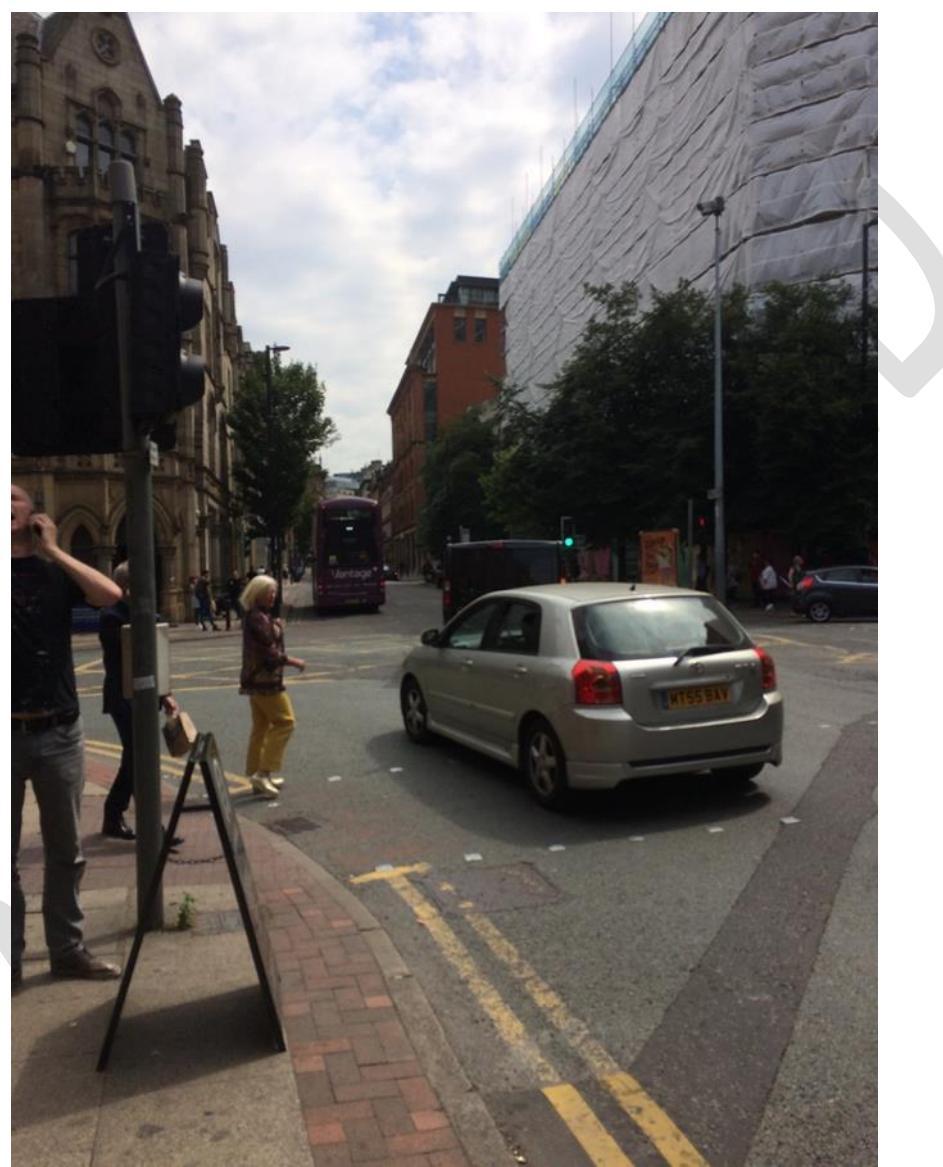
#### A.2.1 Backed up traffic from John Dalton Street

• Congestion: There were regular instances in the morning with inbound traffic on the other side of the junction backed up preventing forward movement through the junction. This could have been due to traffic on John Dalton Street being held for tram movements etc. This is shown in A.2.1.

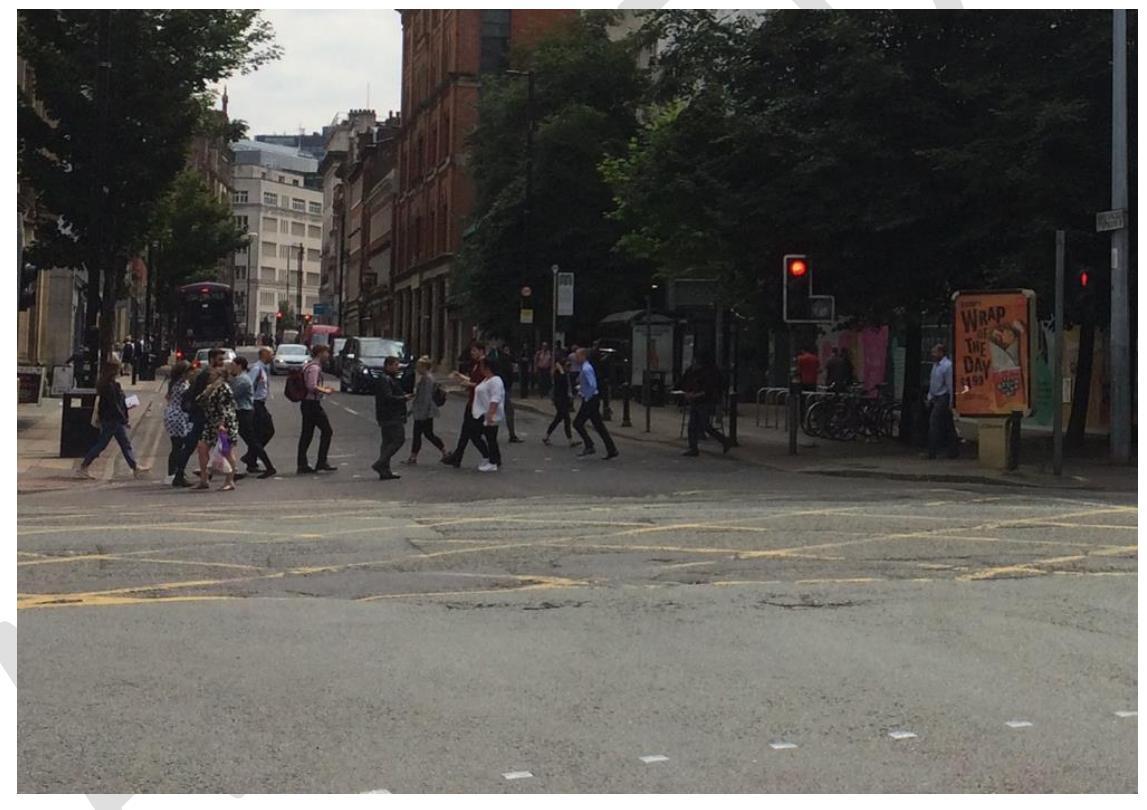
## A.2. 2 Poor quality road surface at Bridge Street/Deansgate junction

- Traffic Lights and timing: The lights seemed to have regular timings which didn't reflect directional traffic flow. There were numerous occasions where three to four double decker buses were sitting in the queue for the lights and the time setting would not allow the queue to clear even if the receiving arm had the capacity to accommodate the vehicles.
- Road Surface quality: The road surface at the Deansgate junction is starting to crack. It is already uneven and has rutting lines running along Deansgate. This means traffic, especially buses, using Bridge Street have to slow down for the junction to give the passenger a smoother ride. This reduces the capacity of the junction. This is shown in A.2. 2 below.

- Pedestrian issues: There is a high flow of pedestrians on Deansgate and at times this could cause some safety near-misses. The poor road surface meant pedestrians were having to deviate from the crossings to avoid potholes.
- Bus issues: It is understood that this is an important bus corridor into the city for multiple routes and Stagecoach & First have multiple routes plus National Express Coaches to Liverpool. A number of buses appeared to be pre-2013 and therefore non-compliant. A large number of these also appeared to be carrying very few passengers. There were frequently buses queued at the traffic signals, and others at a bus stop further down Bridge Street, all idling as they were queuing or waiting.

- Most polluting vehicle(s) that day: A black cab with a 09 registration plate was observed.
- A.2.4 Potential suggestions/solutions:
  - Improvements to the road surface could be made.

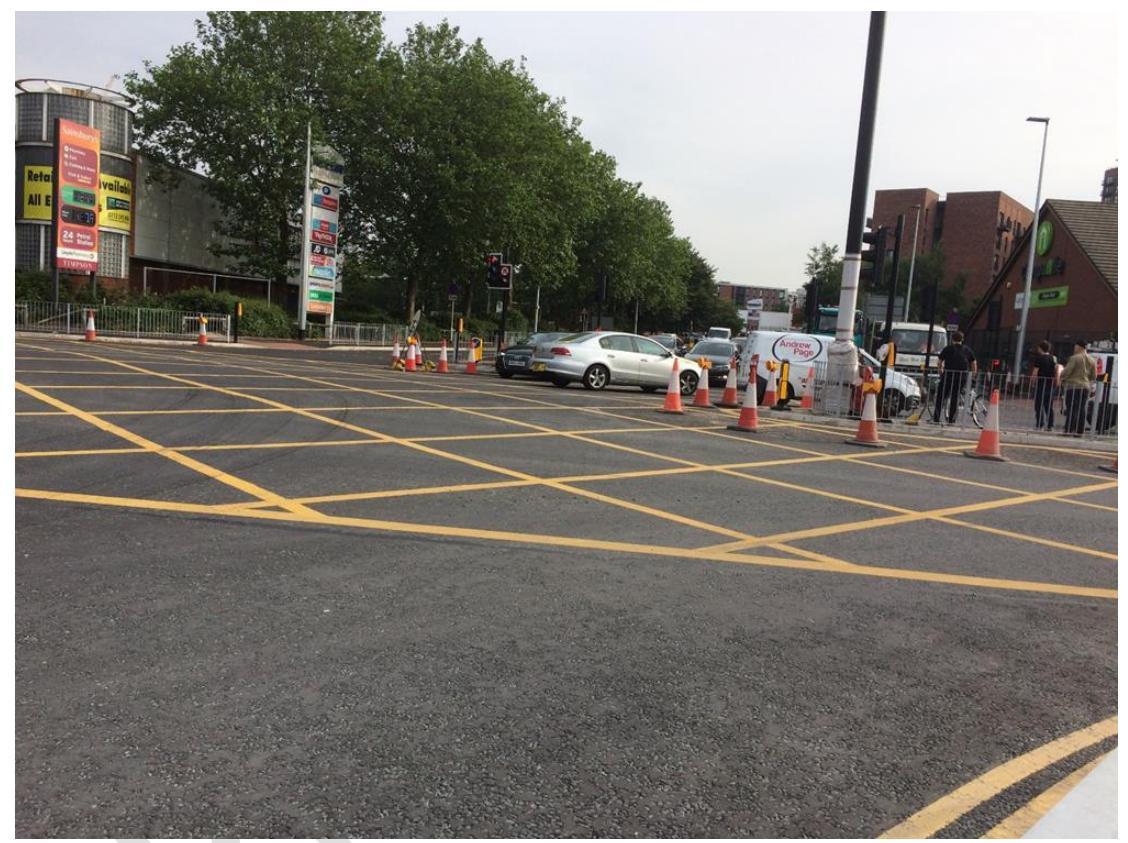
#### A.2. 3 Trapped traffic on Ordsall Lane

• Safety concerns or near misses observed: There was lots of near misses involving cars that had driven through the lights when the exit route was not free, so they were effectively blocking traffic flow. This was despite yellow boxes being painted on the road. **A.2. 3** below shows an example of this – here, inbound traffic is blocking movements out of Ordsall Lane.

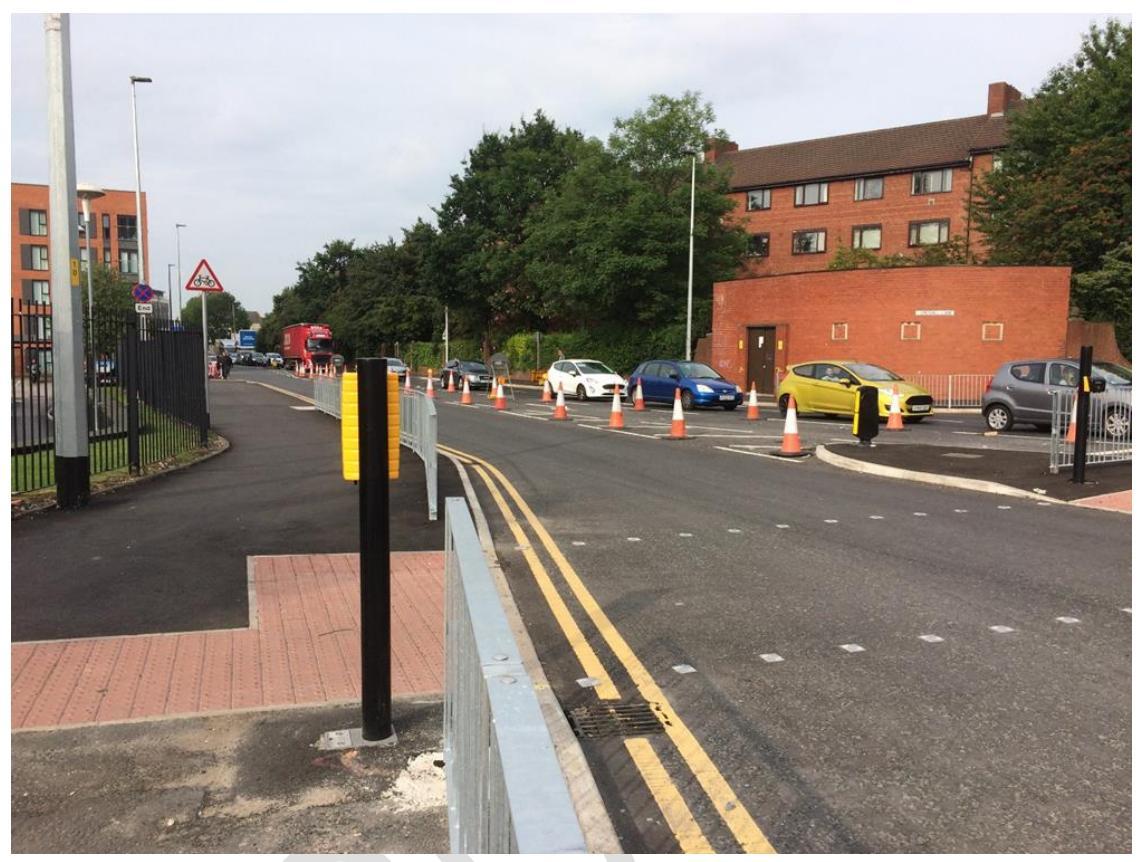
A.2. 4 Traffic queuing on Ordsall Lane

- Traffic Flow: Heavier freight route, serving some of the local major construction projects including new tower blocks and highway improvements. Regent Road was by far the dominant traffic flow. There was a relatively modest flow of traffic on the minor road despite having a retail park nearby.
- Congestion: The whole area was congested as it was reduced to one lane in each direction, significantly increasing journey times and likely to result in drivers (of all vehicles) taking alternative routes. As Regent Road was reduced to one lane in either direction it was causing traffic to build on the side roads, as demonstrated in A.2. 4

- Yellow box: The junction was regularly being blocked by turning vehicles which prevented some through movements on the side roads. See safety concerns above.

- It is clear that once the roadworks in this area are complete then conditions will be vastly improved the road and junctions will operate at a higher capacity, journey times will be faster, polluting construction traffic will be removed, and drivers will be less frustrated and aggressive in their driving. The removal of roadworks may well have positive air quality impacts in other areas too as there will be less rerouting to other routes.
